**23 Year Assessment and Total Reconstruction of Apron at
Ellington Airport using Beam on Elastic Foundation
Technique**

By Adil Godiwalla, P.E.

Houston Airport System

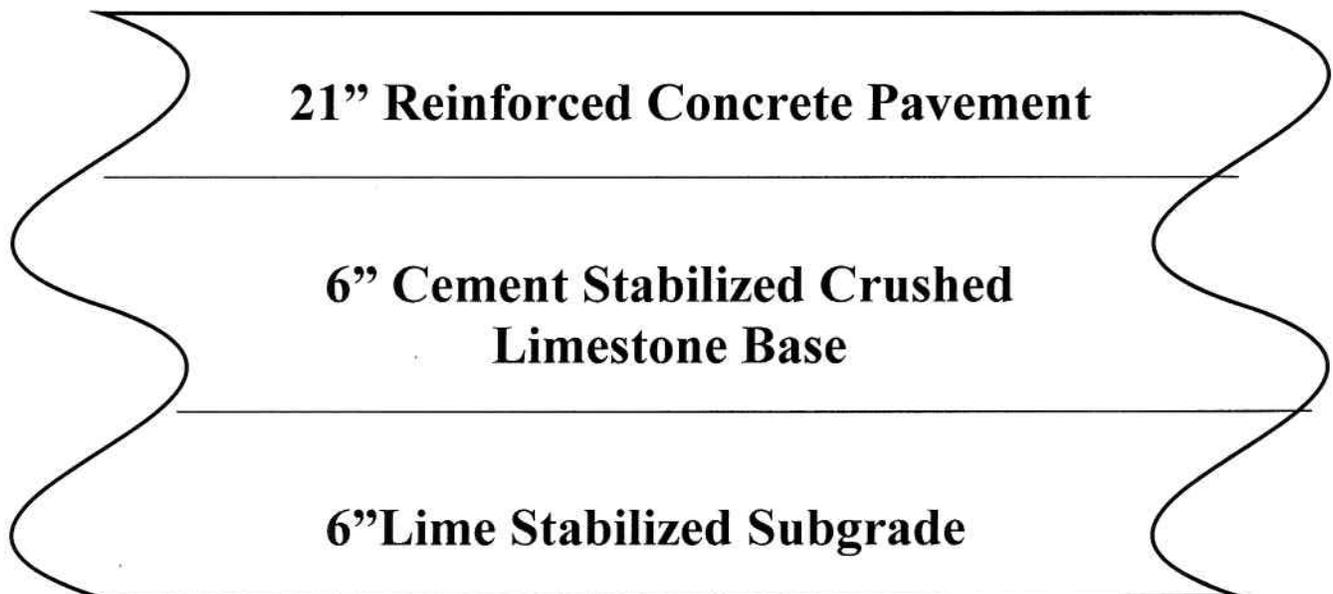
Figure No. 1 : Pavement Cross-Section

The computation worked out to 21” Reinforced Concrete pavement over 6” cement stabilized crushed limestone base over 6” lime stabilized subgrade. Due to the excessive stresses and strains in the concrete pavement, caused by the movement of the fault, I decided to put two layers of reinforcing steel, one near the bottom of the concrete pavement and one near the top surface of the concrete pavement. The pavement cross-section is shown in Figure No. 1.

The design was performed for the pavement to bridge across the geological fault, thereby precluding vertical deformations. This technique was successful as the vertical deflections would have caused the pavement to crack. However, this restraint in the vertical direction caused the pavement to move horizontally in tandem with the fault movements.
