Alkali-Silica Reaction in concrete pavement at Gimpo international Airport a maintenance case using HMA overlays

Pyung-Jin Kwak, Tae-Hun Kim, Je-Il Lee, Woo-Yeong Jung

FAA Worldwide Airport Technology Transfer Conference

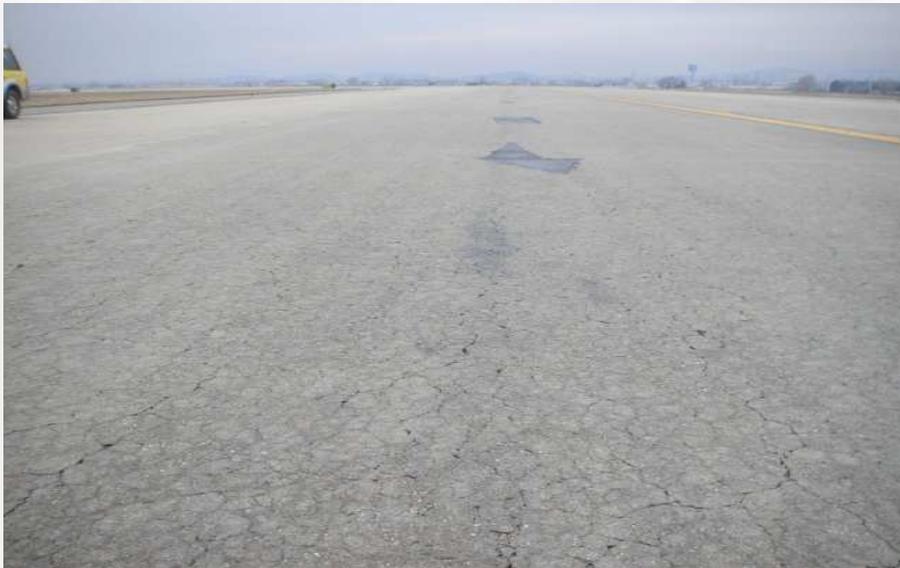
The entire map cracking

- The pavement required either reconstruction of entire pavement layer or repairs of the partial pavement layer
- The entire reconstruction was not feasible
- 4 different types of overlays were carried out to extend the pavement life

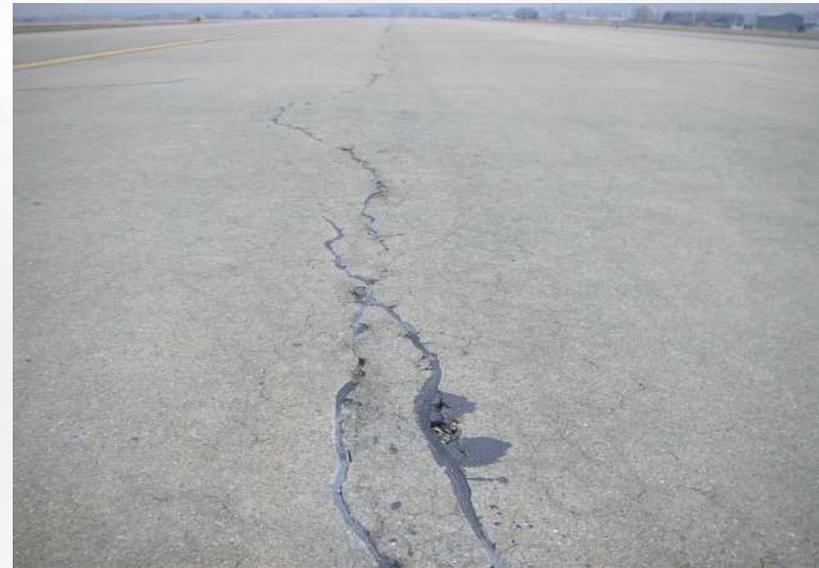
The longitudinal cracking

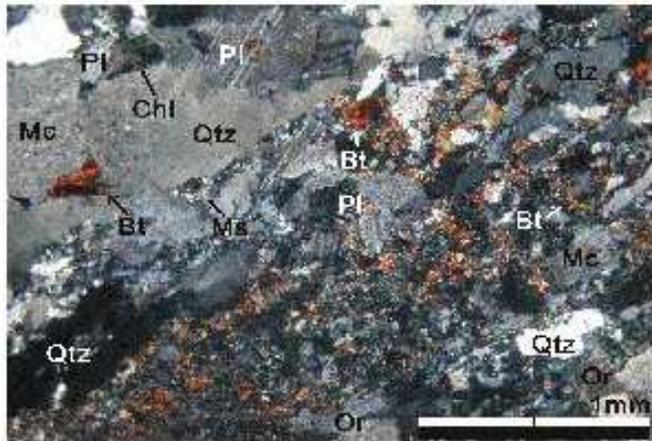
Cross nicol(40X)

Lithological analysis

- Metamorphic rock such as quartz feldspar gneiss, banded gneiss and garnet biotite gneiss.
- Most of the quartz was fine-grained ~ neutrality-grained crystal of the subhedral or oval shape
- showing undulatory extinction and suture texture

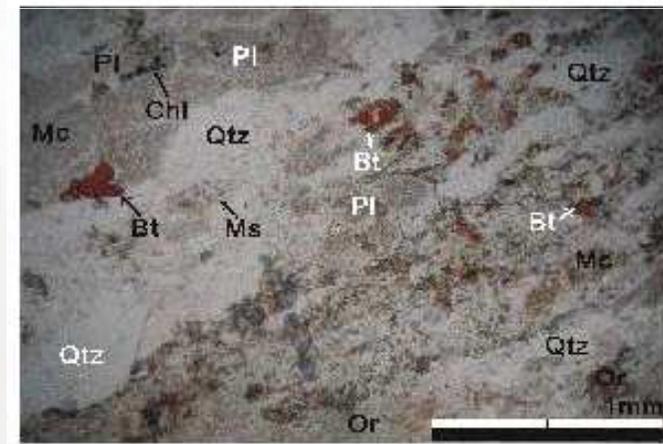
Open nicol(40X)

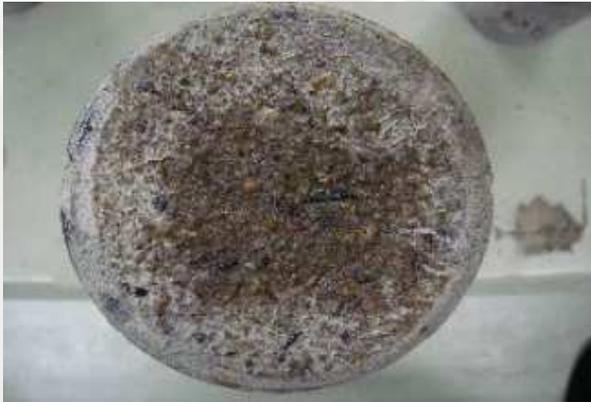
The surface condition

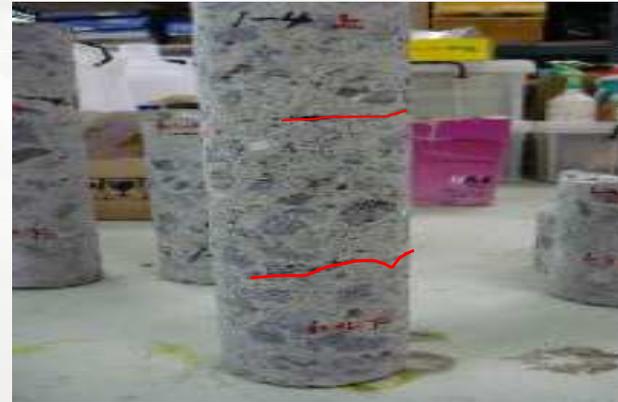
Parallel crack

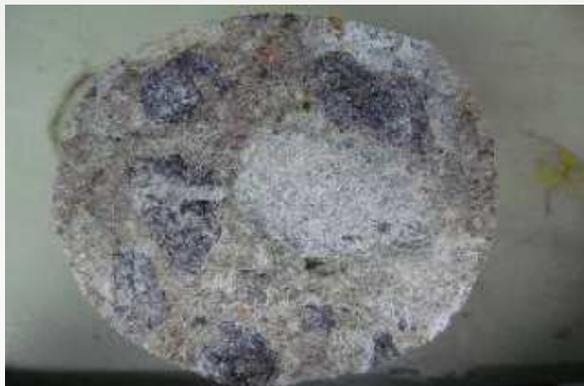
Aggregate reaction product in the parallel crack area

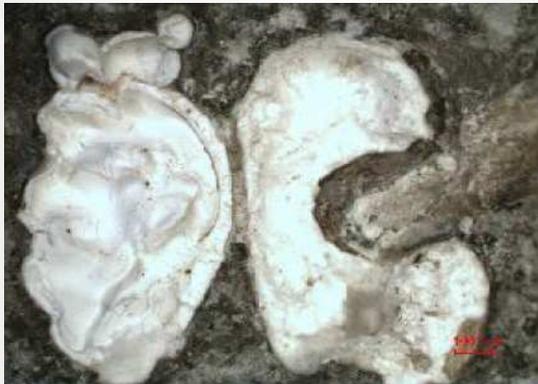
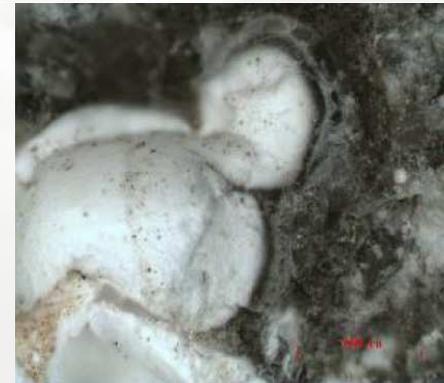
Reaction product within air-void(40X)

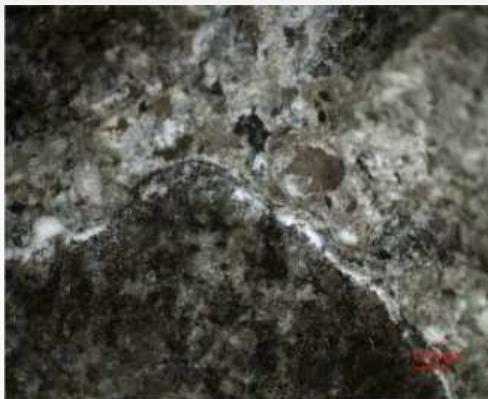
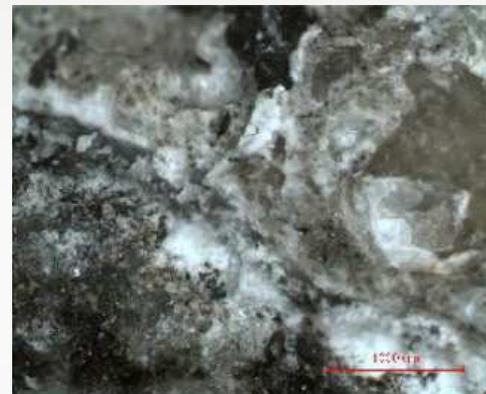
Aggregate reaction product within aggregate boundaries

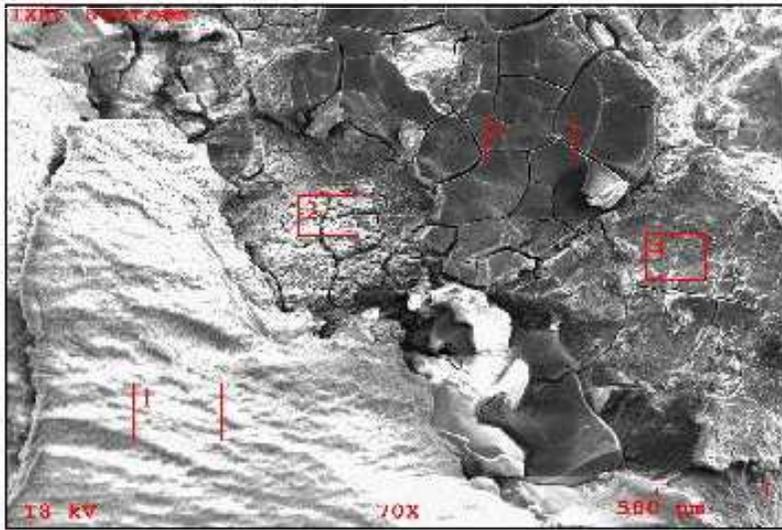
The spectrum of white product in SEM Survey (70X)

- $Si > K > O > Ca$

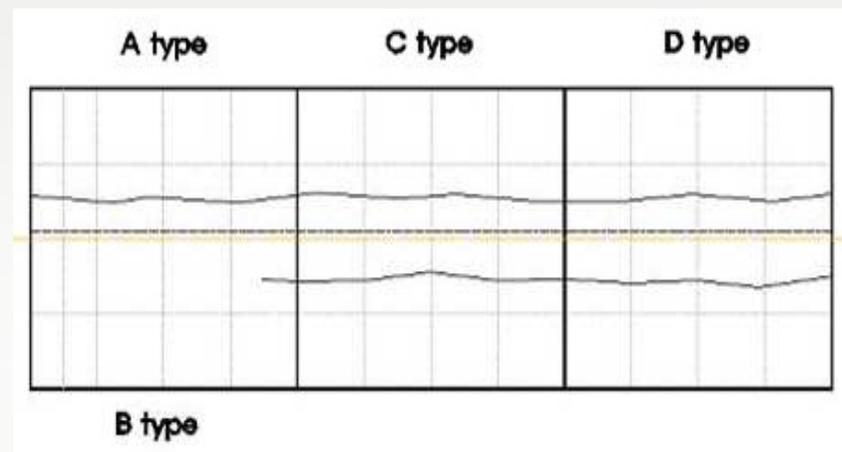
Longitudinal cracking

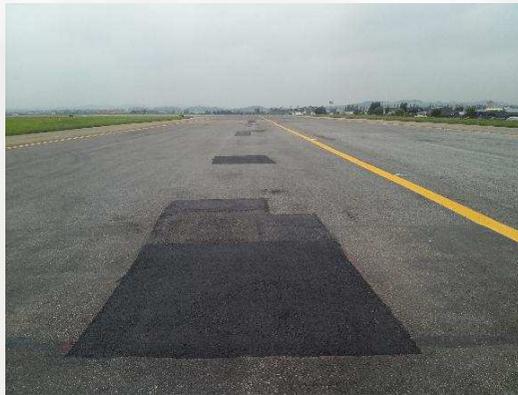
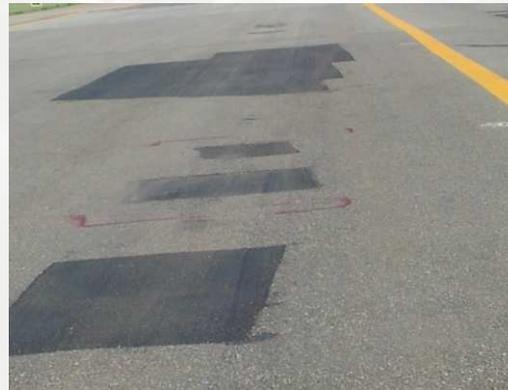
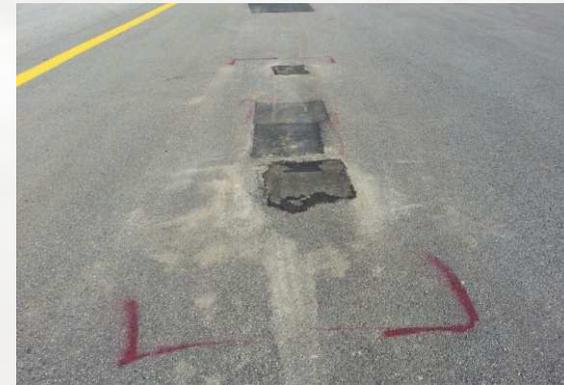
Partial repairs of the potholes area

- B-type was the lowest repair rate than the others
- B-type strong against rutting and fall slightly against top-down cracks
