ALKALI-SILICA REACTION IN CONCRETE PAVEMENT AT GIMPO INTERNATIONAL  
AIRPORT – A MAINTENANCE CASE STUDY USING HMA OVERLAYS

PRESENTED FOR THE  
2014 FAA WORLDWIDE AIRPORT TECHNOLOGY TRANSFER CONFERENCE  
Galloway, New Jersey, USA

AUGUST 2014

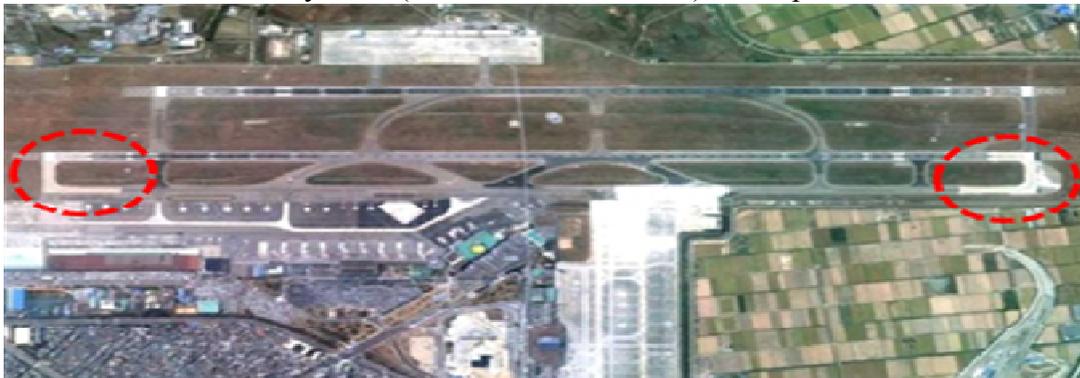
Concrete pavement at the threshold of the runway in Gimpo International Airport, was constructed in 1996 and the parallel taxiway concrete pavement that was completed in 1995 was found to have cracks caused by ASR (Alkali-Silica Reaction) in the pavement evaluation in 2009.

Figure 1. ASR occurrence site

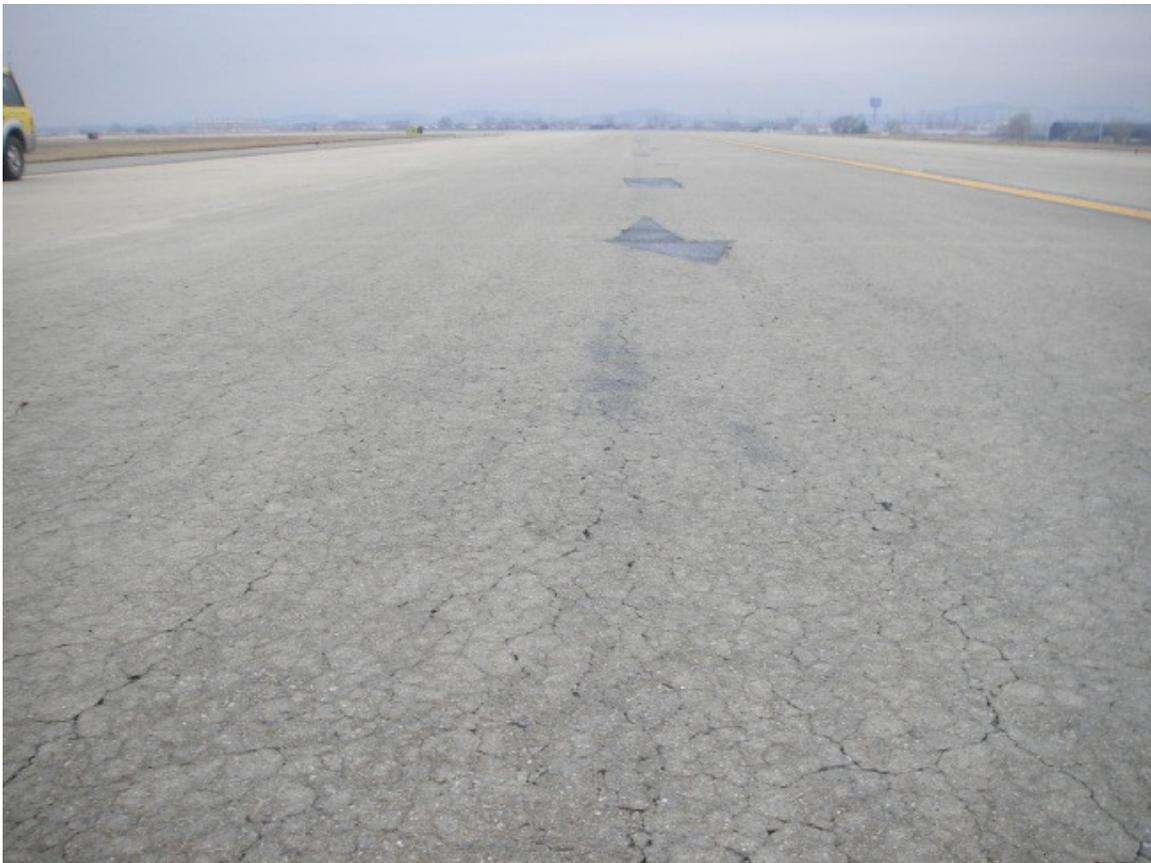
Due to strong effect of ASR reaction, there are severe cracks occurring on most parallel taxiway pavement at which we are going to have a test. F.O.D resulted from longitudinal cracking influenced by ASR was occurring in the particular area of the wheel path, which required either the reconstruction of the entire pavement layer or repairs of the partial pavement layer on top of the existing pavement. Since partial repairs of the pavement area were not feasible, 4 types of milling and overlay methods by using asphalt mixture on top of the existing pavement were carried out in order to extend the pavement life.

Figure 2. Surface map-cracking

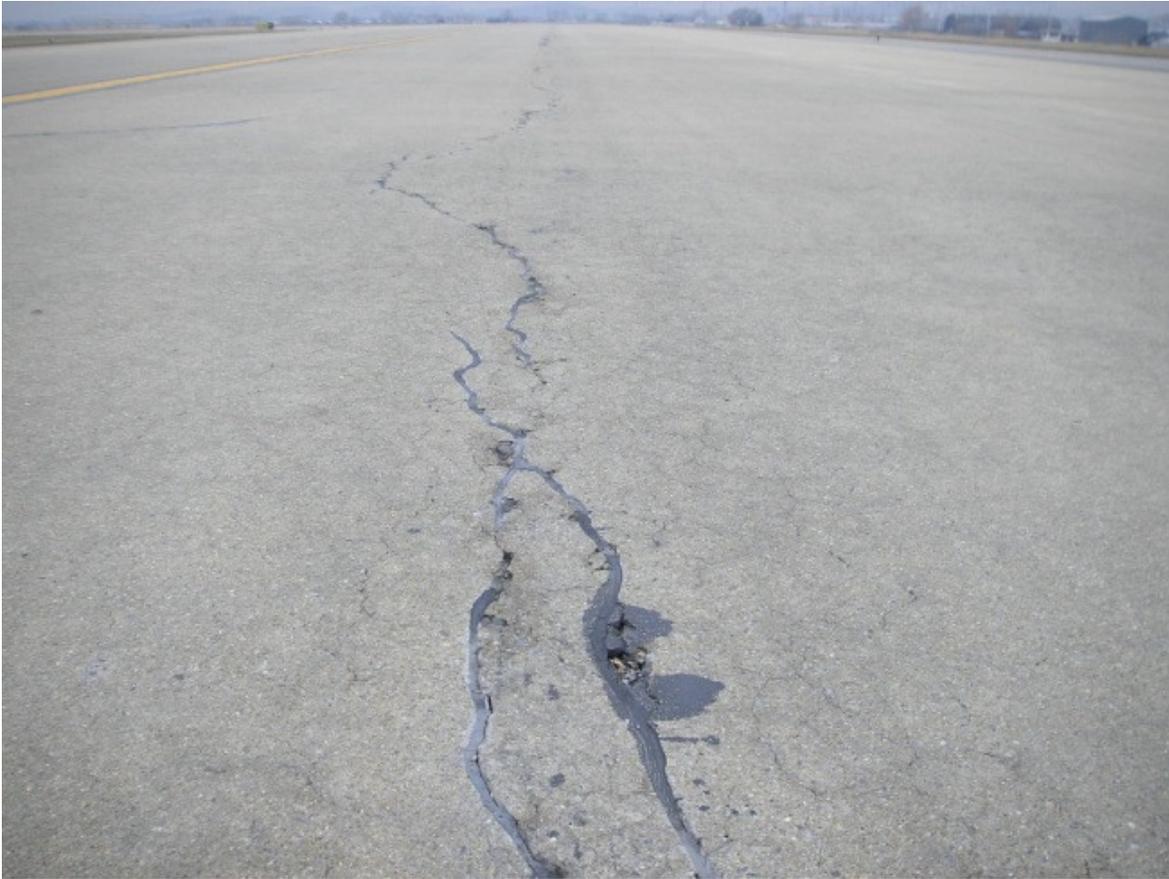
Figure 3. Surface longitudinal cracking

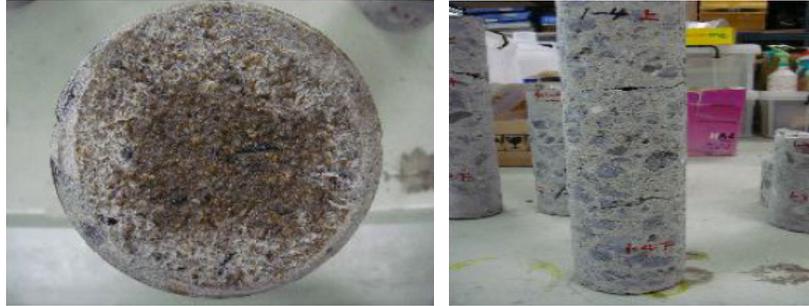
subhedral or oval shape, and showing undulatory extinction and suture texture. It will be suspected to be the principal reason for the ASR reaction. The Horizontal cracks were present and developed in 7 out of 8 cores, as demonstrated in Figure 4 and the reaction products were seen in the vicinity of the aggregate grains as in Figure 5 and also the white reaction product was found to exist within air-voids.

Figure 4. Surface and parallel crack

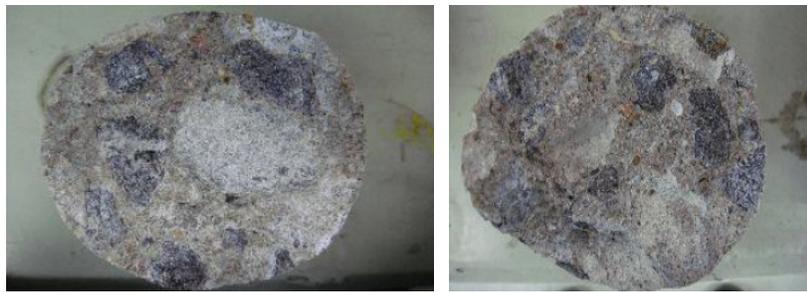
Figure 5. Chemical reaction in the parallel crack section

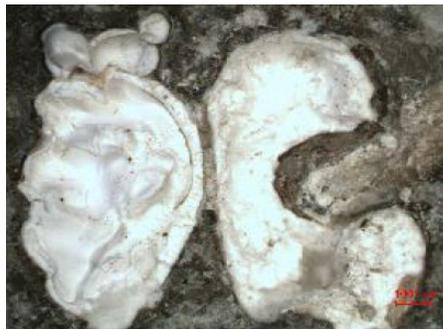
As a result of the microscopic observation into the concrete using the Phase-contrast microscope, the reaction product filled in air-void was found to be formed by the transparent gel around air-void in white shape as shown in Figure 6a. The white gel was formed on the boundaries between aggregate and cement material as shown in Figure 6b.

Figure 6a. Reaction product within air-void (40X)

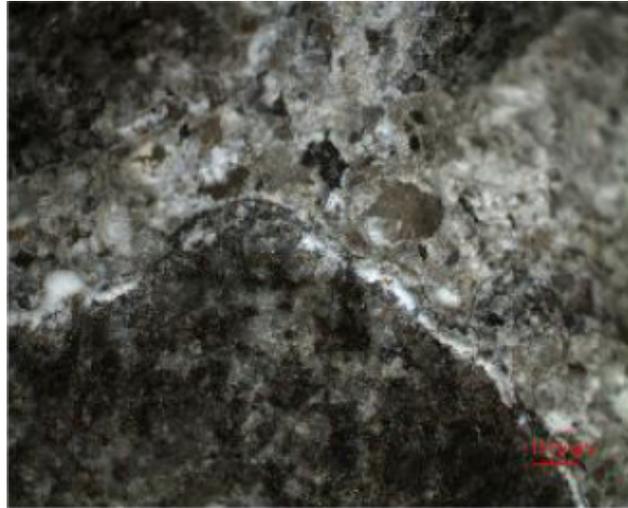
Figure 6b. Reaction product within aggregate boundaries (10X)

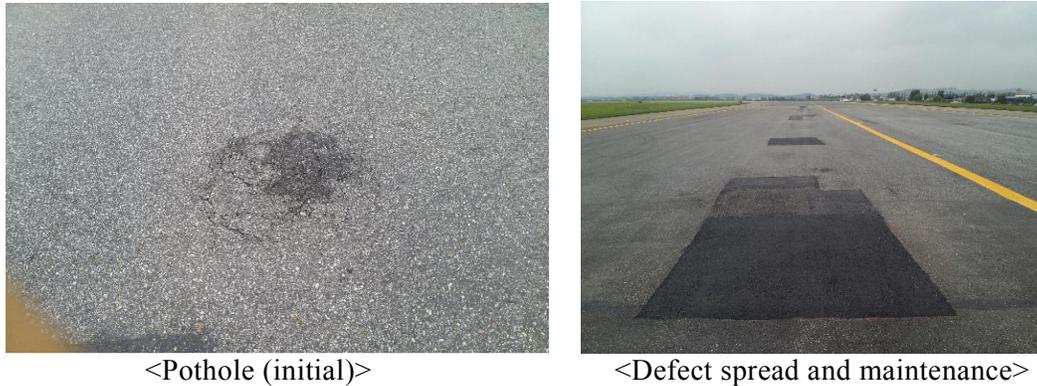
rainfall infiltration into reflective cracking. In the case of 10cm HMA overlay thickness on concrete, it could be little variation according to region and traffic, generally reported that most reflective cracking occurs in 5 years from overlay. In the result of milling and overlay (T=10cm) on parallel taxiway at Gimpo airport, reflective cracking did not occur on any of the overlay types after three years. However, Potholes were found on wheel path areas on all overlay types. In the case of B-type, the potholes occurred less than the other types and alligator cracking of low severity occurred across the B-Type overlay areas. By these results, CRM (Crumb Rubber Modified) pavement can be strong against rutting but can fall slightly against the Top-Down cracking on the low temperature in winter season. It was assumed that hot mix production quality control is one of the other reasons for the alligator cracks

Figure 16. Maintenance status

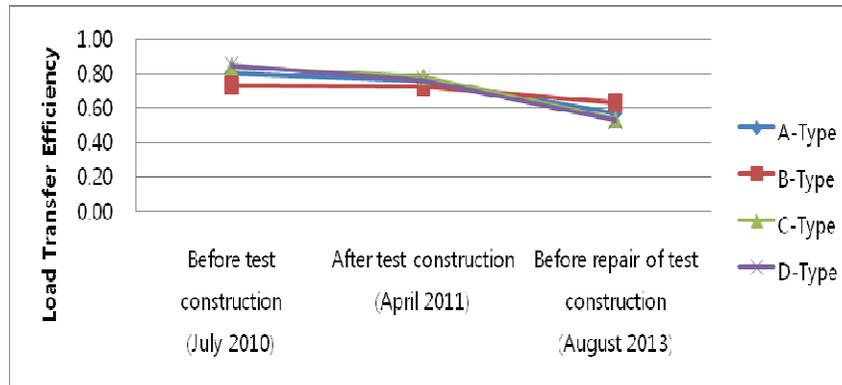
As for the result of HWD test, Load transfer efficiency was decreased considerably in contrast to the before test construction. The decline of the C-Type and D-Type was larger than the other types, thus requiring a large number of repair works. The decline of B-Type was smaller than the other type, and this type required the least amount of maintenance. According to this result, it is estimated that the damaged slabs around the dowel bar at joints were assumed to be deteriorated further because of the ASR. The discovery that the dowels were too high in the pavement may have lost contact when the slabs were thinned.

Figure 18. Decline of the load transfer efficiency

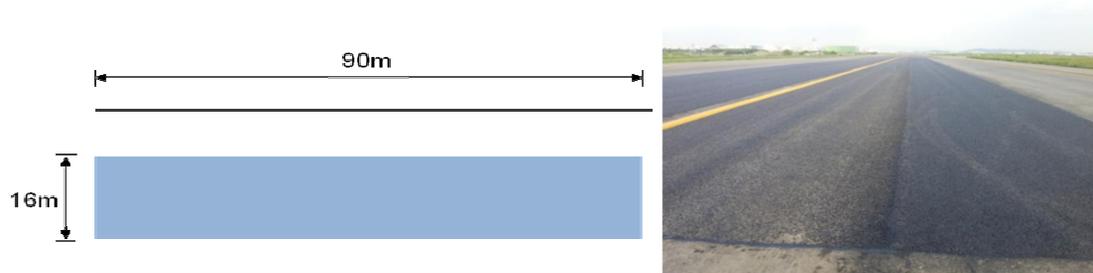
As for the main reason of the premature defects, it is estimated that there is a limit for HMA overlay to protect rainfall infiltration. And especially, milling and overlay method on the impermeable concrete slabs will make the occurrence of premature defects inevitable such as the parallel delamination and potholes on the high tire pressure of the aircraft. Therefore, repair work was implemented by using Polymer Modified SMA in September 2013. The Polymer Modified SMA (Stone Mastic Asphalt concrete) can be effective in preventing rutting while reducing air void. The second test construction was paved and compacted using SMA, adding T=5cm thick pavement twice after milling the existing overlay pavement of 10cm depth. The second overlay was each consisted of 13mm and 10mm maximum size of coarse aggregate.

Figure 21. Repair size and photograph after repair work

- Asphalt binder: SBS Polymer Modified Asphalt(PG 76-22)
- maximum size of coarse aggregate: 13mm (t=5cm) + 10mm(t=5cm)
- Repair area: width 16m of the wheel path area that have potholes
