**HEAVING OF AIRFIELD PAVEMENT  
AT  
HONG KONG INTERNATIONAL AIRPORT**

Presented for the  
2007 FAA Worldwide Airport Technology Transfer Conference  
Atlantic City, New Jersey, USA

April 2007

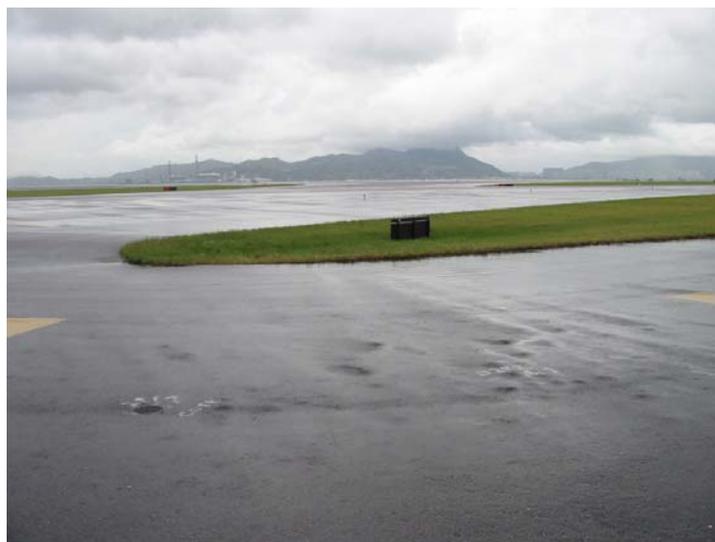
Figure 2 - Heaving at Shoulder

Pavement damage associated with the heave of the wearing course was first observed on the taxiway shoulders within the North Runway Area between July and September 1999. At some of these locations the wearing course was observed to be temporarily lifted away from the underlying crushed aggregate base course forming a dome with height of up to 400 mm and a diameter up to approximately 10m. At the remaining locations the damage was observed in the form of cracking and localized bulging of the wearing course. (See Figure 2). It was noticed that the heaving phenomena occurred only after prolonged heavy rainfall during the summer months. Air bubbles were also observed at the locations of the damaged pavement surfaces during the heaving occurrence. The duration of each heaving occurrence was also very short, about one or two hours, after which, the dome disappeared.

The most obvious correlation of the heaving damage phenomenon was with rainfall. However, based on the porosity of the sand capping layer and the rainfall data during the heaving incidents, the rise of water table did not exceed 0.5m. It was therefore unlikely that the heave was associated directly with water pressure lifting the wearing course, as the perched water table would remain well below the underside of the pavement. The rainfall acted as a trigger for the heave damage rather than being directly responsible.

A detailed review of the tidal record indicated that all of the heaving incidents occurred during a rapidly rising “ Spring” tide and after continuous heavy rainfall for a few days. Spring tides are associated with either a full moon or new moon and are the highest tides of the monthly cycle. A high tide is associated with a rapid rate of rise tide approximately 3 hours before the actual high tide. Site measurement revealed that the water level during a rising tide was almost 5 meters below the pavement surface, the heaving caused by direct tidal water force was also ruled out. After review of the combined tide and rainfall record, followed by site measurement and laboratory soil testing, the investigation concluded that the pavement heaving was caused by the build-up of air pressure underneath the pavement due to the rising tide and blockage of free air flow in the saturated capping sand layer. Under dry weather, a rising tide would push the air in the void below the geotextile up through the relatively permeable sand capping and this air would escape slowly through the pavement layers or through the landscaped areas. (Figure 5) During periods of heavy rain a perched water table built up within the sand capping layer directly above the geotextile and the soil in the landscape area was saturated with rainwater. The air permeability in the saturated soil was reduced. [1]

The wetting of the surface of the MAWC also reduced the air permeability of the asphalt pavement and its ability to dissipate air pressure. The rapidly rising tide pressurized the trapped air in the air voids in the granular layer beneath the pavement and caused the heaving. (Figure 6) Calculations indicated that a pressure of 3 kPa would lift a 125 mm full thickness pavement (wearing course and base course) and a pressure of 1.2 kPa would lift a 55 mm pavement. (debonded wearing course or shoulder pavement)

The inspections on the North Runway and associated taxiways, particularly the high pressure zone, by the Airfield Operation staff were immediately stepped up during high tide periods when the rate of rising tide exceeded 0.3m/hr and there was heavy rain fall for a couple of days. Maintenance staff were geared up with electrical hand-drill tools

and 12mm diameter pressure relief holes were drilled on the pavement once heaving was observed.

As a short term preventive measure, 160,000 of 12 mm diameter x 130 mm deep air pressure relief holes were drilled through the asphalt pavement in the high and medium pressure zones. One meter spacing was provided in aircraft wheel path areas, two meter spacing was provided outside aircraft wheel path area and 3 meters spacing was used in medium pressure zones.

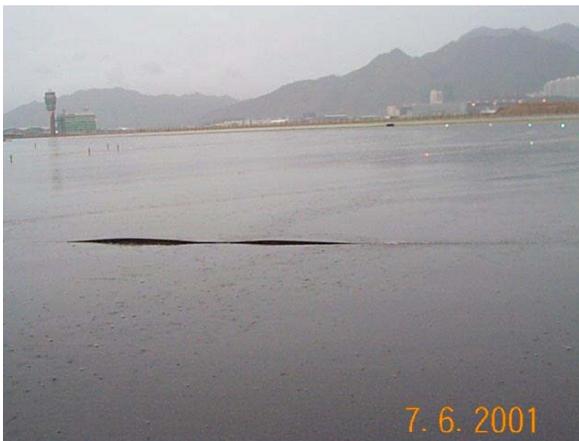
Figure 3 - Heaving at Taxiway

During the summer months of 2000, the heaving at the shoulder area continued. In 2001, the heaving problem extended to the aircraft traffic area in a taxiway and a runway. On 7 June 2001, after 5 days of heavy rainfall, an area of taxiway pavement at Rapid Exit Taxiway (RET) A5 heaved and fractured the pavement along a construction joint. (See figure 3). On the following day, heaving damage was also observed on the runway along the centerline paving joint. Although no dome was observed, it was clear that the MAWC had been separated from the MABC. (See Figure 4) The taxiway and runway had to be closed for several hours to facilitate the emergency repair.

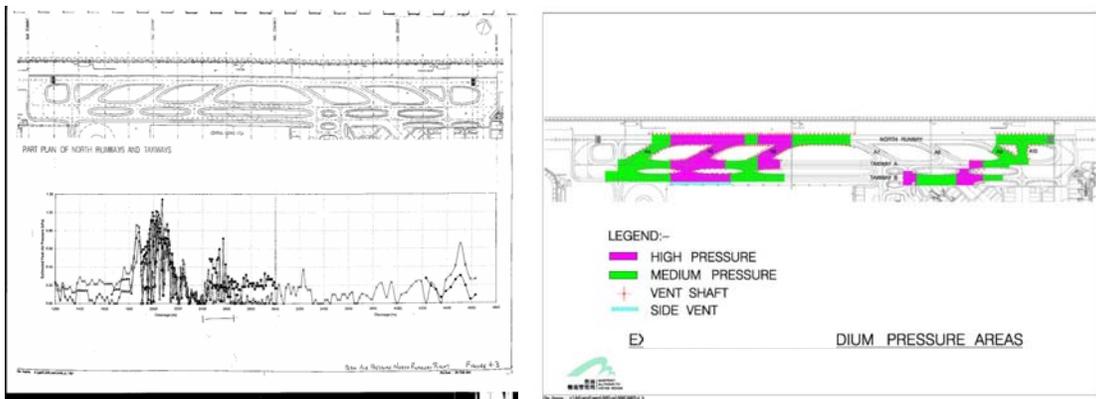
Figure 7 - Pressure zone plan

In order to identify the extent of the heaving problem, pressure sensors were installed along the centre of the North Runway and its associated taxiways to measure the air pressure build up underneath the pavement during dry and wet weather and under rising tide conditions. Based on the collected data, the entire length of the runway was classified into high-pressure, medium-pressure or low-pressure zones. High-pressure zones (pressure build up to 3 kPa) indicated that the likelihood of pavement heaving occurrence was high when there were continuous heavy rainfall and a rapidly rising tide.
