Application of a Materials-Related Distress Rating System for Portland Cement Concrete Airfield Pavements

Applied Pavement Technology, Inc.

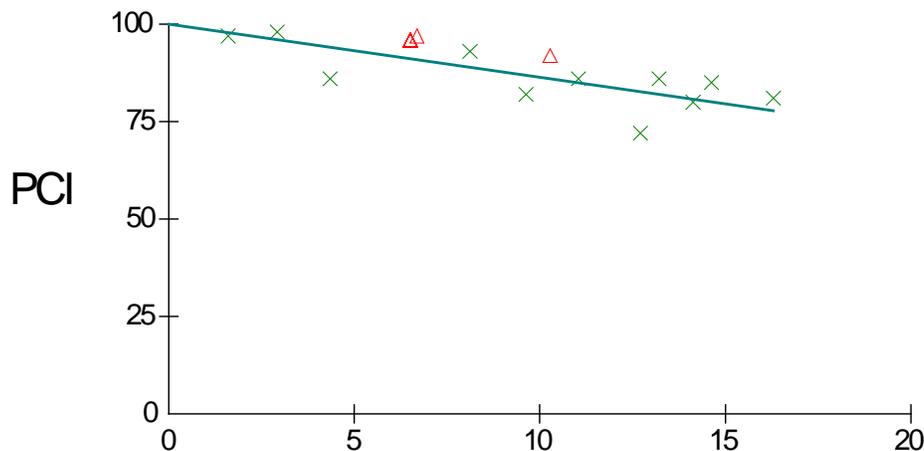
Figure 7. PCI deterioration curve for pavement.

Using the available PCI data for the facility a PCI deterioration curve is estimated. The curve is developed from both the collected project-level data as well as available historical airport pavement management system (APMS) data. The model determined for the facility is as follows and summarized in figure 7:

Based on this model, a critical PCI of 65 is reached around 2018, which suggests major rehabilitation would not be needed for approximately 8 more years.

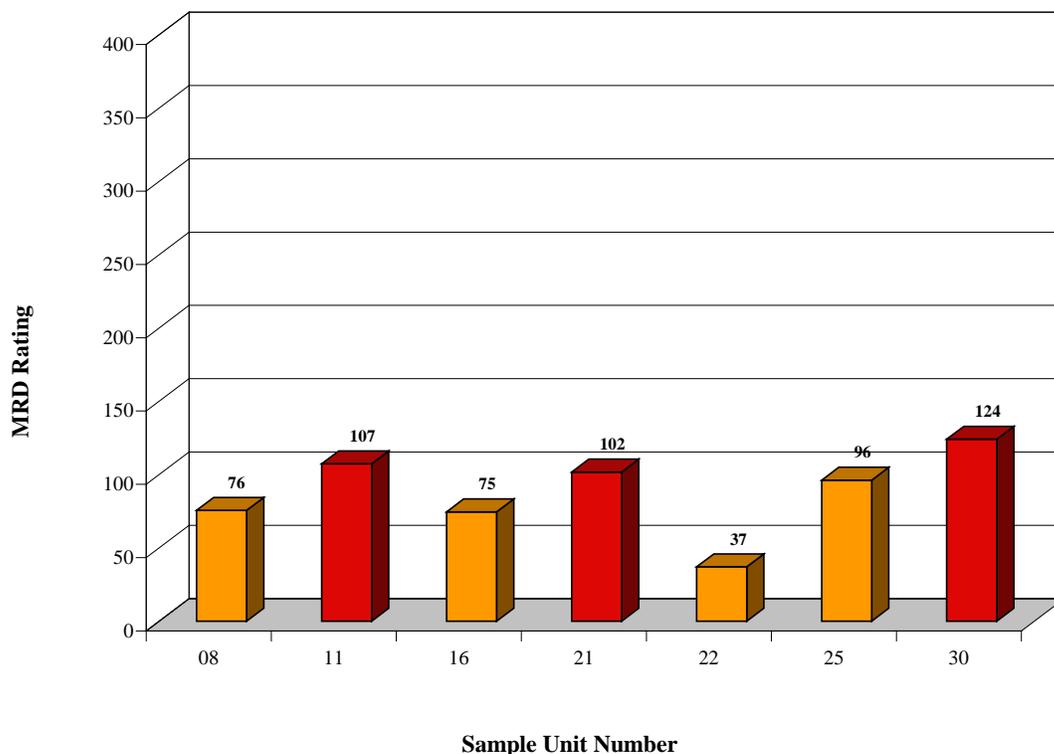
Figure 8. Summary of sample unit MRDR for section 10.

The MRDR procedure was also applied as part of the investigation. For this study, it was determined to use the network-level sampling rate to facilitate future inspections (the same sample units used in the APMS were used for the MRDR) and to balance project time/budget concerns. The determined MRDR are summarized in table 4; figures 8, 9, and 10 illustrate the MRDR for each sample unit in the feature sections inspected as part of the MRD survey. The fourth section is not full-strength pavement and was not included in the MRDR procedure.

Pavement Section	MRDR
10	88
20	103
30	54

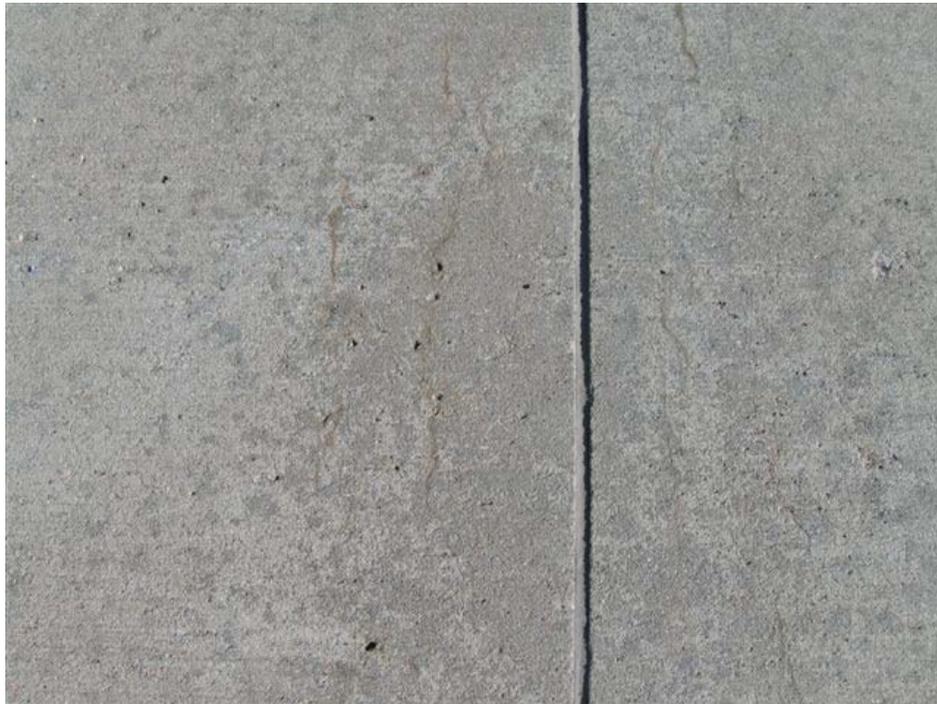
The primary MRD indicators on the feature are parallel and perpendicular cracking, illustrated in figures 11, 12, and 13. Both cracking types were observed with and without discoloration. The deterioration has also progressed to joint disintegration (figure 14) in numerous locations. Other observed widespread MRD indicators are honeycombing, popouts, patching (primarily repairs of previous joint/corner disintegration), and staining.

Figure 11. Low-severity parallel cracking with discoloration and staining.

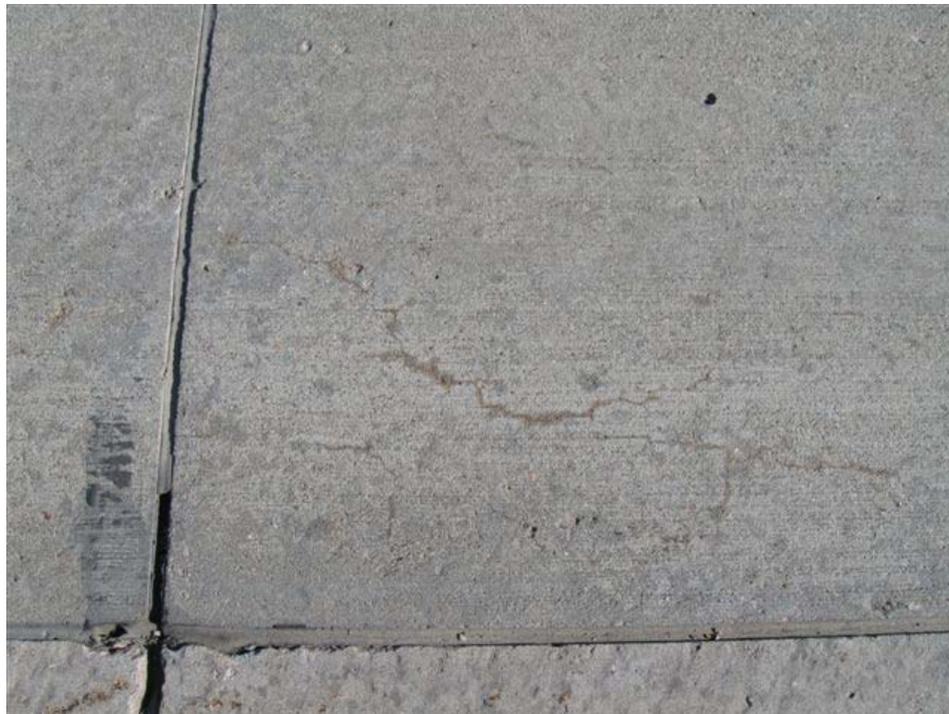
Figure 12. Low-severity perpendicular and parallel cracking with discoloration and staining.

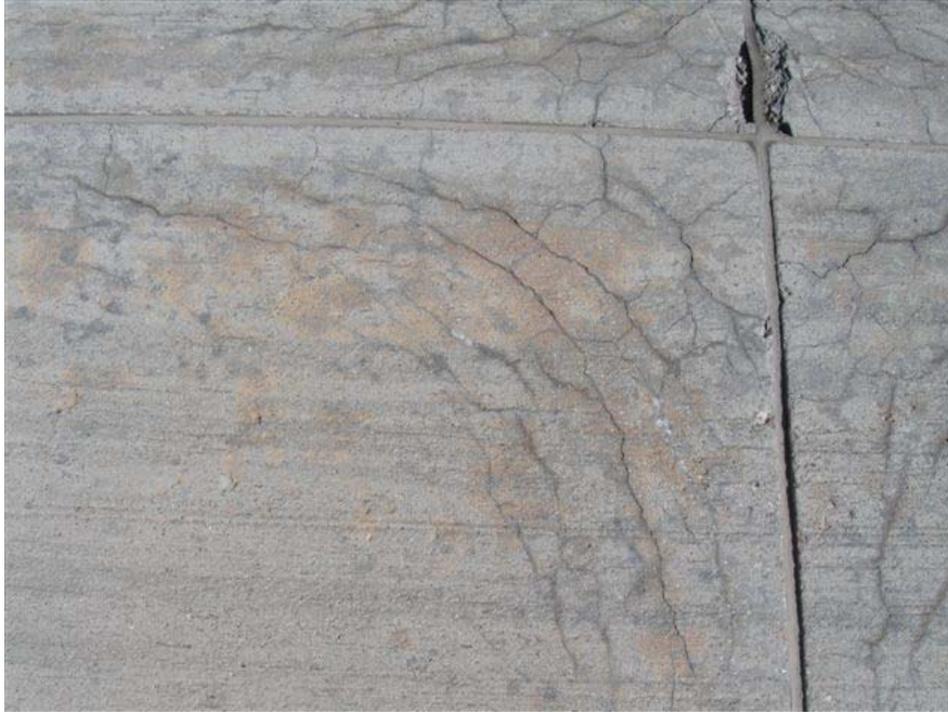
Figure 13. Medium-severity perpendicular and parallel cracking with discoloration and staining.
(Note: corners at top of photograph have progressed to disintegration)

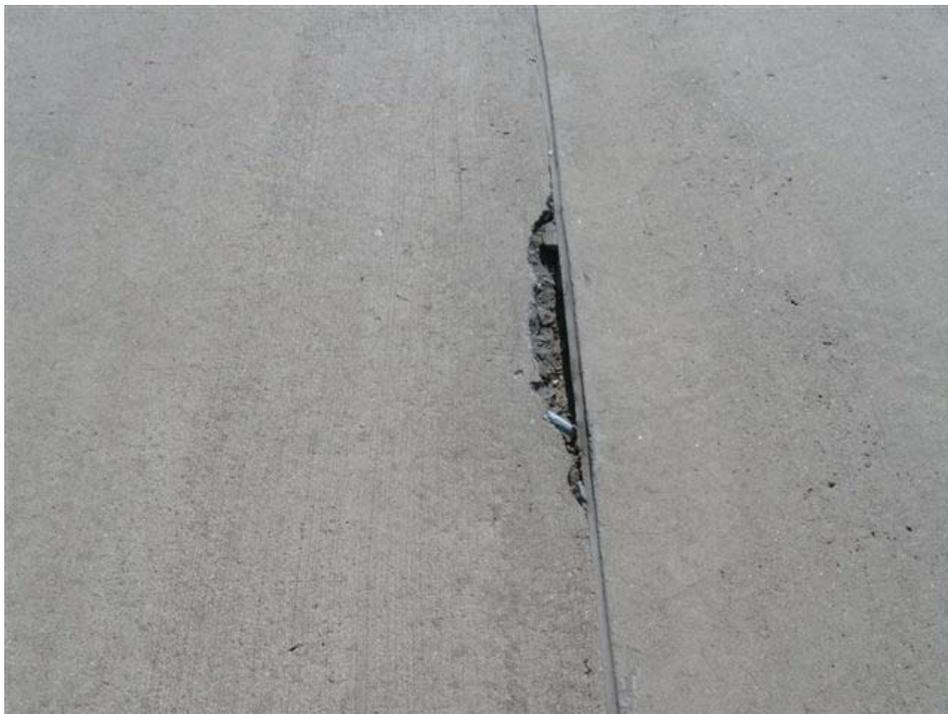
Figure 14. Joint disintegration.

The airport has on-going maintenance to address FOD, primarily partial-depth repairs. The repairs are typically short-lived because of the continued deterioration of the original pavement adjacent to the repair as well as below the repair. The areas of FOD-producing distresses have become so widespread that they are an operational concern for the airport. In this case, the MRDR better reflects the pavement performance and immediate needs.

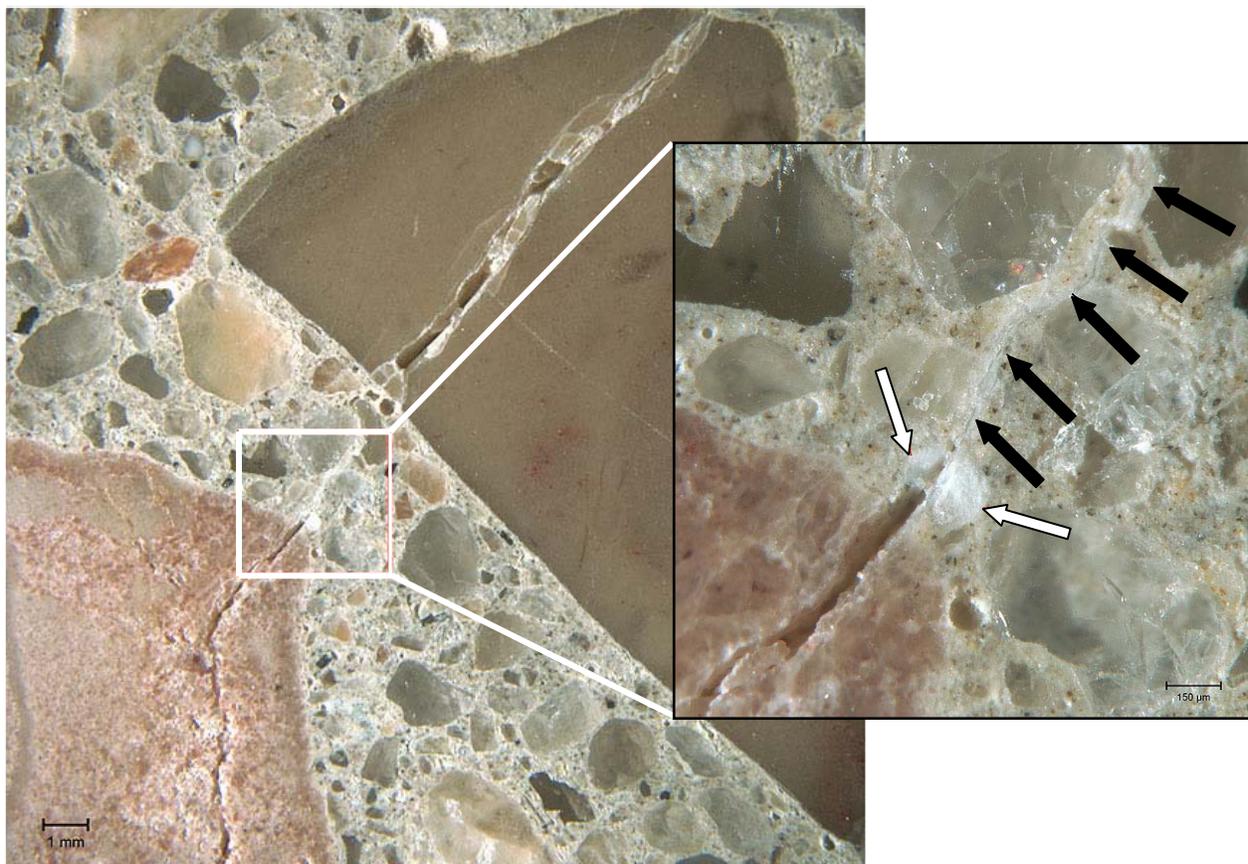
Petrographic examination of four cores indicates the coarse aggregate consists of limestone and dolomitic limestone, and the fine aggregate is siliceous material, consisting primarily of quartz and feldspar. The cores all include a Class C fly ash. ASR was identified in all core specimens, but the associated micro-cracking and gel product are relatively localized and do not appear to be resulting in wide-spread deterioration. Only in a few instances does the micro-cracking extend into the surrounding paste, as shown in figure 15. Secondary ettringite deposits are also observed within air voids, but are not considered to be responsible for the observed deterioration.

Figure 15. Illustration of micro-cracking and ASR gel formation within core C-6.
(Note: white and black arrows indicate void and crack, respectively, filled with ASR gel.)

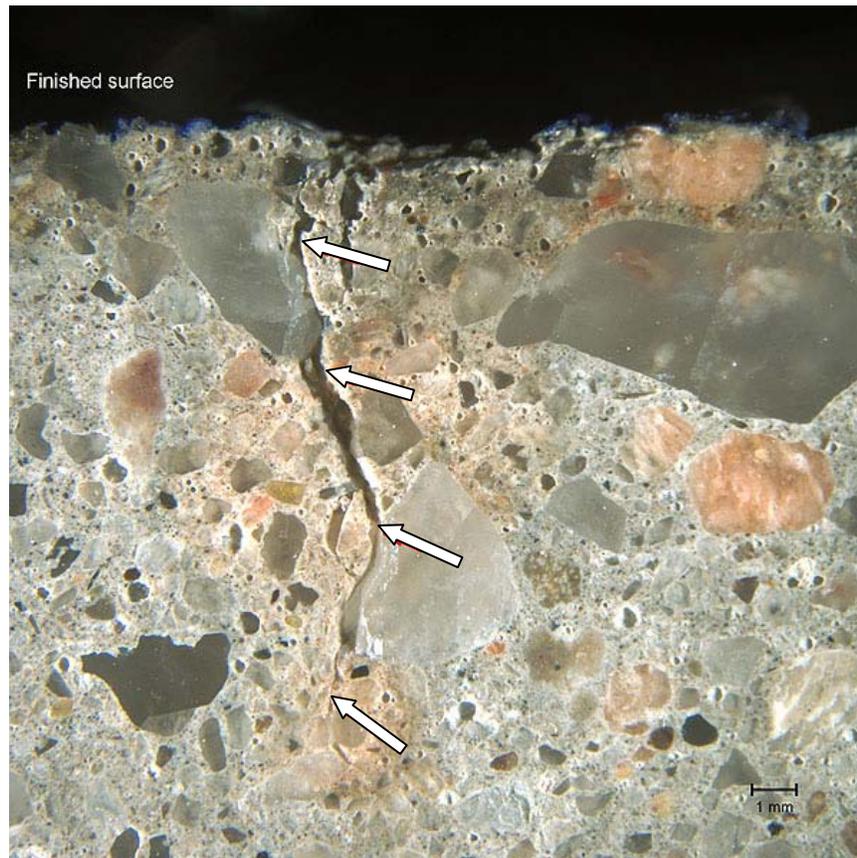
The observed map cracking appears to be relatively confined to the surface (i.e., it does not extend significantly into the pavement), as shown in figure 16, generally indicating that it is likely the result of early-age volume change.

Figure 16. Sub-surface micro-crack.
(Note: white arrows indicate subsurface micro-crack.)
