**EVALUATION OF ASR DISTRESS IN AIRFIELD CONCRETE PAVEMENTS**

Seungwook Lim, Dan G. Zollinger, Ph.D., P.E. and Shondeep L. Sarkar, Ph.D., P.E.  
Texas Transportation Institute, Texas A&M University  
College Station, TX 77843-3135

PRESENTED FOR THE 2002 FEDERAL AVIATION ADMINISTRATION AIRPORT  
TECHNOLOGY TRANSFER CONFERENCE

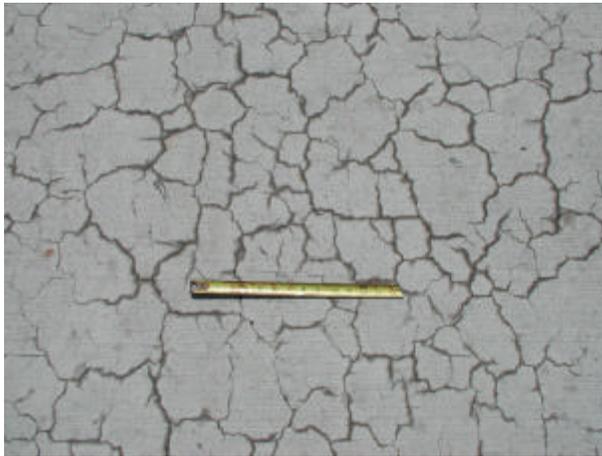
Seven different sections of concrete pavements, including runway, taxiway, and apron were selected for a detailed visual inspection. The general descriptions of the test sections are summarized in Table 1. All the test sections showed typical expansive distress features, such as map cracks, compressed joints, and joint misalignments, in different degrees of severity. Figure 1 shows some of the distress features observed. Upheaval of pavements was noted to be minimal in these sections, but joint misalignment was conspicuous. Aggregate pop-outs were also negligible in proportion to the amount of distress.

(a) High severity map cracks (section 2)

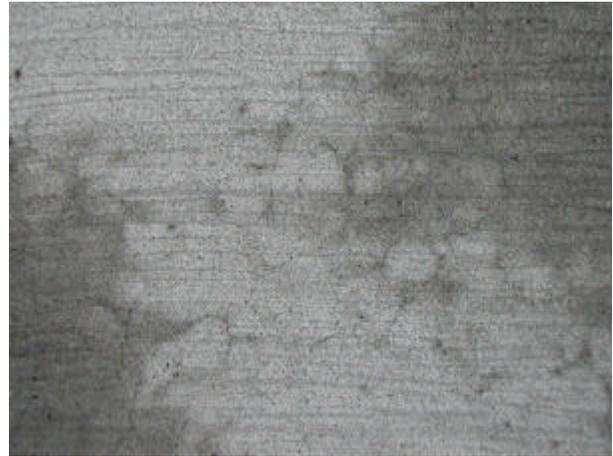
(b) Low severity map cracks (section 6)

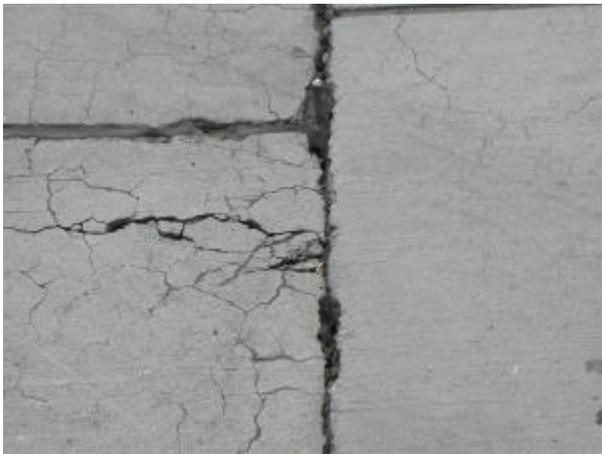
(c) Compressed joint (section 2)

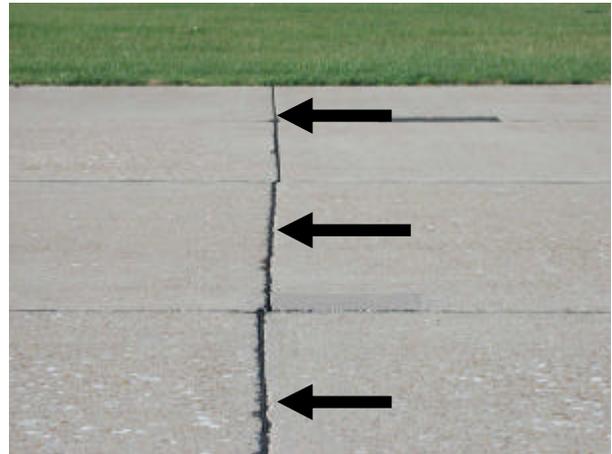
(d) Joint misalignment (section 3A)

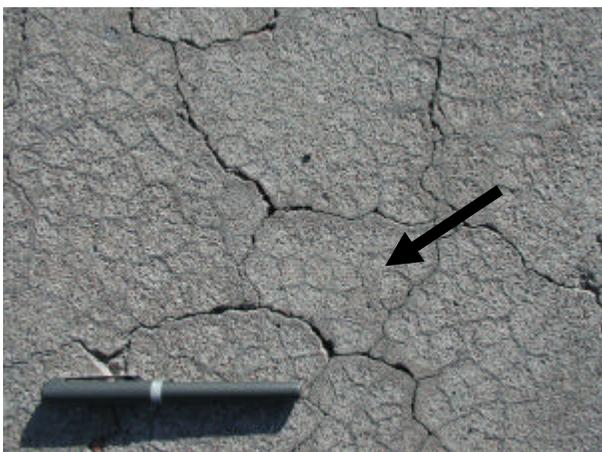
One unique feature of ASR is the presence of “gel”, a reaction product of ASR. Although not always present on the exposed surface, it helps to identify ASR. In some cases, the gel product can be recognized with unaided eye from exudation on concrete surface. Figure 2 shows an example of gel exudation observed in pavement section 4. It should be noted, however, that this exudation normally indicates severely processed ASR. The pavement shown in Figure 2 was constructed in 1950s, and is no longer in service. In most cases, expert microscopic examination

**Figure 2.** Exudation of ASR gel through cracks

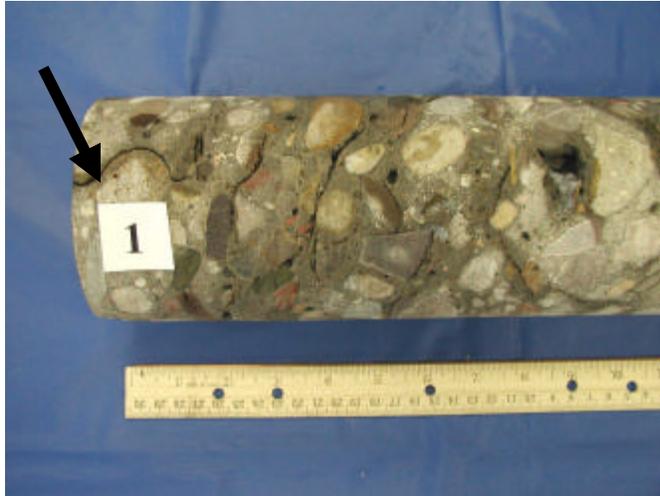
It is interesting to compare the cores from sections 1 and 2 (Figures 3 (a) and (b)). Both sections manifested high severity map cracking, and crack density shown on the pavement surface was estimated to be the same. However, the cores indicate that the degree of deterioration under the surface is significantly different. This is attributed to the age of the concrete. Pavement section 1 has been in service over 20 years longer than section 2, and presumably so does the period of ASR development.

The difference also helps to explain the mechanism of cracking due to ASR. General sequence of ASR distress follows steps such (a) development of high concentration of alkalis in pore solution, (b) reaction with aggregate and formation of reaction gel product, (c) expansion arising from moisture flow into the gel, and (d) cracking and subsequent deterioration<sup>(4)</sup>. Pore solution near the slab surface generally has high alkali concentration due to drying of pore water, and therefore, the reaction and subsequent gel formation is more preponderant at the surface. Moisture, that is required for the gel to expand, is also easily accessible at pavement surface. As a consequence, ASR deterioration tends to initiate from the surface. Concrete expansion at or near a free surface can result in bursting of the concrete, and subsequent vertical cracking. The cracks provide pathways for pore water evaporation as well as for the ingress of external water into concrete. As a result, deterioration continues to proceed to inner concrete. Although the expansive force should be same in all directions, actual expansion occurs in the direction of least restraint. The confining effect in the direction of the thickness of the slab is much less than in the lateral direction. Furthermore, by then the concrete near the upper surface has already weakened. Therefore, the inner concrete tends to disintegrate upward rather than expand laterally.

(a) Section 1: High severity cracks.  
Pavement constructed in 1960's

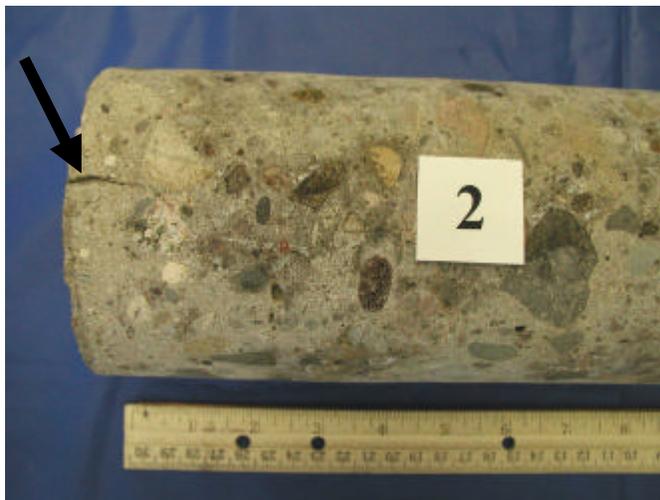
(b) Section 2: High severity cracks in  
pavement constructed in 1985; pavement  
condition is shown in the Figure 1 (a).

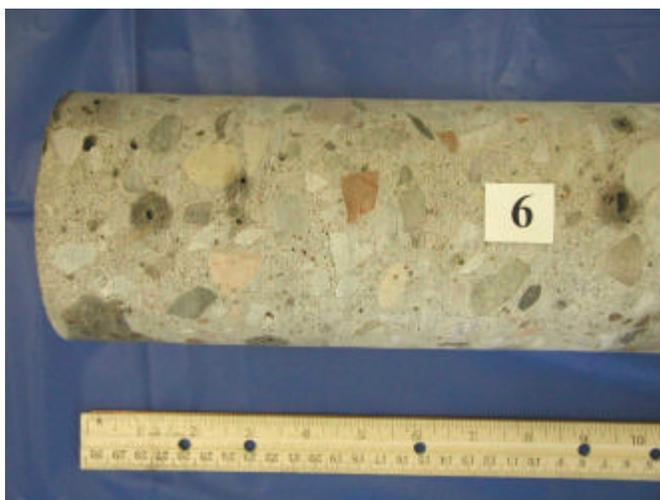
Figure 3 shows some cores taken from the test sections. Cracks of varying severity are visible. Numbers shown in the pictures represent the identification of test section. Test sections 1 and 2 showed severe map cracks, while map cracks in section 6 were faintly visible when the surface was wetted. The condition of test sections 2 and 6 are represented in the Figures 1 (a) and 1 (b), respectively. Figure 3 clearly indicates that concrete cores from sections 1 and 2 that have high severity cracking, manifest more damage compared to the core from section 6, that has low severity cracking.

(c) Section 6: Low severity cracks in  
pavement constructed in 1987; pavement  
condition is shown in the Figure 1 (b).

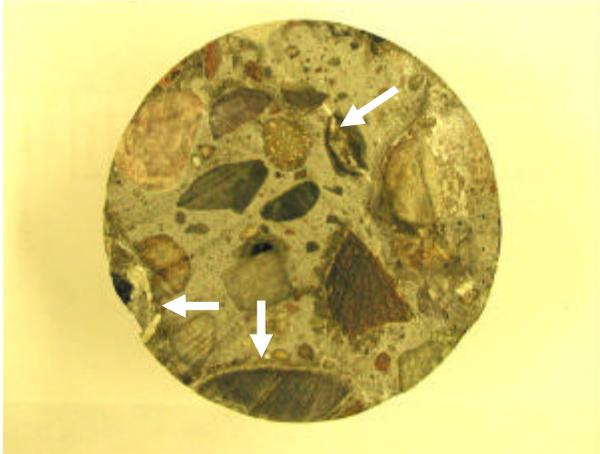
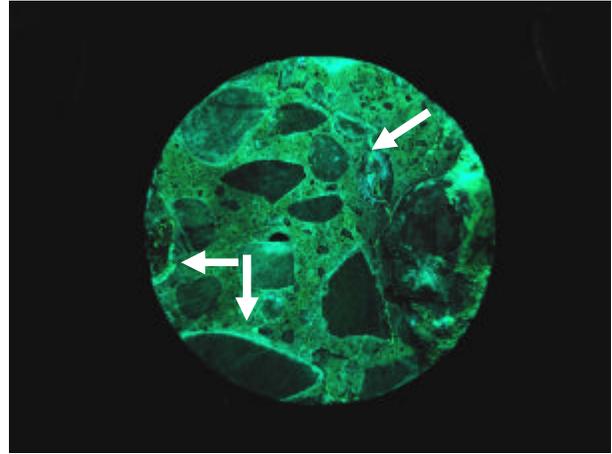
(a) Cross-section at 2-inch depth

In addition to field application, the efficacy of UAFM was evaluated on cores in the laboratory. Cores were sliced into two or three pieces as a function of depth, and uranyl acetate solution was applied to the sectional surface of each slice. Figure 4 shows sliced core samples before and after UAFM. The core shown in this figure was collected from section 1. The length of core was 14.5 inches, and it was cut into three pieces at 2, 6, and 12-inch depth. By applying UAFM, the presence of ASR gel is identified by bright yellowish green glow under UV light. UAFM revealed clear evidence of the presence of ASR gel, particularly for the top and mid-

**Figure 4.** Laboratory application of UAFM to sliced core samples at different depths: The core was collected from test section 1 where the pavement surface showed severe map cracking that appeared through the seal coated surface.

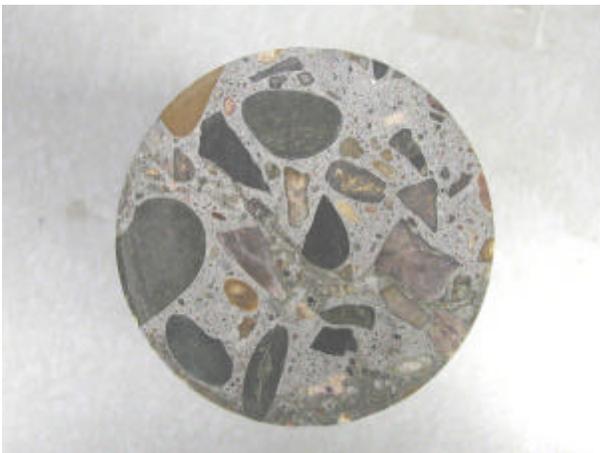
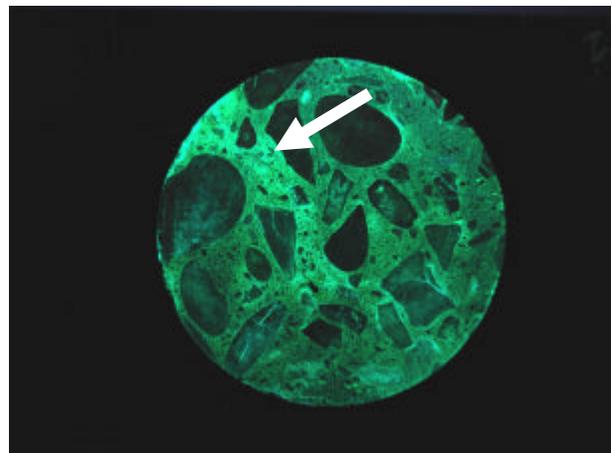
(e) Cross-section at 12" depth (2.5-inch from bottom)

depth samples. Although the bottom sample also displayed marginal amount of glow around aggregate particles, it was not a definitive identification of ASR compared to the upper samples. Nonetheless, this observation supports that ASR deterioration proceeds from upper surface to bottom of pavement slab.

UAFM was found to be effective for identification of ASR gel in the laboratory. According to the authors, in-field application of UAFM did not provide very satisfactory results. It is recommended that laboratory examination of core samples must be included in the framework of ASR distress evaluation. There are indications that the gel may exist without any expansion and subsequent deterioration. Therefore, other factors, such as moisture accessibility and environmental condition of the area, must be considered in addition to a detailed visual inspection of core samples before drawing conclusions about the distress under investigation, whether it has been caused by ASR, and if so, the extent of damage it has caused.

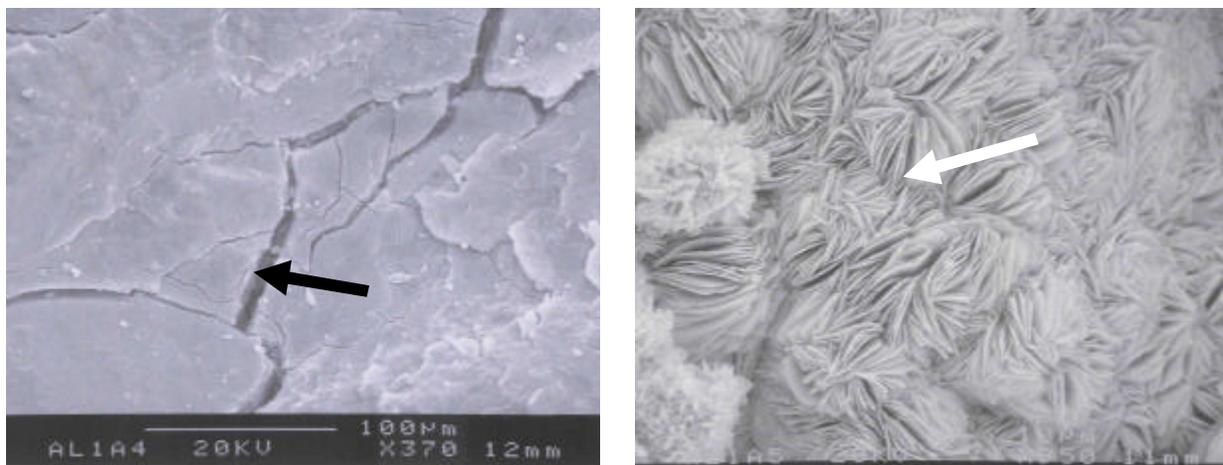
Microstructural analysis conducted on sliced core samples from section 1 is shown in the Figures 4 (a) and (c). Selected samples were taken from locations that previously displayed a bright glow by UAFM, and analyzed using SEM/EDXA. According to the analysis, the gel was noted to exist at paste-aggregate interface and also in the paste. Two types of gel morphology, namely the rosette type and the massive cracked type<sup>(5)</sup> of gel were observed in the paste. These are illustrated in Figure 5. Additionally, presence of lamellar gel was observed at the paste-aggregate interface (Figure 6). No difference in chemical composition was detected between the different types. Generally, the gel has a characteristic composition shown in Figure 7. Several air voids were packed with ettringite needles (Figure 8), but no signs of deterioration were observed around them. This implies that the main cause of distress in this pavement section is ASR. The C-S-H at times was found to be rich in potassium (Figure 9), whereas elsewhere only nominal amounts of impurities such as iron and aluminum were present (Figure 10).

**Figure 5.** SEM images of ASR gel products in test sample from section 1

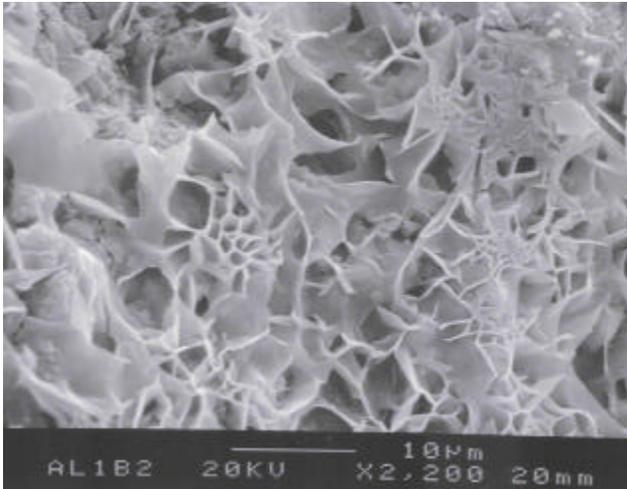
**Figure 6.** Lamellar gel at the surface of aggregate

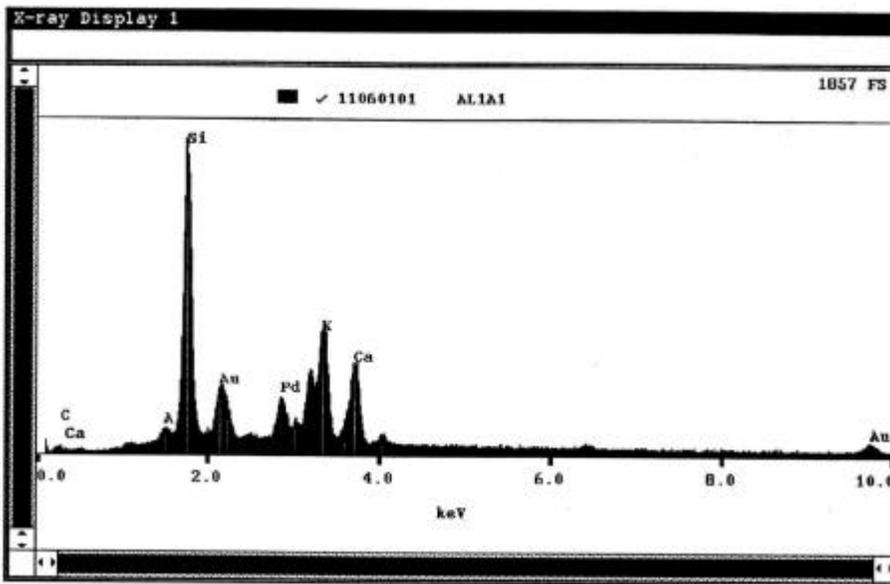
**Figure 7.** Composition of ASR gel (Ca, Si, K)

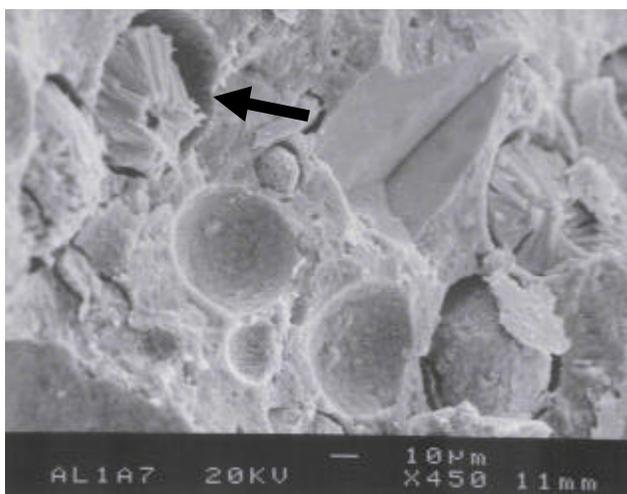
**Figure 8.** Ettringite formation in air voids: no signs of deterioration around the ettringite suggest ASR as a main cause of distress

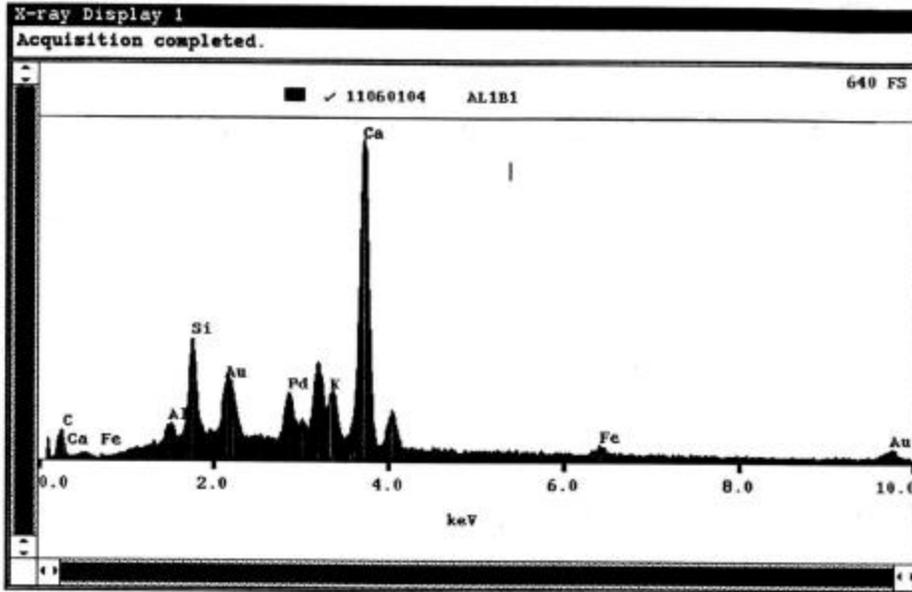
Figure 9. EDX spectrum of C-S-H showing high amount of potassium

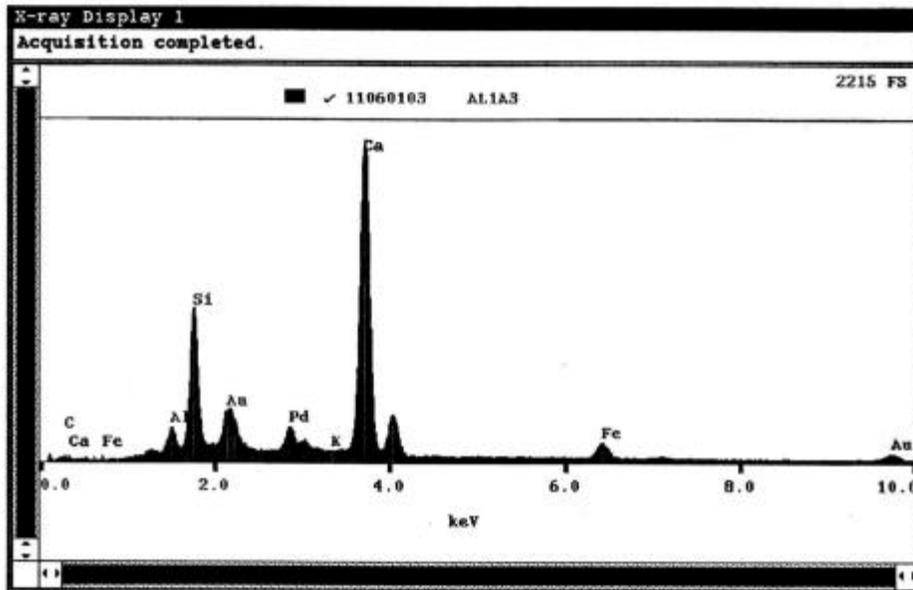
Figure 10. EDX of C-S-H showing only small amounts of Fe and Al as impurities
