**POLYMER CONCRETE MICRO-OVERLAY
FOR FUEL AND ABRASION RESISTANT SURFACING:
LABORATORY RESULTS AND FIELD DEMONSTRATIONS**

**By
Kent Newman, PhD
and
James E. Shoenberger, PhD**

**US Army Engineer Research and Development Center
Vicksburg, Mississippi, USA**

**PRESENTED FOR THE 2002 FEDERAL AVIATION ADMINISTRATION
AIRPORT TECHNOLOGY TRANSFER CONFERENCE**

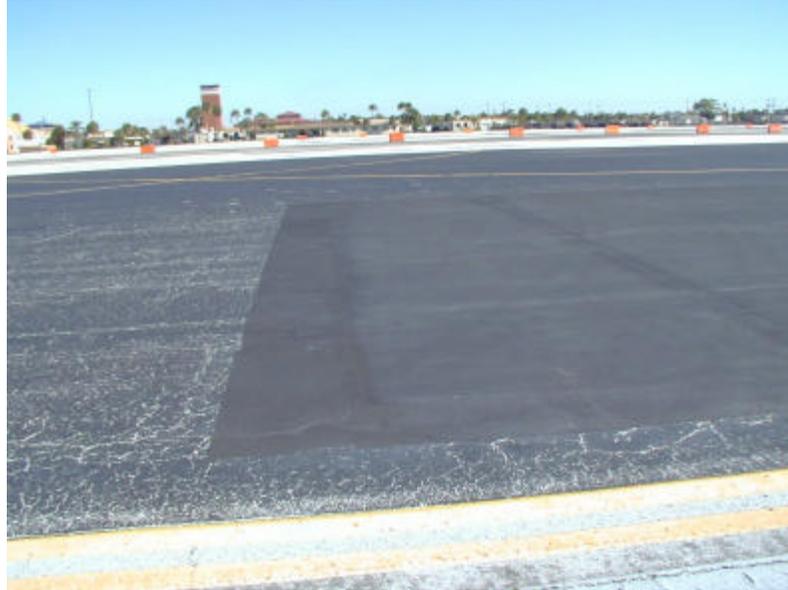
Figure 4. PCMO surface in October 2000 at MacDill AFB. The adjacent pavement is coal tar that is approximately 14 years old and is severely deteriorated.

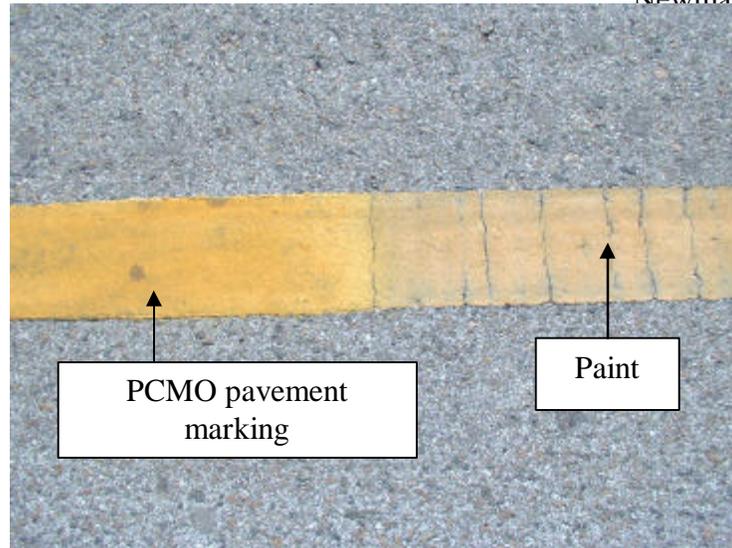
Figure 6. PCMO pavement marking line at MacDill AFB in October 2000 after 2 full years in service. Note the transverse cracking in the conventional airfield pavement marking paint. The marking paint is approximately 3 years old in this picture.
