NIGHT PAVING IN TRINIDAD
ACHIEVING QUALITY

PRESENTED FOR THE
2010 FAA WORLDWIDE AIRPORT TECHNOLOGY TRANSFER CONFERENCE
Atlantic City, New Jersey, USA

April 2010

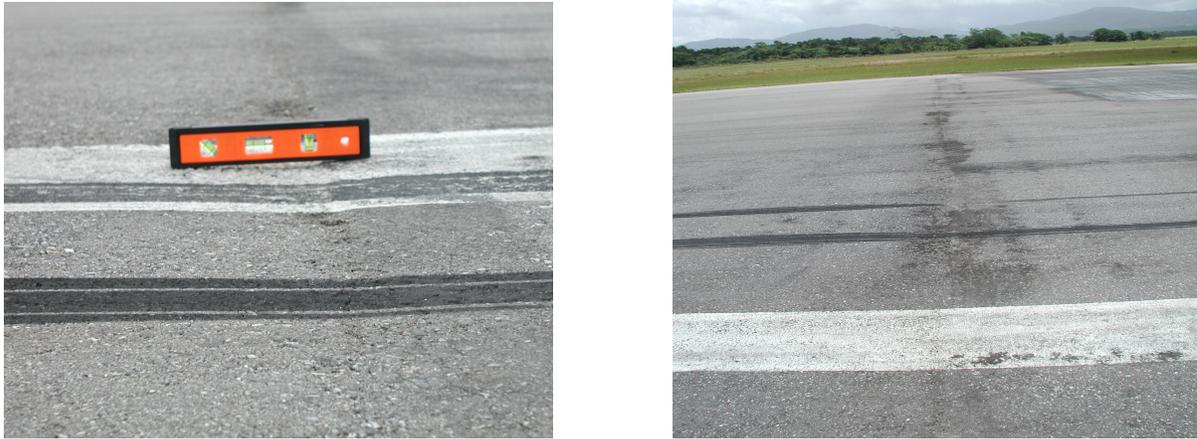
Figure 2. Transverse Joint Construction.

Pavement Condition. Typical workmanship issues on the runway pavement prior to the final rehabilitation are shown in Figures 2 through 4.

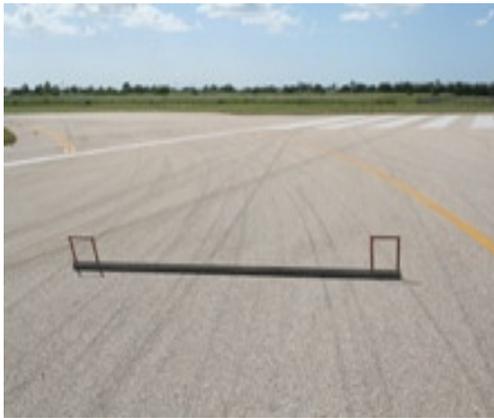
Figure 11. Runway Condition.

To evaluate the in-situ performance of the HMA materials, a series of straight-edge tests were performed at 5m intervals in both longitudinal and transverse directions on the Runway 10 end (the end receiving > 95 percent of traffic) in December 2009 (approximately three years after completion of construction of the Runway 10 end, and 115,500 departures) to identify the presence of any rutting or plastic deformation. Photos depicting the representative condition of the pavement surface are shown in Figures 11 and 12. As shown, no measurable rutting was observed. The reasons for this are attributable to:

- TLA asphalt blend;
- Dense, optimized aggregate gradation structure;
- Superior QA/QC program implementation; and
- Full compliance with compaction requirements of the specification.
