RUBBER TIRE BUILDUP REMOVAL AT HARTSFIELD-JACKSON ATLANTA
INTERNATIONAL AIRPORT
2010 FAA WORLDWIDE TECHNOLOGY TRANSFER CONFERENCE

Rubber Tire Buildup Removal at Hartsfield-Jackson Atlanta International Airport

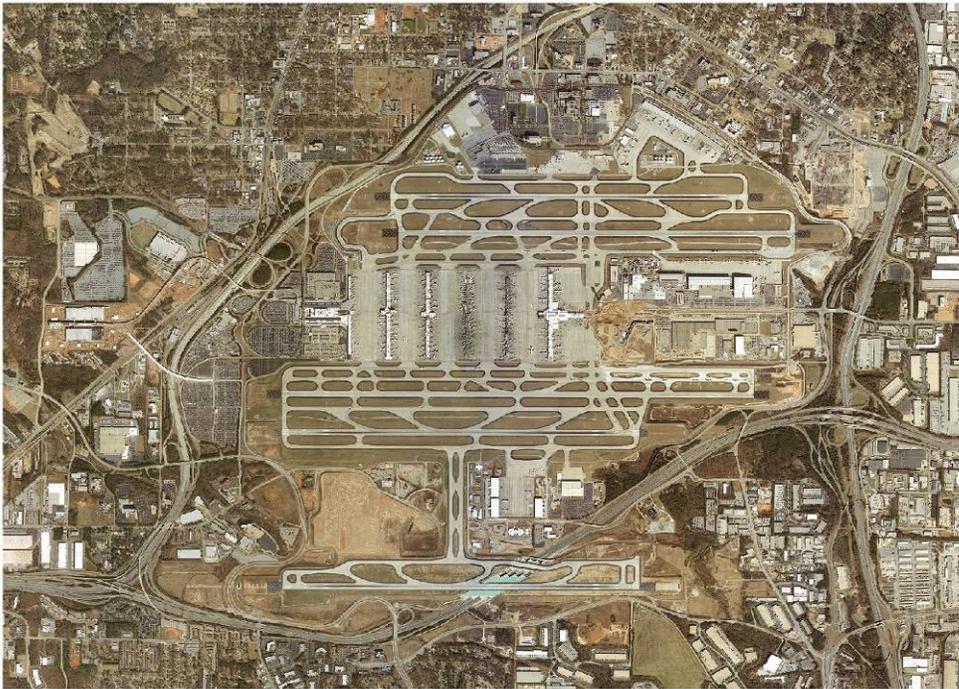
Figure 1: Aerial photo of Hartsfield-Jackson Atlanta International Airport

Hartsfield-Jackson Atlanta International Airport (H-JAIA) has five parallel runways that experience heavy rubber tire buildup. The pavement network at H-JAIA is shown in Figure 1. The system includes 5 parallel runways; runways 8L-26R and 8R-26L are located on the north side of the midfield concourses, runways 9L-27R and 9R-27L are located on the south side of the midfield concourses, and runway 10-28 is located further south, spanning an 8-lane interstate freeway. The arrival runways at H-JAIA are 8L-26R, 9R-27L and 10-28. They currently handle approximately 400,000 landing operations per year. This equates to about 365 operations per day per runway. The departure runways are 8R-26L and 9L-27R which experience an occasional landing in the morning.

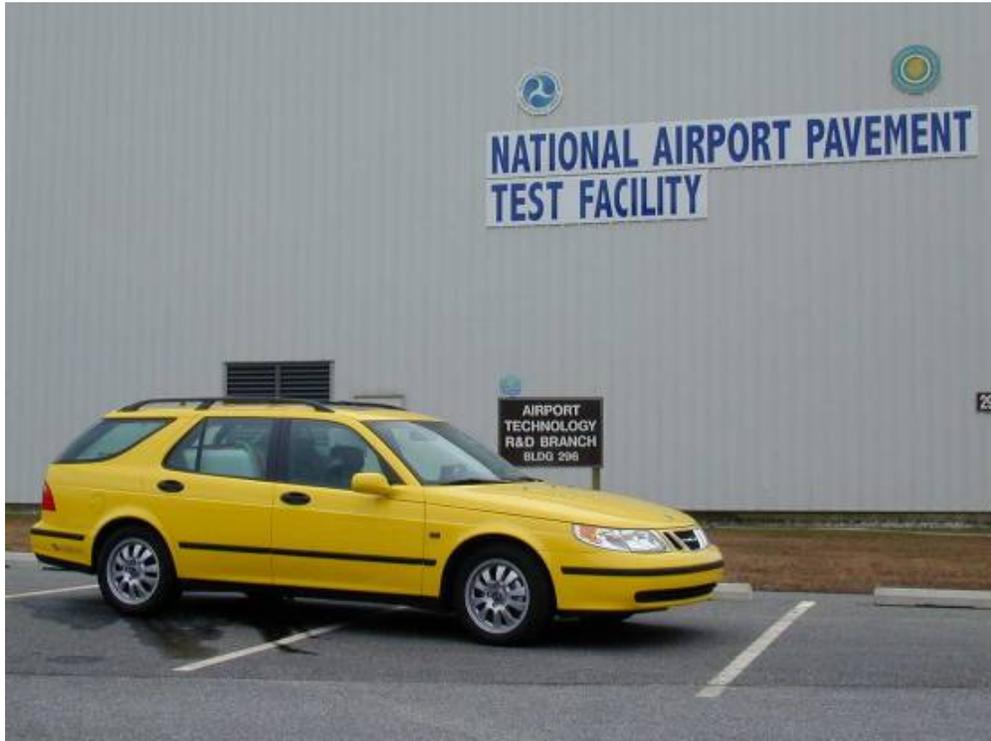
Figure 2: Saab 9-5 equipped with Scandinavian Airport and Road Systems AB (SARSYS) Friction Tester (SFT)

The airport currently uses a Saab 9-5 equipped with Scandinavian Airport and Road Systems AB (SARSYS) Friction Tester (SFT) as shown in Figure 2. The SFT is programmed to measure in accordance with regulations issued by FAA. The Saab is equipped with a water system for measuring on wet surface. The airport uses the smooth tire and rubber buildup is measured every other week on the three primary arrival runways.

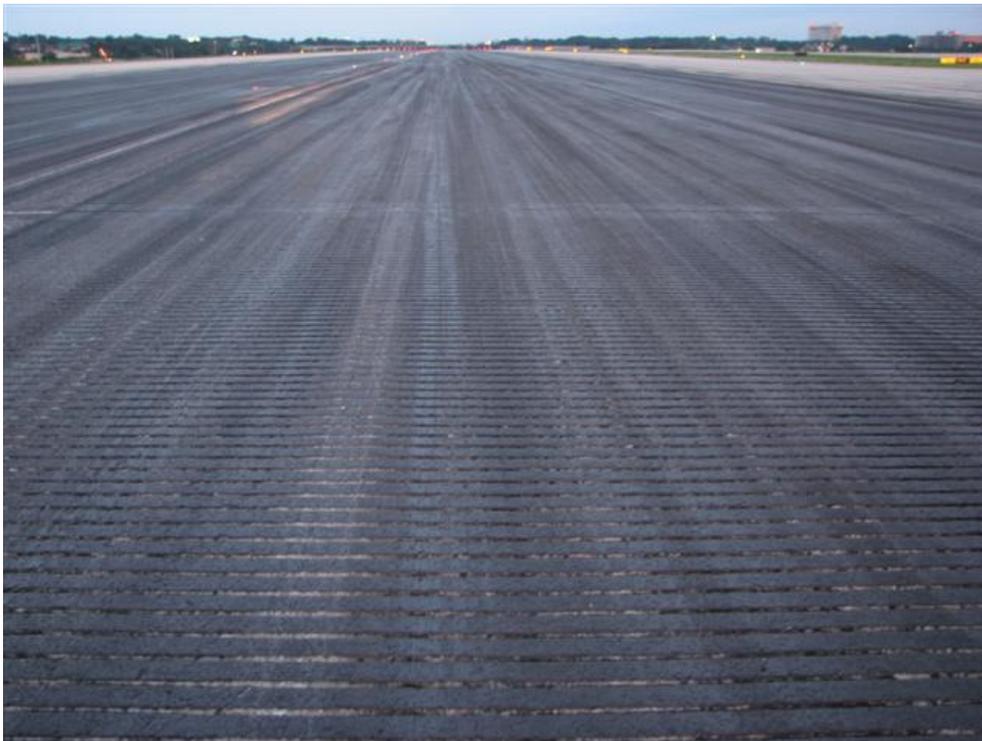
Figure 3: Runway pavement before chemical removal

noticed damage to the pavement due to the chemical removal process. Before and after photos of chemical removal can be seen in Figures 3 and 4.

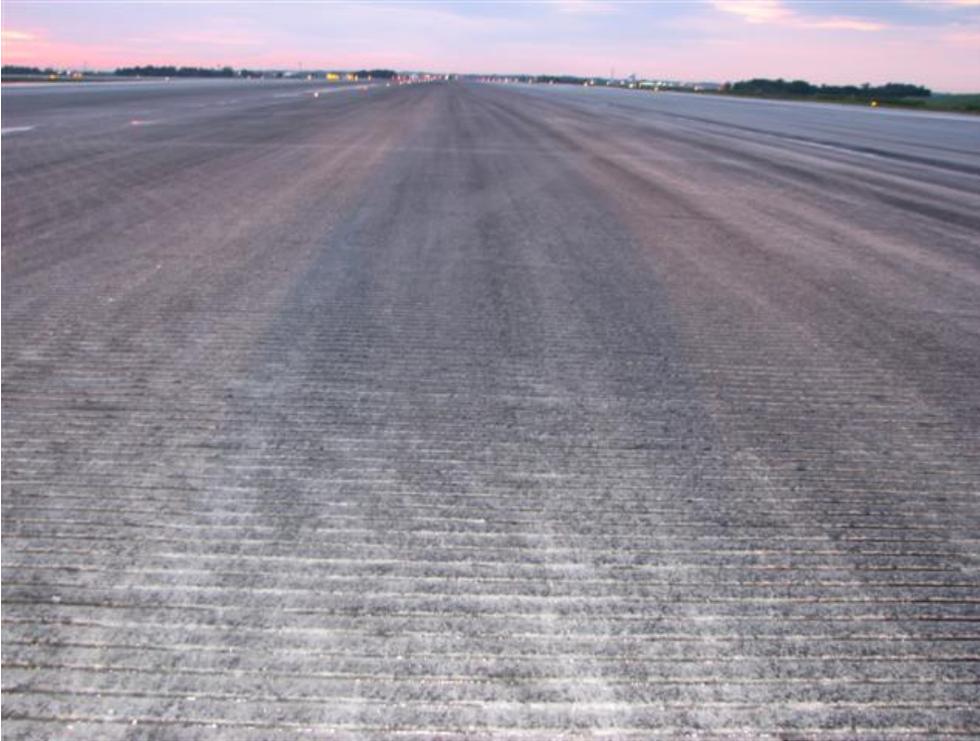
Figure 4: Runway pavement after chemical removal

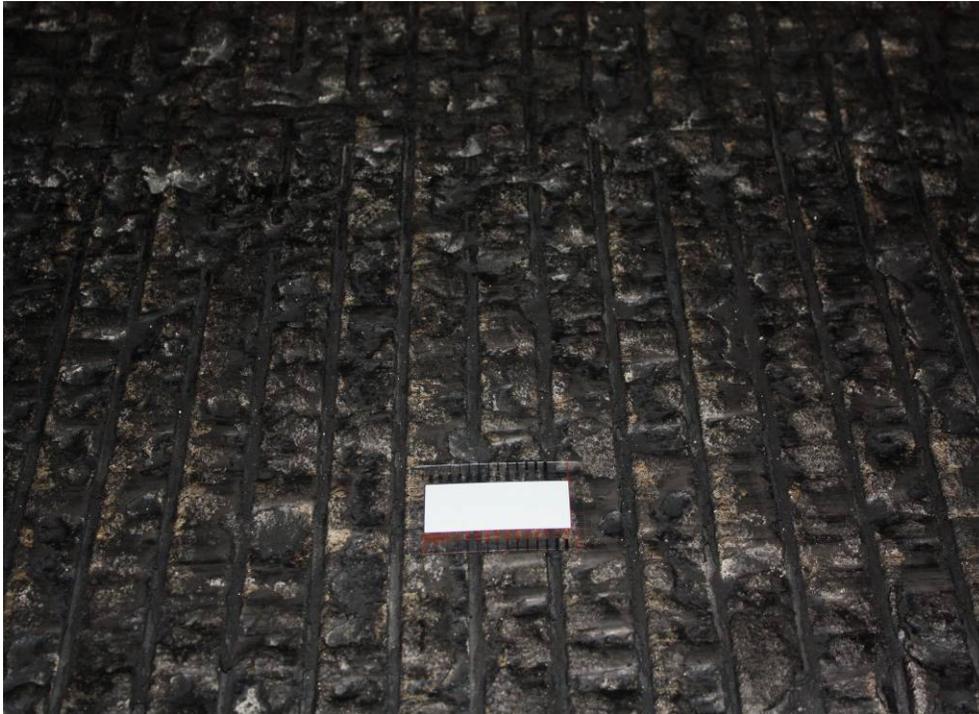
Figure 5: Runway pavement before shot blast

The airport has used a contractor to perform shot blasting on the runways since the late 1990's. The main reasons for using shotblasting was it minimized impact on operations, satisfaction with final product, speed of the operation and it retextured the pavement surface in addition to cleaning it. The single most important reason was the satisfaction with the final product. Before and after photos of shot blast removal can be seen in Figures 5 and 6.

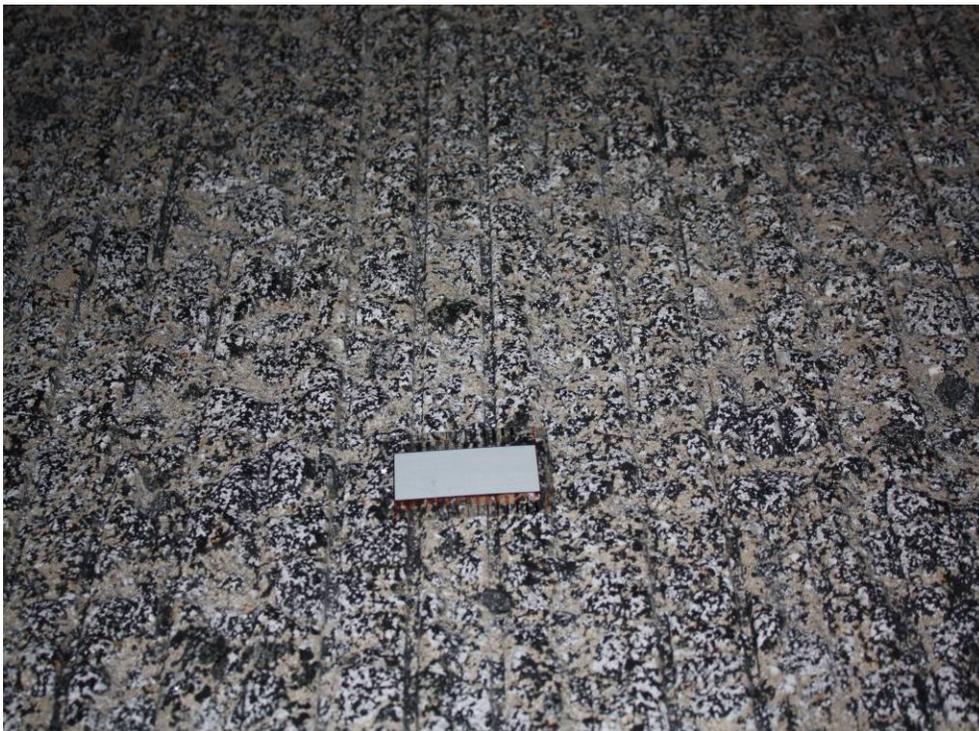
Figure 6: Runway pavement after shot blast

There was damage observed to the pavement surface. The grooves were deteriorated on two of the runways. One runway was constructed in 1999 and it was regrooved in 2006. They typically experience loss of the pavement surface during this operation.
