DURABILITY OF HIGH-STABILITY ASPHALT MIXTURE
UNDER AIRCRAFT LOADING

PRESENTED FOR THE
2014 FAA WORLDWIDE AIRPORT TECHNOLOGY TRANSFER CONFERENCE
Galloway, New Jersey, USA

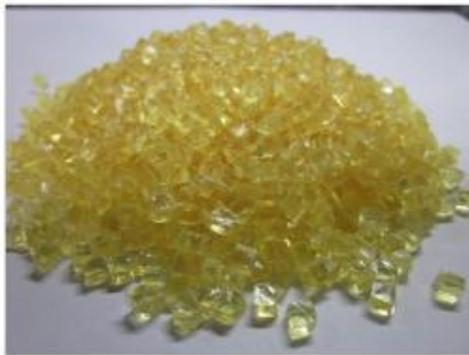
Figure 1. Special thermoplastic resin

The authors have developed a high-stability asphalt (HSA) mixture [1]. The newly developed asphalt is composed of a special thermoplastic resin, shown in Figure 1, and an asphalt modified with styrene-butadiene-styrene block copolymer (SBS). It has a high resistance to rutting, and oil and can be applied using the same construction procedure used for conventional hot mix asphalt mixtures in Japan. The unit price of the HSA mixture is about three times as high as that of the straight asphalt (SA) mixture. Although the rutting resistance under vehicle loading has been found to be equal to a semi-flexible pavement material, which is an open-graded asphalt mixture filled with a cement grout, little is known about the durability such as the rutting resistance and groove stability under aircraft loading. In order to investigate the durability of the HSA mixture, we carried out laboratory tests involving simulated aircraft loading. A full-scale loading test was then performed in order to confirm the results of the laboratory tests.

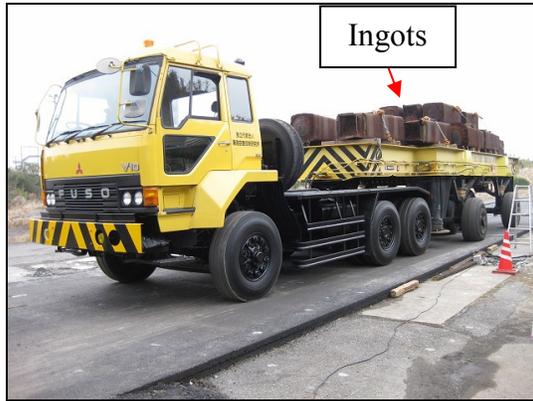
Figure 12. Loading vehicle

A repeated-loading test was performed on the test pavement in order to confirm the results of the laboratory test. The loading vehicle shown in Figure 12 was used in the test. The vehicle was a six-wheeled truck with a trailer. Figure 13 shows the loading wheels of the trailer. The configuration of the loading wheels is the same as that of the main gear of a B747-400. The other wheels of the trailer are safety wheels. The safety wheels were lifted and left unresolved during the test. The load can be adjusted by placing ingots on the trailer bed. The test conditions are listed in Table 9. During the test, the load was adjusted in order to obtain a contact pressure of 1.5 MPa, which is equivalent to the load generated by a large aircraft, such as a B747-400. The traveling speed was approximately 5 km/h, taking into consideration the trailer performance and safety during the test. The maximum number of wheel passes was 600. The rut depth and residual ratio for the groove were evaluated at 0, 40, 80, 200, 320, and 600 wheel passes. The definition of the residual ratio was the same as that for the laboratory tests. However, the volume
