CC6 Update

Presented to: Airport Pavement Working Group
By: David R. Brill, Ph.D., P.E. and Hao Yin, Ph.D.
Date: April 16, 2013

CC6 Objectives

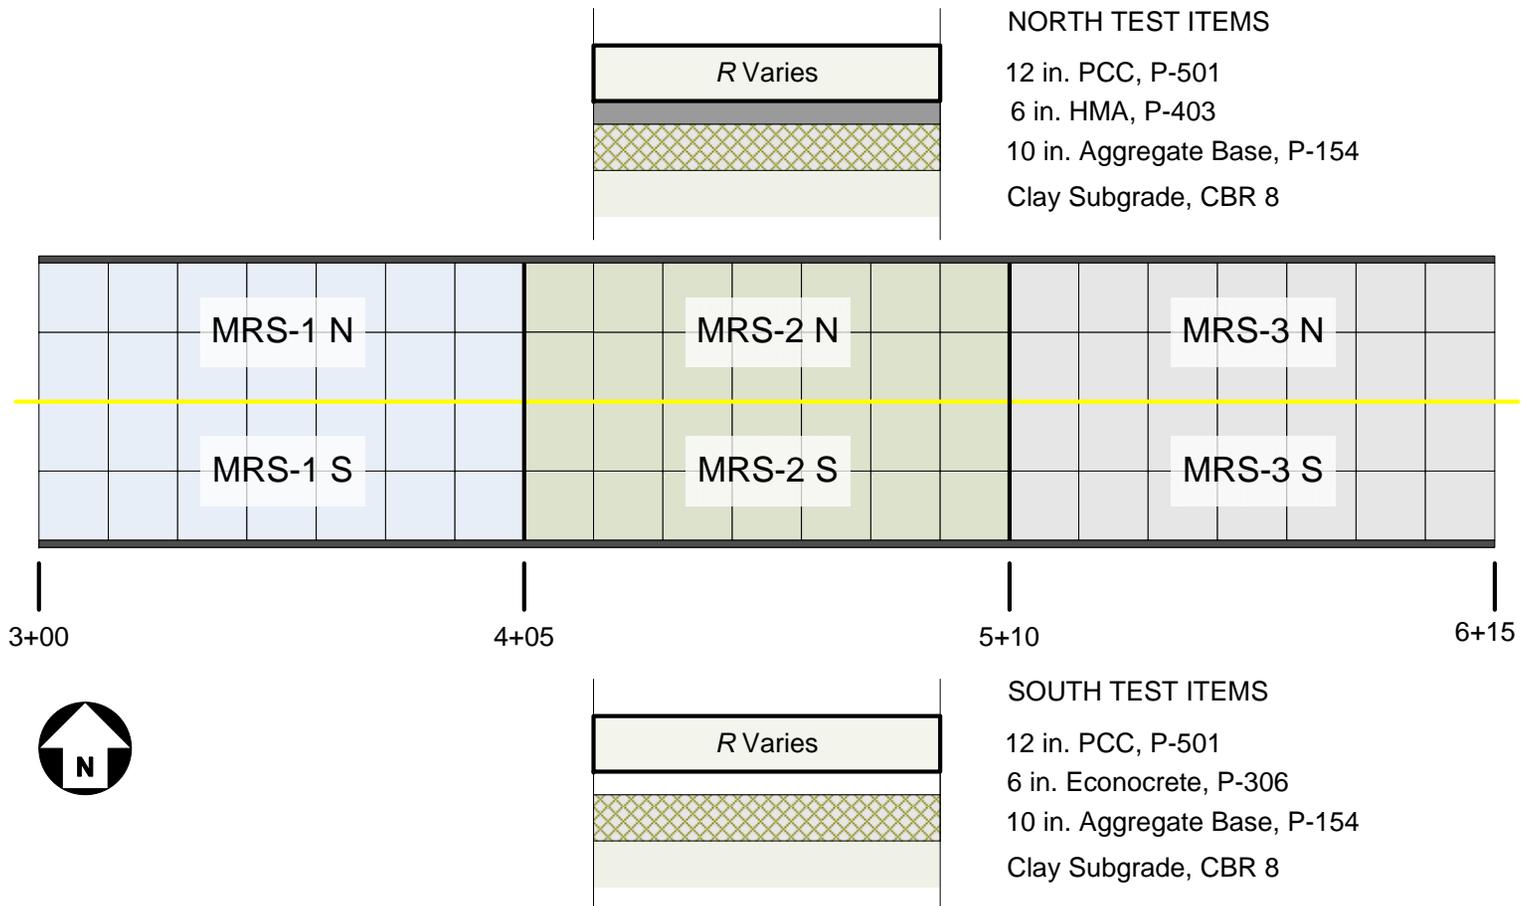
CC6 Test Item Structure Summary

“Low Strength”
Target 500 psi

“Medium Strength”
Target 750 psi

“High Strength”
Target 1000 psi

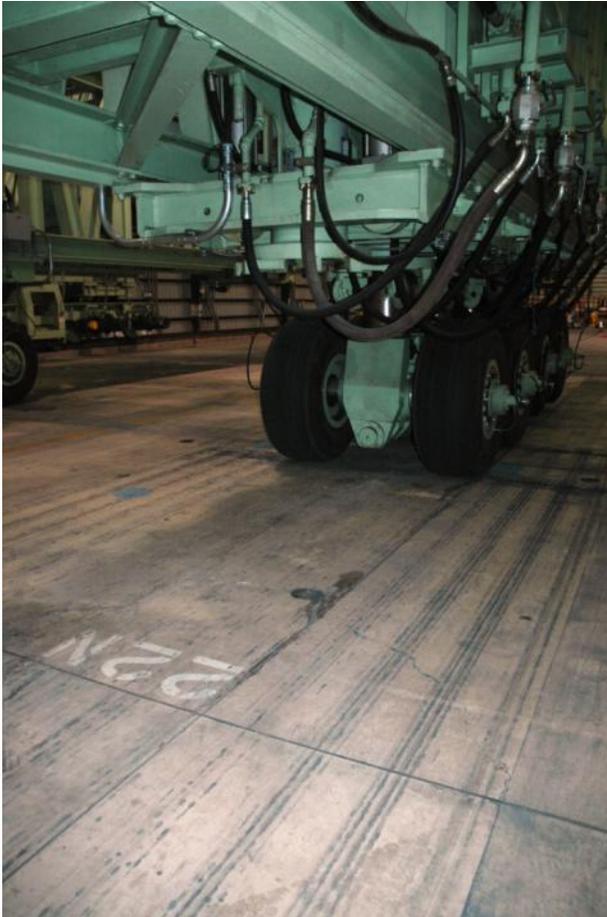
CC6 Current Status

- **Traffic ended 4/25/2012. All test items were trafficked to full failure.**
- **Total of 39,270 passes of the test vehicle.**
- **Post-traffic testing is in progress.**
- **Parallel laboratory effort (beam fatigue & fracture testing) is in progress.**

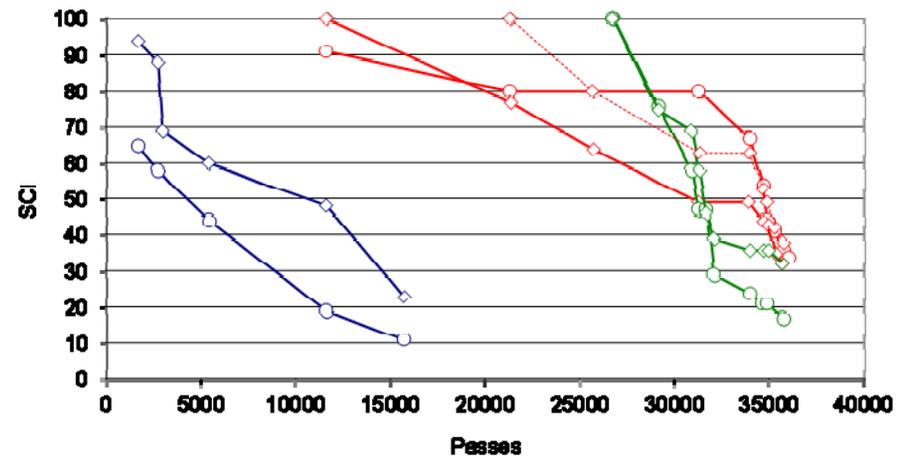
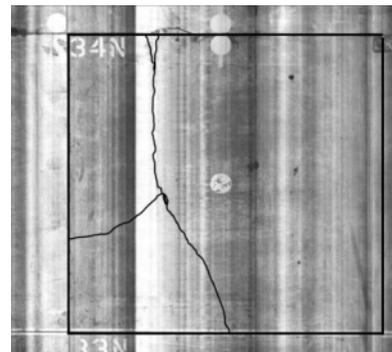
Use of Laser Imaging to Document CC6 Distresses

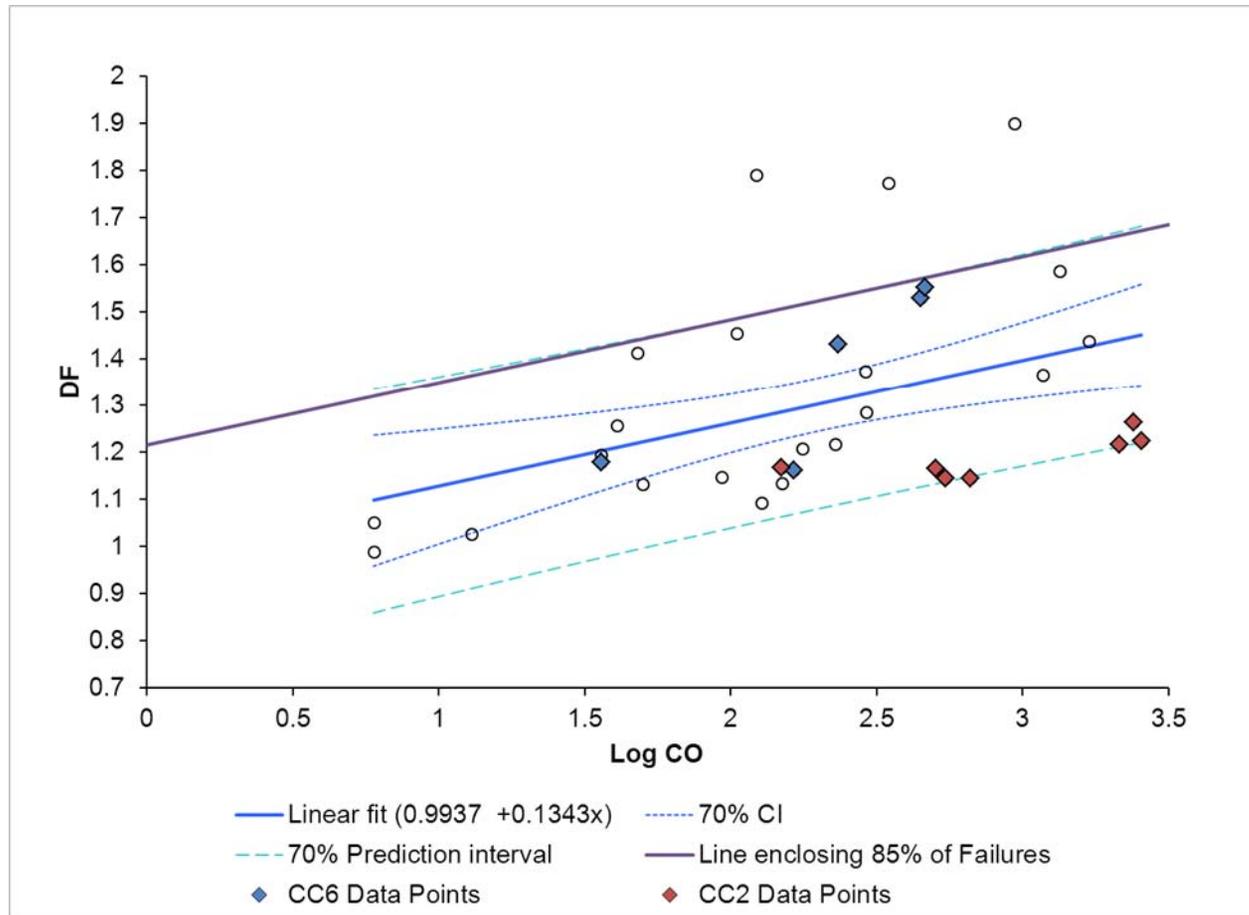
Rigid Failure Data Reanalysis (1)

Design Factor vs. Adjusted Coverages to 1st Crack

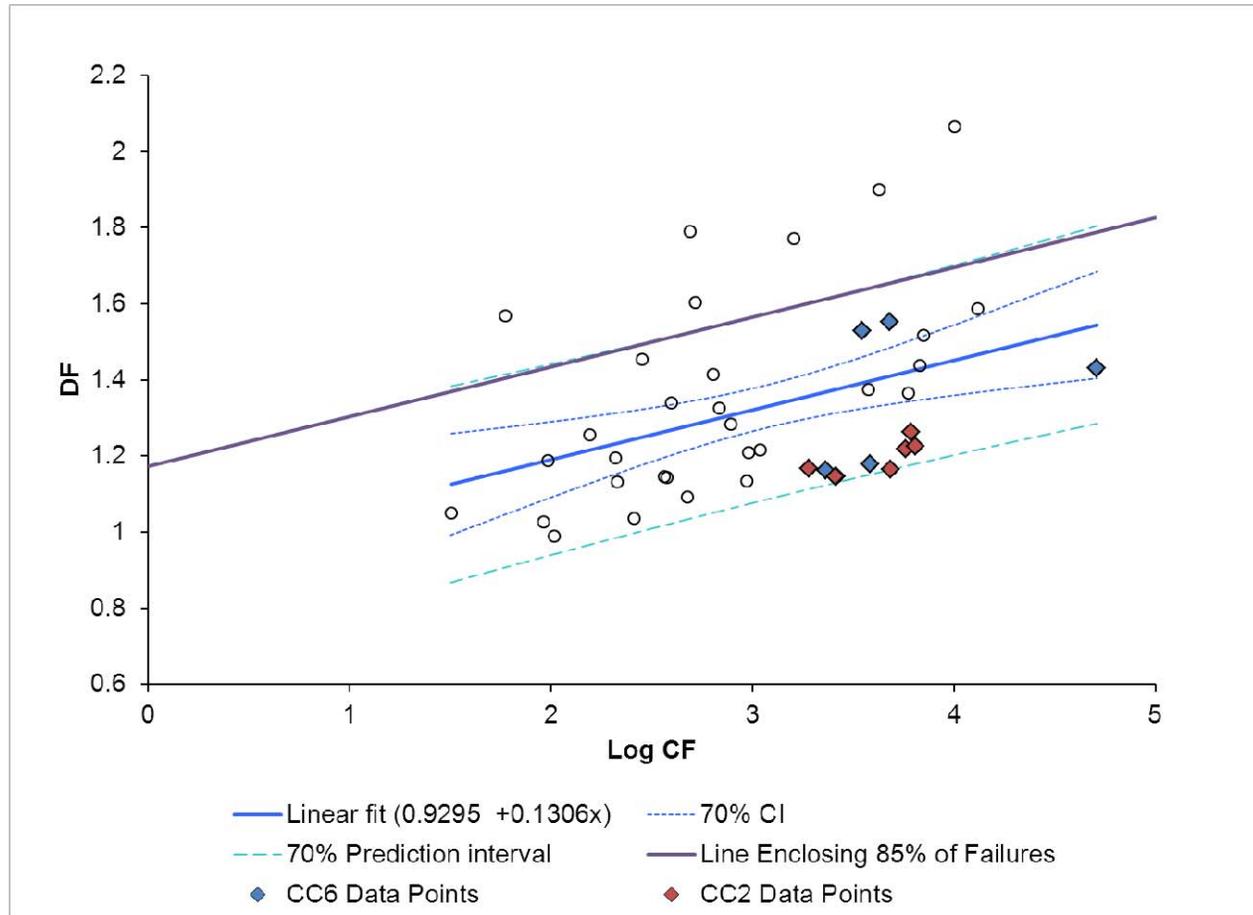
Rigid Failure Data Reanalysis (2)

Design Factor vs. Adjusted Coverages to Full Failure

a	b	c	d
85%ile Values	1.173	0.1306	1.215	0.1343
50%ile Values	0.9295	0.1306	0.9937	0.1343
Current Values	0.5878	0.2523	0.7409	0.2465

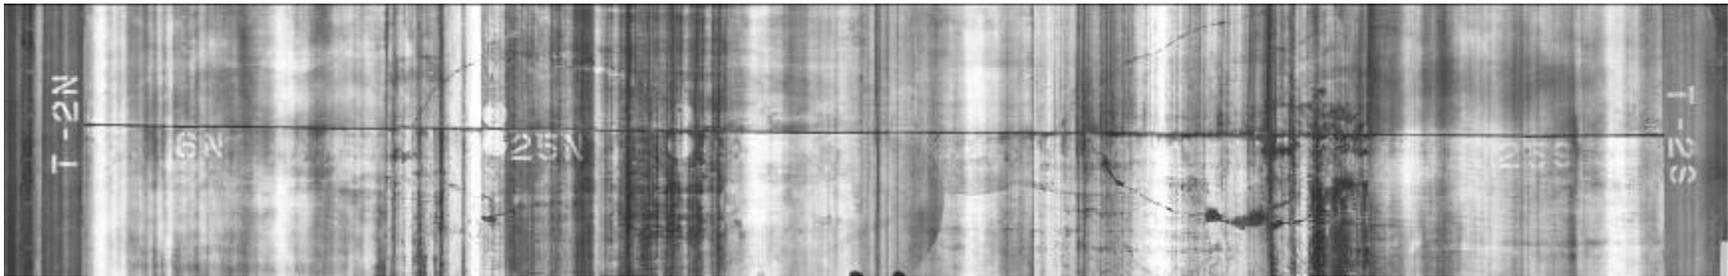
Isolation Joint Damage

Reinforced Isolation Joint

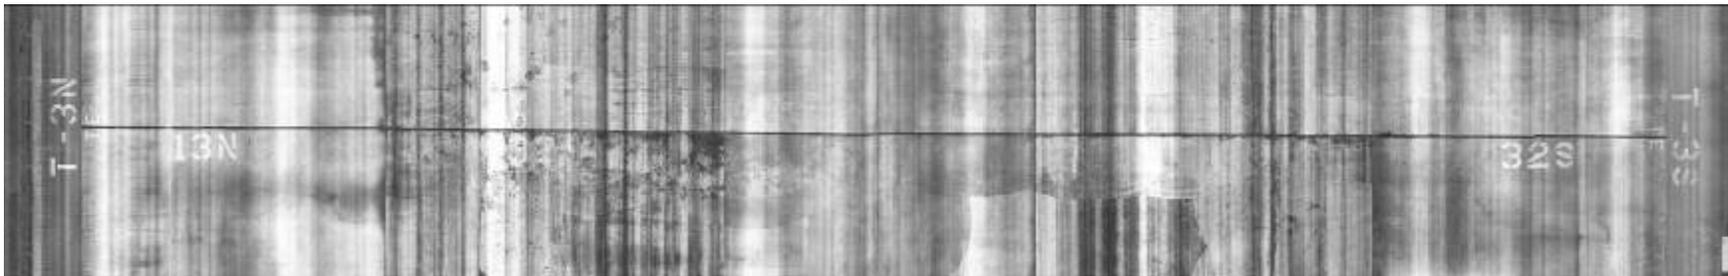
Thickened Edge Isolation Joint

- Rigid pavement life is strongly correlated to concrete flexural strength.
- Higher strength test items required more passes at higher loads to fail.
- No significant difference in performance for base types. However, some differences in crack patterns observed.
- Thickened edge joint performed better than reinforced isolation joint.

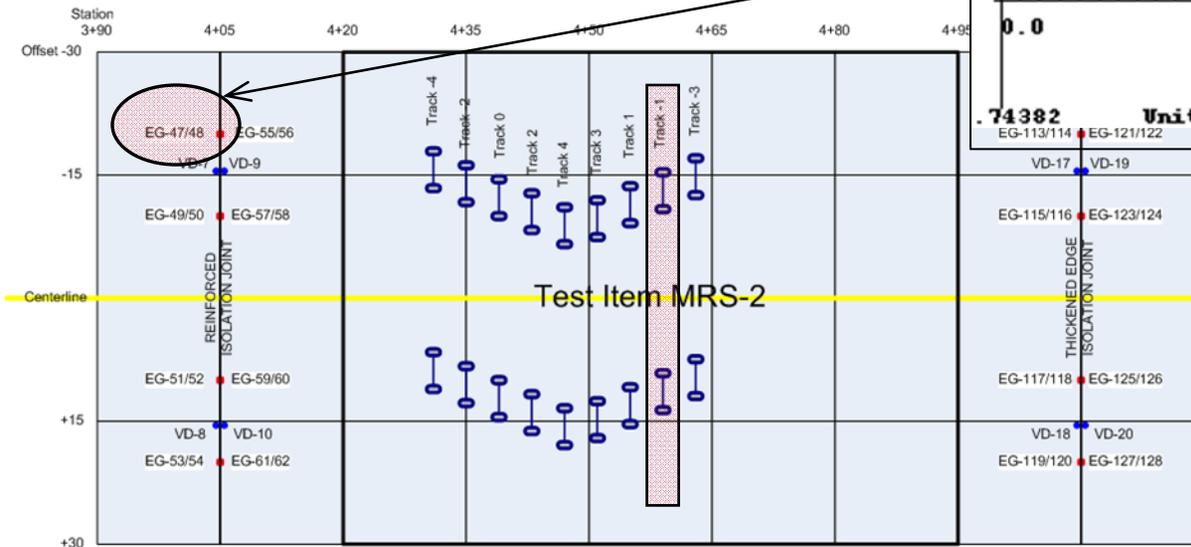
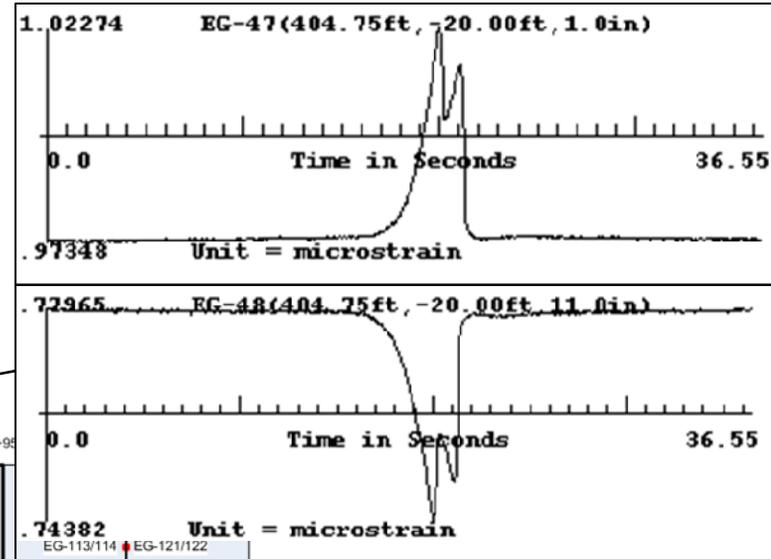
Isolation Joint Analysis

The load-induced tensile peak strain at the top of the slab for the reinforced joint (EG-47) was approximately 29% higher than the corresponding bottom strain.

Pass 15 – 8/30/2011
Wheel Load = 45 kip

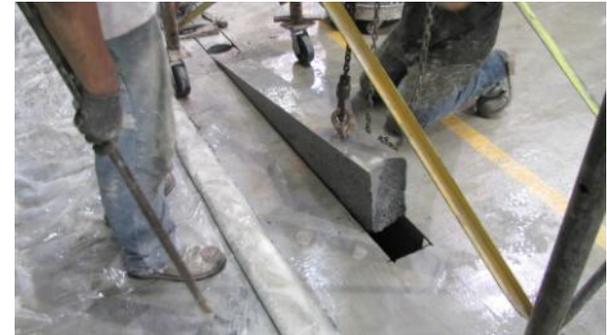
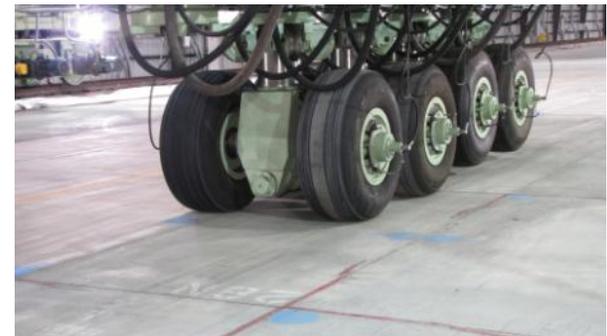
Post-Traffic Testing Summary

- **Tests performed since 5/12:**
 - Flexural strength and fatigue tests on field-cut beams.
 - Split tensile tests on lab-cured and field-cut cylinders.
 - Residual stress tests (MRS-2 and MRS-3) .
 - Slab strength tests (MRS-2 and MRS-3).
 - HWD and vehicle load tests (MRS-2).
 - Ultrasonic tomography tests on slabs and beams.
 - Transverse profiles.
 - PSPA.
- **Planned tests:**
 - Plate load tests.
 - CBR and post-traffic density.
