Non – Destructive Airport Pavement Testing

Technology Update

Presented to: FAA Working Group

Date: April 17, 2013

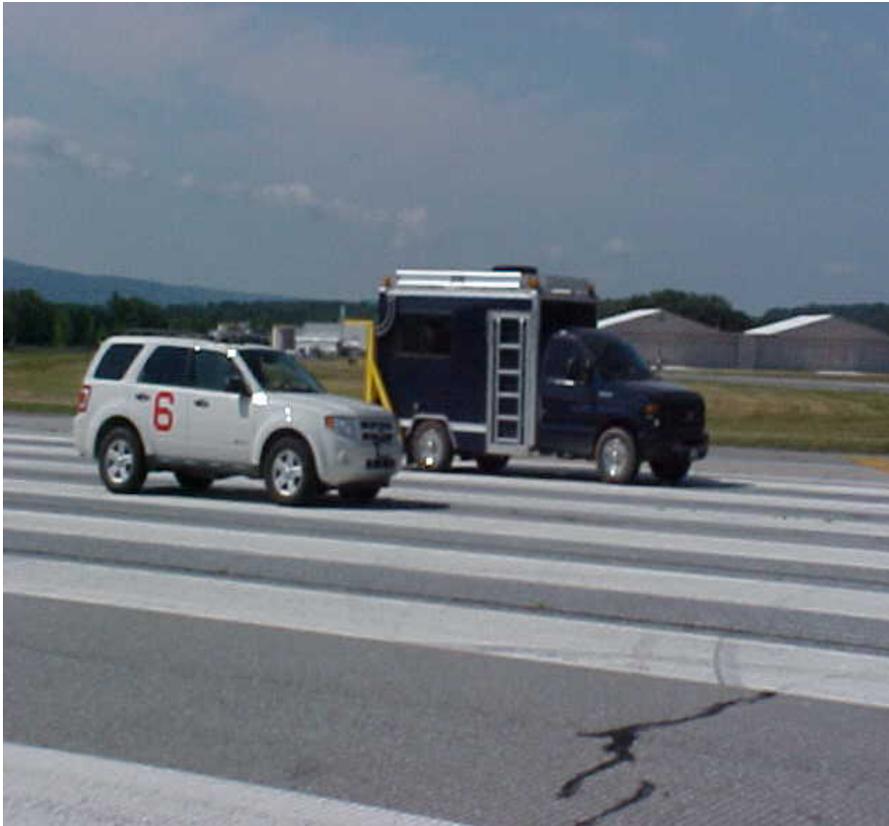
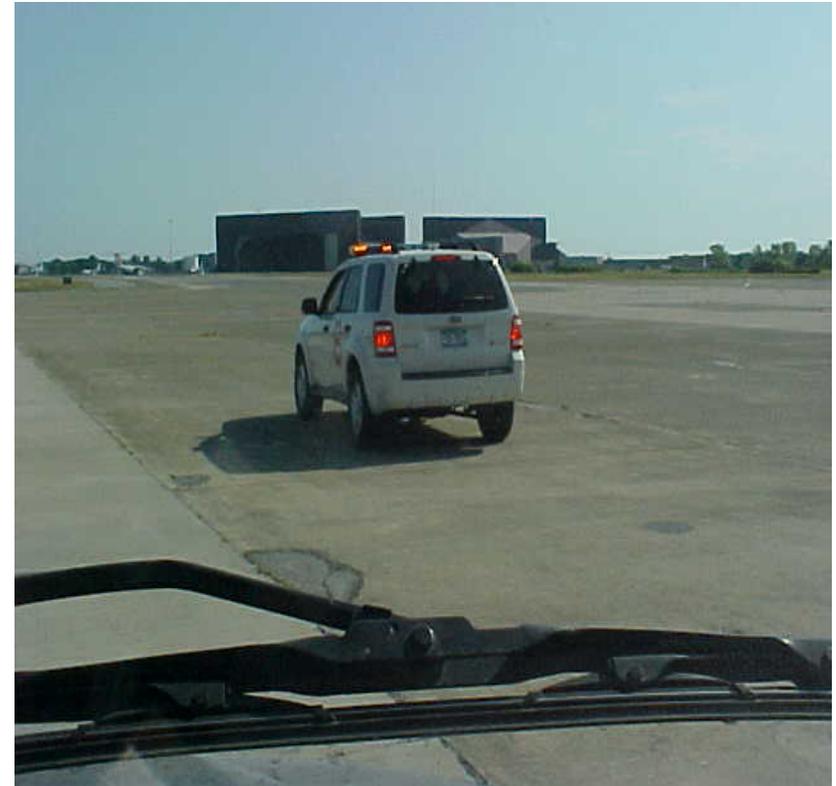
Pavement Imaging at Stewart IAP

- On July 11, 2012 three representatives from the Tech Center traveled to Stewart to image runway 16 – 34.
- Crosswind runway 16-34 is 6,006 feet long by 150 feet wide.
- This runway is asphalt surface course approximately 18 years old and is scheduled for rehabilitation in 2013.

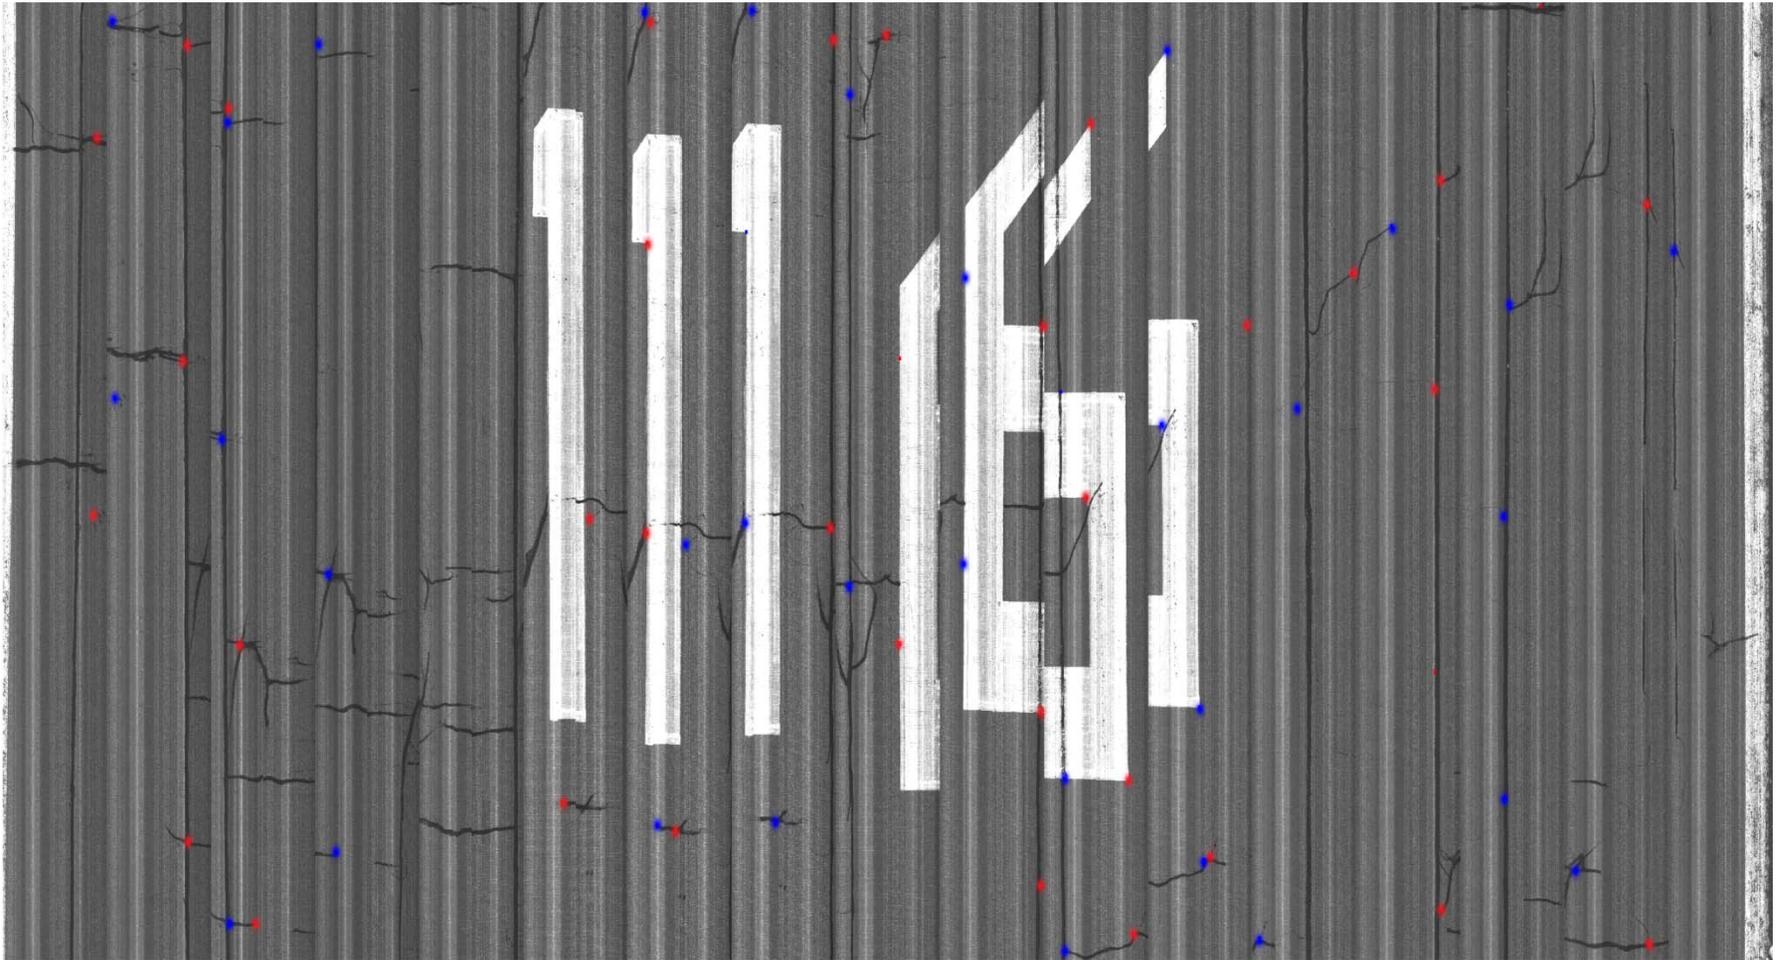
Unstitched Image of Runway 16-34

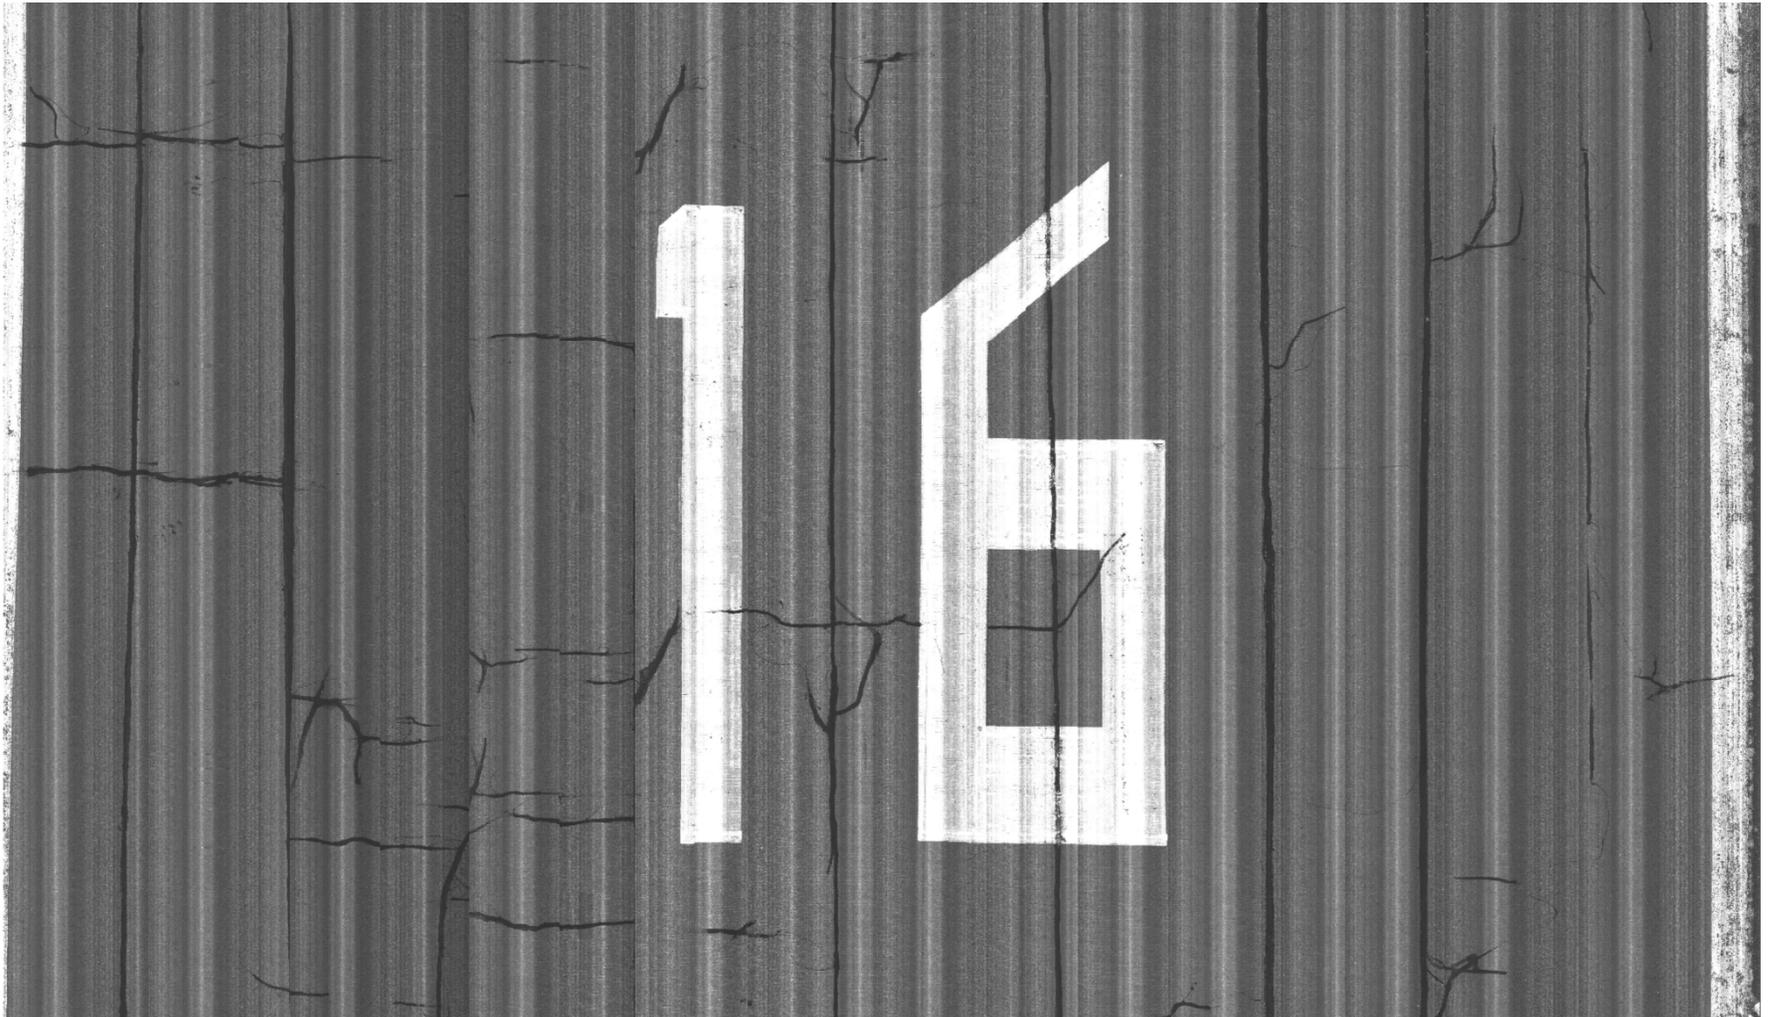
Stitched Image of Runway 16-34

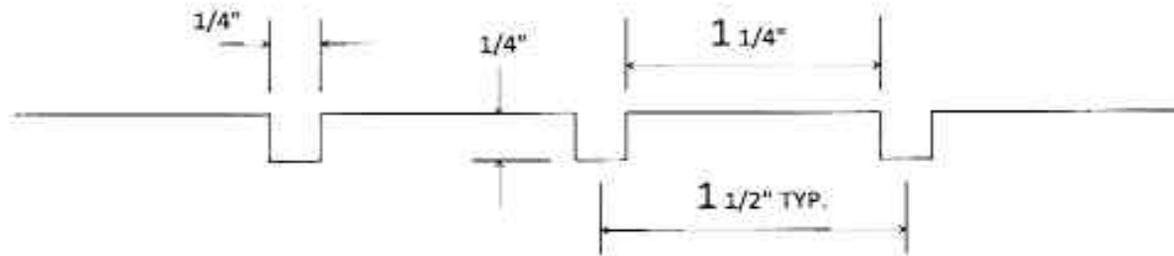
FAA Groove Dimensions

STANDARD FAA GROOVE PATTERN

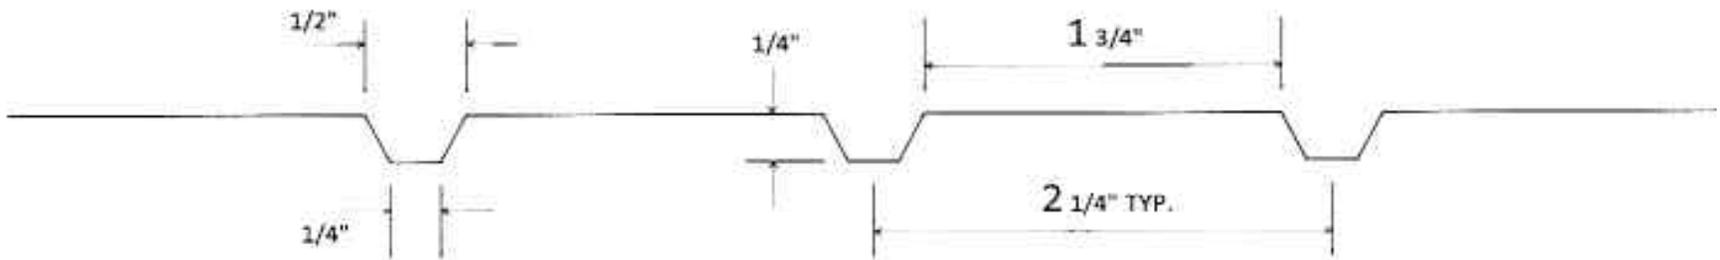
TRAPEZOIDAL GROOVE PATTERN

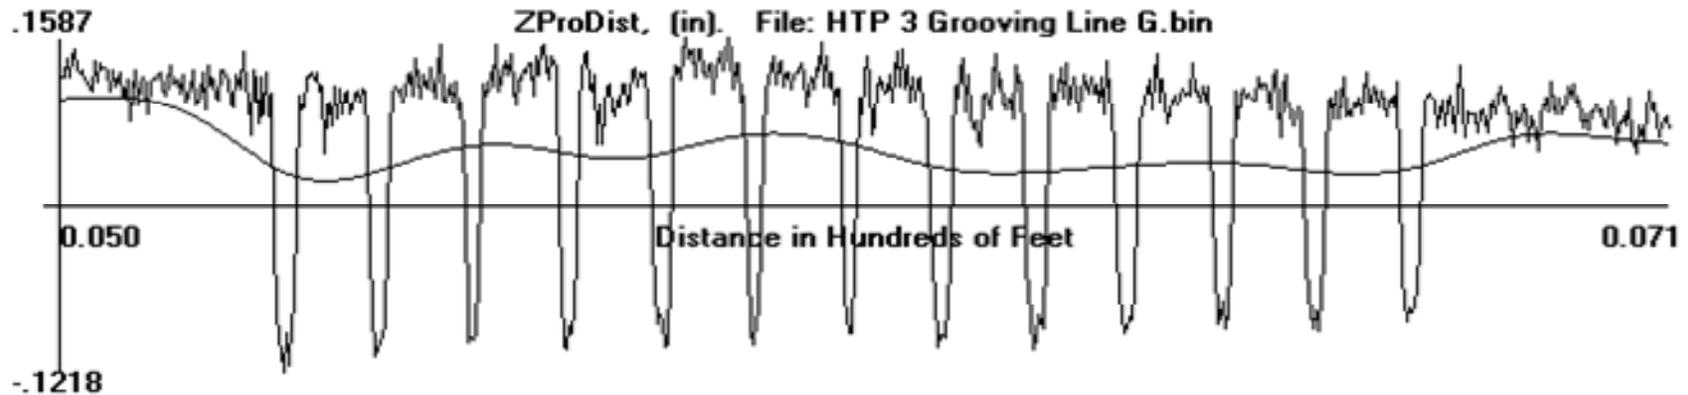
Unheated Rectangular Grooves

June 6, 2012

0 passes

<u>0 Passes</u>		<u>2,555 Passes</u>	
Unheated Rect.	0.197 in	0.063	$\Delta = 0.134$ in.	(68%)
Heated Rect.	0.1021	0.075	$\Delta = 0.0271$ in.	(26.5%)
Unheated Trap.	0.237	0.180	$\Delta = 0.057$ in.	(24.1%)
Heated Trap.	0.135	0.111	$\Delta = 0.024$ in.	(17.8%)

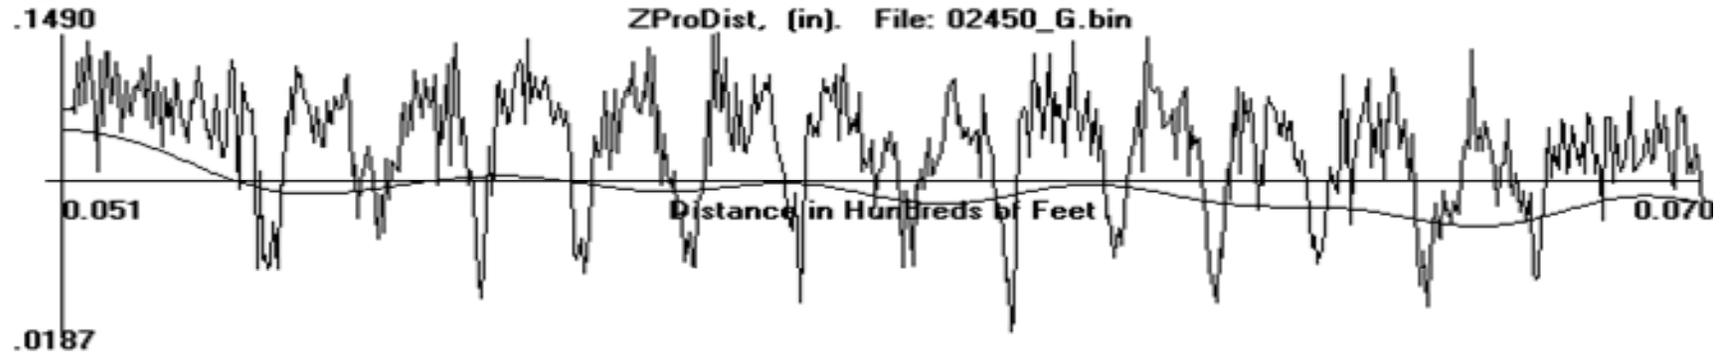
August 3, 2012

2555 Passes

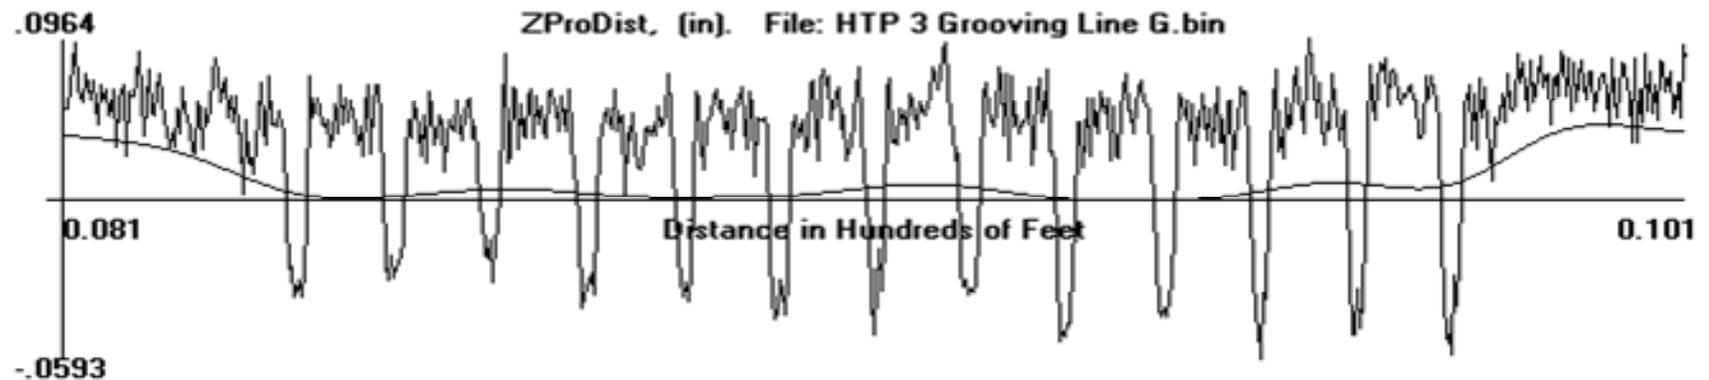
Heated Rectangular Grooves

June 6, 2012

0 passes

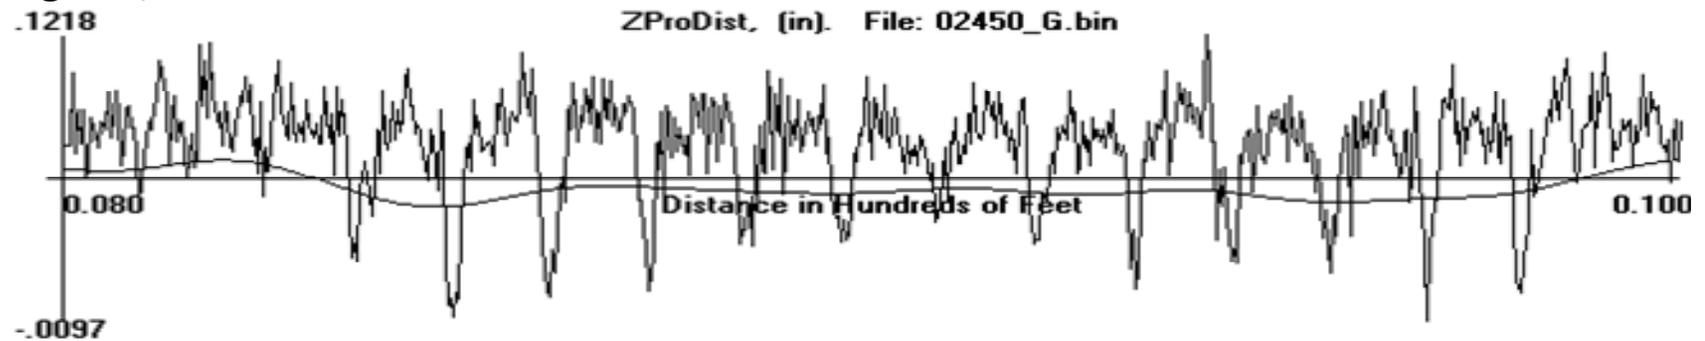
August 3, 2012

2555 Passes

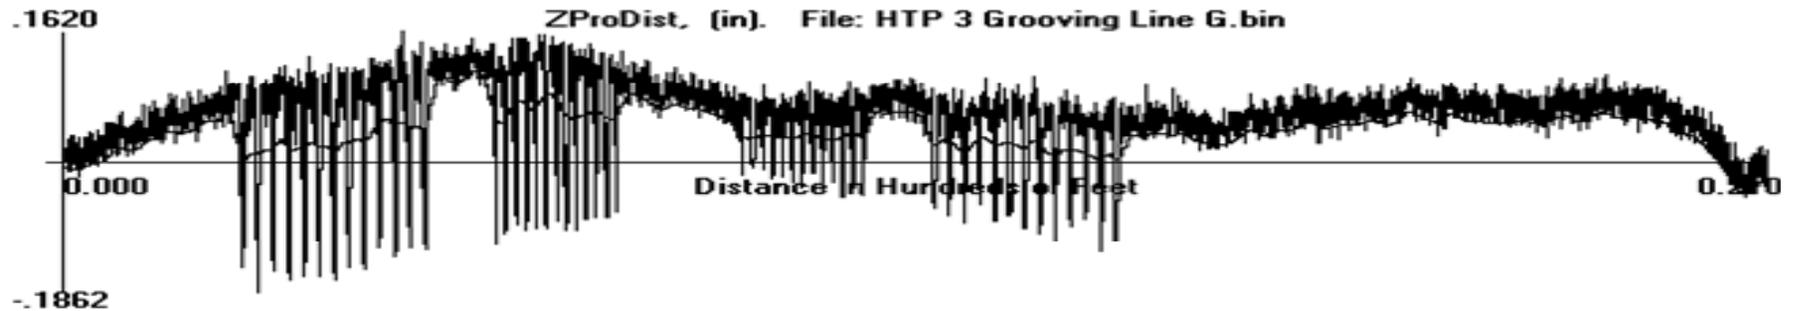
ProGroove Plot at 0 and 2555 Passes

June 6, 2012 Pre – Traffic Grooves

0 Passes

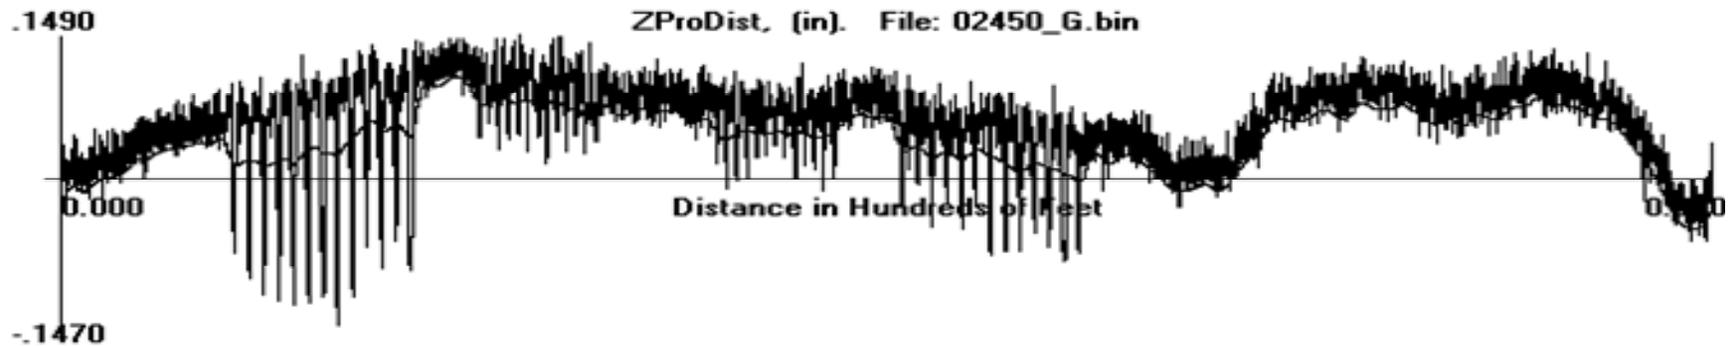
August 3, 2012

2555 Passes
