Instrumentation Projects at Airports

Presented to: FAA Working Group Meeting

By: Navneet Garg, Ph.D., FAA ANG-E262

Date: April 17, 2013

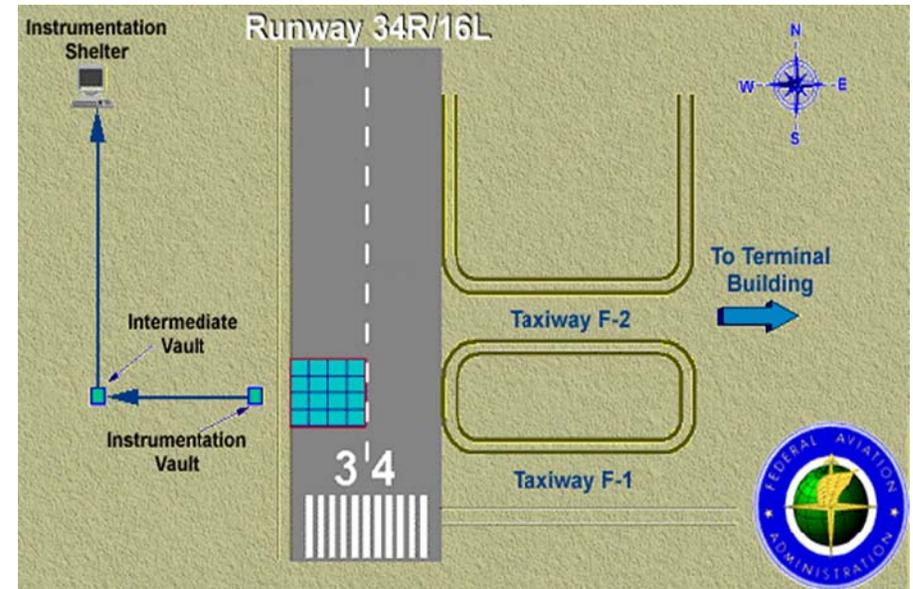
- Initiated in 1992.
- Focused on measuring PCC pavement responses due to different loading conditions
 - Aircraft; and
 - Environment (temperature/moisture).
- 16 slabs in the take-off area of Runway 34R-16L instrumented.
- 460 static and dynamic sensors installed.
