CHARACTERIZATION OF RUBBLIZED CONCRETE AIRPORT PAVEMENTS AT THE
NAPTF USING NON-DESTRUCTIVE TESTING METHODS

PRESENTED FOR THE
2007 FAA WORLDWIDE AIRPORT TECHNOLOGY TRANSFER CONFERENCE
Atlantic City, New Jersey, USA

April 2007

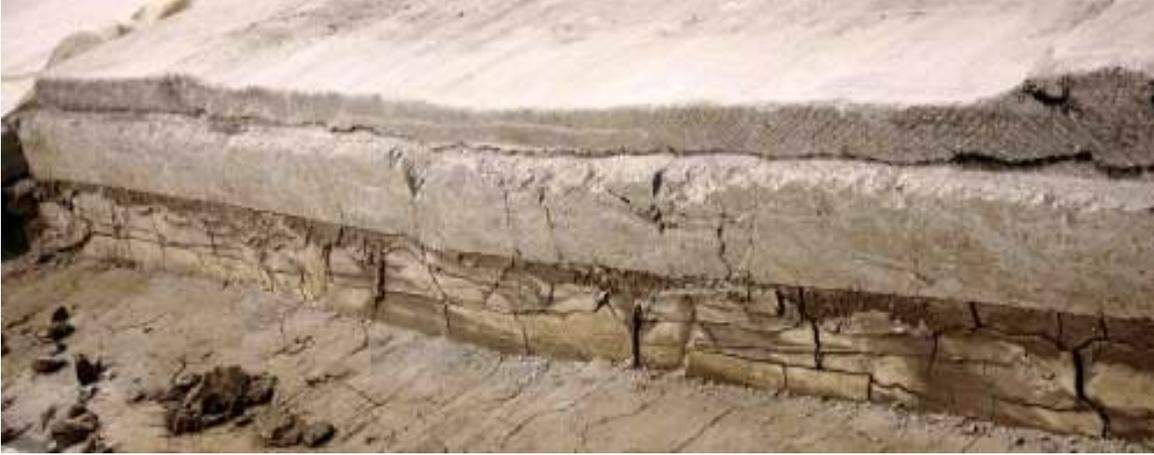
Figure 10. Photograph of MRG Trench.

At the end of trafficking, the AREA values were reduced by approximately 29-percent of the initial value for MRG, and reduced by 17-percent for MRS. The rubblized concrete in the MRG and MRS trenches (figures 10 and 11) showed no significant signs of deterioration at the end of trafficking.

The results from posttraffic testing in the trenches show that, in test item MRC, the failure in the subgrade resulted in failure of the pavement structure, including the full depth of the rubblized layer. In test item MRC, the top 3 to 4 inches of the subgrade had reduced strength (CBR 3 to 4) because of moisture migration from the P-154 subbase into the subgrade. This weak layer of subgrade allowed for higher vertical deflection in the pavement structure which resulted in a faster rate of deterioration of interlock between the rubblized concrete pieces and ultimate failure of the pavement structure. Profile measurements showed that the top of the rubblized layer (3 inches of finely rubblized material) contributed to the rutting. Excluding the top 3 inches of finely rubblized material, the rubblized concrete layer behaved as a tightly interlocked high density unbound base. The strength of the rubblized concrete layer was derived from the tight interlock between the rubblized concrete pieces and the confinement provided by the HMA overlay and the support system underneath (subbase and subgrade etc.). As can be observed from figure 10 (for MRG) and figure 11 (for MRS), the rubblized layer did not experience severe deterioration since the support system and the HMA overlay provided sufficient confinement and allowed for limited vertical movement. This resulted in longer pavement structural life.

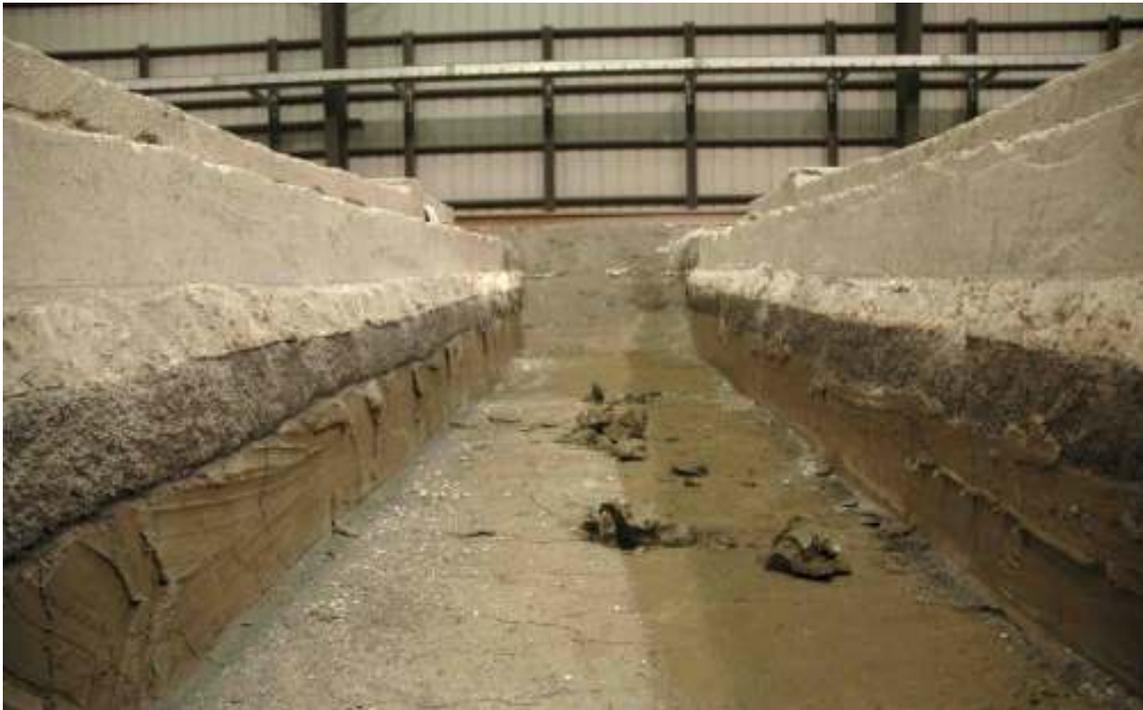
Figure 11. Photograph of MRS Trench.
