FAA RIGID PAVEMENT INSTRUMENTATION AT ATLANTA HARTSFIELD-JACKSON  
INTERNATIONAL AIRPORT

David R. Brill, P.E., Ph.D., Robert “Murphy” Flynn and Frank Pecht  
FAA Airport Technology R&D Branch, AJP-6310

PRESENTED FOR THE  
2007 FAA WORLDWIDE AIRPORT TECHNOLOGY TRANSFER CONFERENCE  
Atlantic City, New Jersey, USA

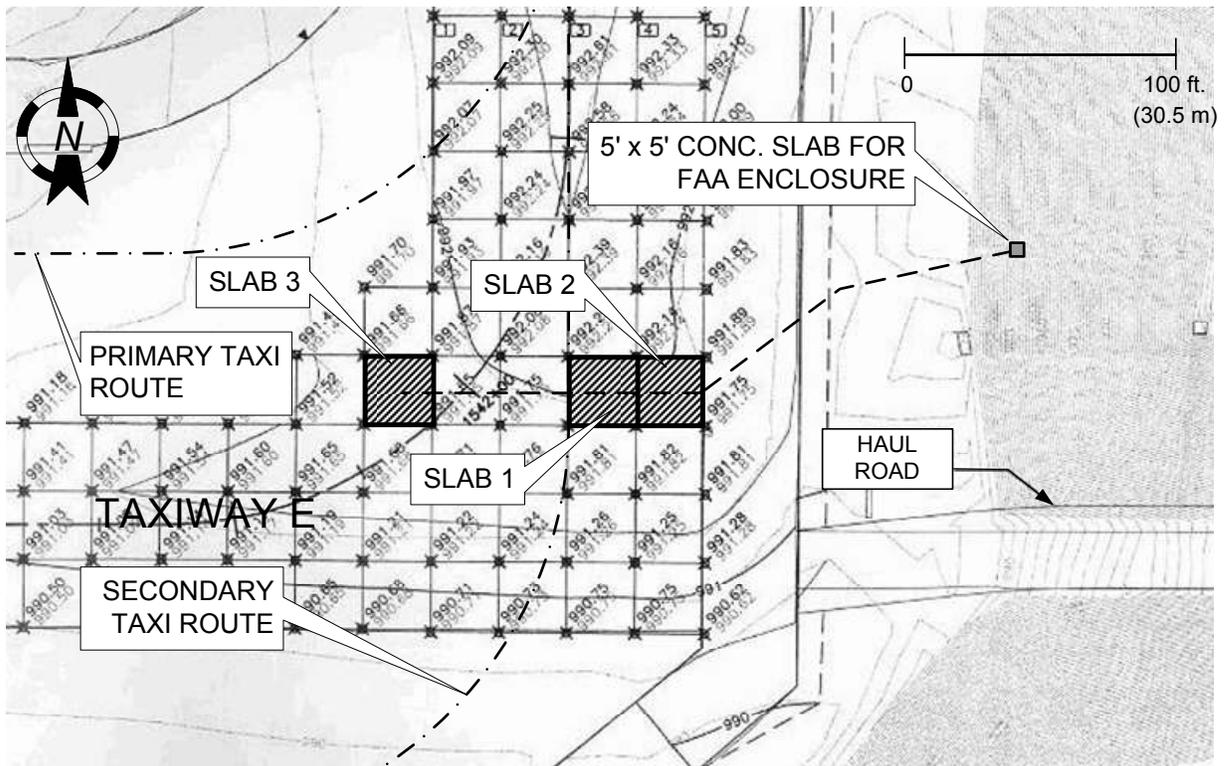
(b) Detail of Instrumented Slabs Location

Figure 1. Location of Instrumented Slabs at ATL Taxiway E.

The particular slabs were selected for three different load conditions. Slab 1 is designated the “loaded” slab since it is subject to frequent heavy wheel loads from taxiing aircraft. As shown in figure 1(b), slab 1 is adjacent to the centerline of the secondary taxi route. Aircraft using this route generally are coming from, or heading to, the holding area in Taxiway E. Although most traffic using Taxiway E will follow the primary taxi route to the north and west of the instrumented slabs, a significant number of aircraft will still traverse slab 1 over the life of the pavement. Slab 2, adjacent to slab 1 but out of the wheel path, will not experience direct

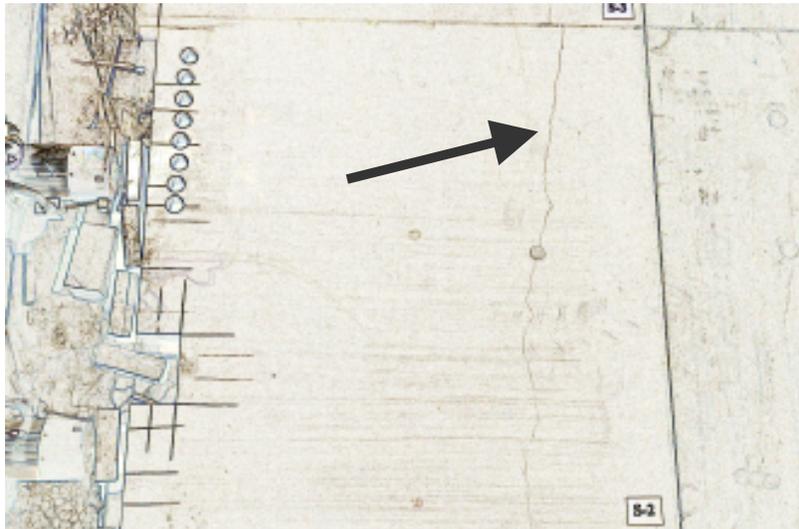
Figure 2. Top-Down Longitudinal Crack of Unloaded Slab Observed at NAPTF (CC2, Slab S-2).

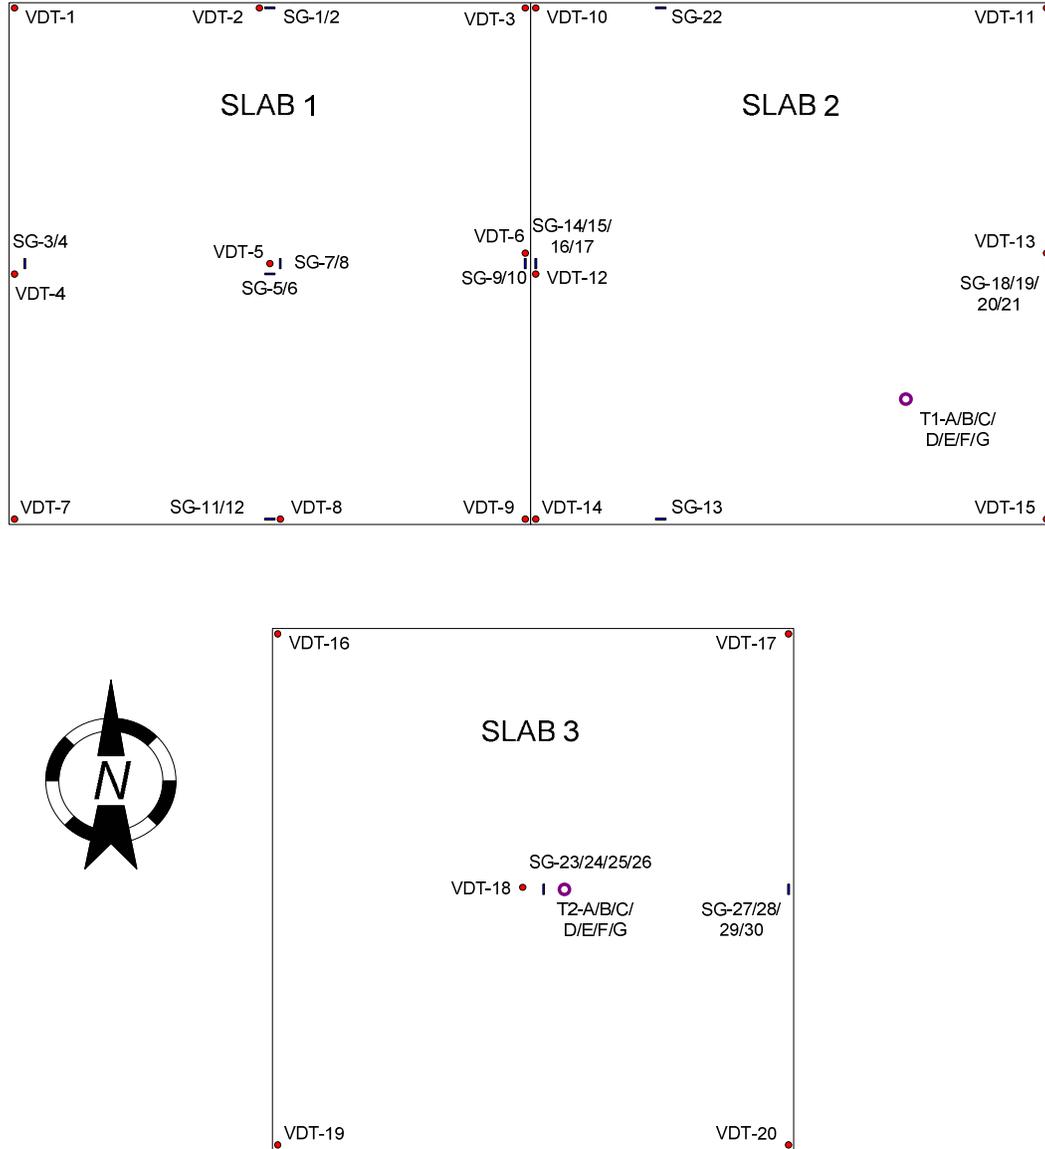
Figure 3. Sensor Layout in Taxiway E Instrumented Slabs.

The sensor layout for all three slabs is shown in figure 3. Three types of embedded sensors were installed. The vertical displacement transducers (VDT) are actually a type of joint meter manufactured by TML (Tokyo Sokki Kenkyujo Co., Ltd.) of Japan, and distributed in the United States by Texas Measurements, Inc. The joint meter (figure 4) was installed in a vertical position

Concrete strain gages (SG) manufactured by CTL, Inc. were installed at the locations shown in figure 3. Where strain gage numbers are separated by a slash (/), strain gages were installed at multiple depths at the same location in order to obtain the variation of strain with depth. In slab 1, strain gages were installed at the top and bottom of the slab (1 in./2.5 cm and 19 in./48.3 cm below the slab surface). In slabs 2 and 3, gages were installed at 1, 4, 10, and 19 in. (2.5, 10.2, 25.4, and 48.3 cm) below the slab surface. Output from all four gages can be used to define the nonlinear distribution of strain in the slab [6]. The only exceptions were gages SG-13 and SG-22 in slab 2. At those locations, a single gage was placed 1 in. (2.5 cm) from the top surface.

Temperature sensors were installed at the two locations marked T1 and T2 in figure 3. In both cases, an array of thermocouple sensors (figure 4) was used, with sensors placed at the following vertical locations below the slab surface: 0.5, 1.5, 2.5, 6.0, 10.0, 14.0 and 19.0 in. (1.3, 3.8, 6.4, 15.2, 25.4, 35.6 and 48.3 cm). It was originally planned to install an array of three relative humidity gages along the vertical face of slab 2 adjoining the shoulder. Unfortunately, this was not feasible due to the fact that the concrete cap of the shoulder was placed first and used to form the slab, making the side face of the slab inaccessible.

Figure 3(b) shows the location of the weatherproof enclosure for data collection equipment on a 8 × 8 ft (2.4 × 2.4 m) concrete pad. Due to airport safety requirements, the entire pad had to be located outside of the taxiway object-free zone, which extends 160 ft. (49 m) from the taxiway centerline. When completed (estimated late March 2007), the permanent data collection system will consist of an Iotech Wavebook™ Ethernet-based data acquisition (DAQ) system with seven 8-channel strain modules (used for input from both SG and VDT sensors), and one 14-channel thermocouple module, controlled from a Panasonic Toughbook™ rugged laptop computer. The laptop and DAQ system can be run from direct current (DC) battery power, eliminating the need to obtain alternating current (AC) electrical service from the airport. In order to keep the batteries charged, a self-contained power supply was designed, consisting of an array of solar panels combined with a wind generator. When fully operational, it is estimated that the solar panels and wind generator will generate sufficient power to acquire data once per hour continually for the life of the system.

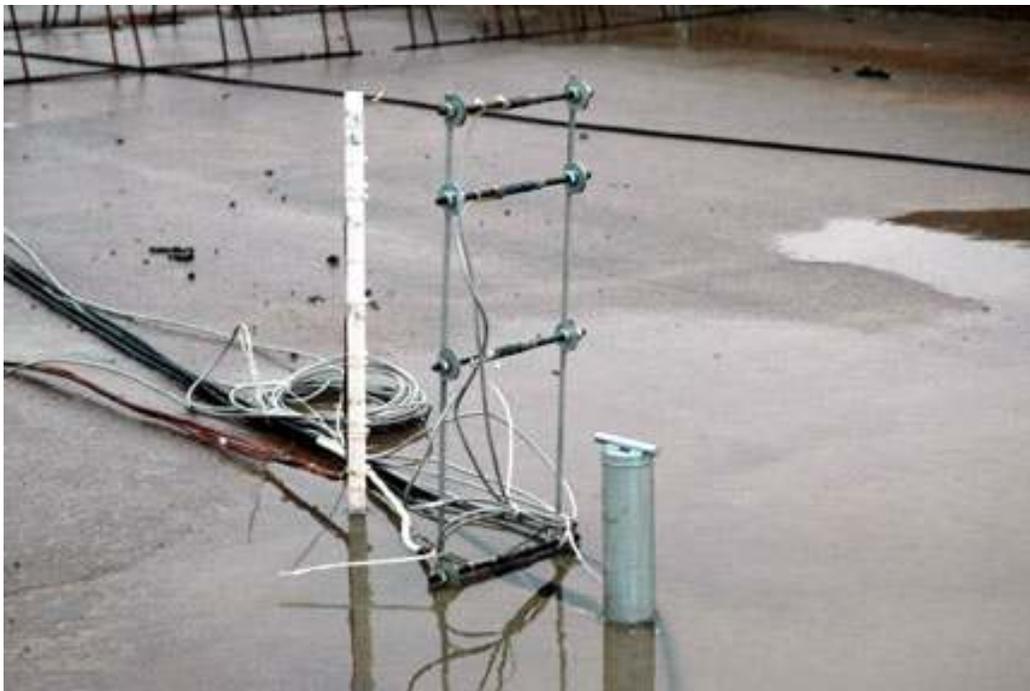
Figure 4. Center of Slab 3 Prior to Placement, Showing Thermocouple Tree (left), Strain Gage Array (center), and Vertical Displacement Transducer (right) Installed.

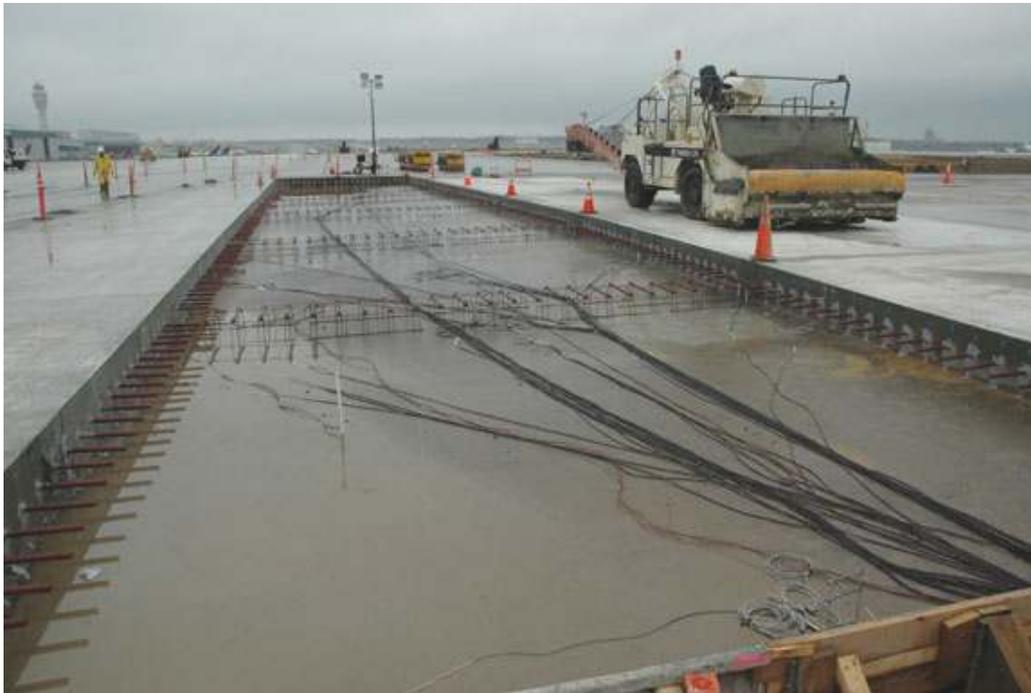
Figure 5. Instrumentation and Cabling Installed Prior to Concrete Placement.

On October 12, FAA personnel returned to Atlanta to complete the installation. The slabs were rescheduled to be placed on October 16. The instrumentation wires were pulled through the conduit on October 15 with the assistance of Atlanta DOA's electrical contractor. After several long days, the instrumentation was in position and ready for concrete. The concrete was eventually placed on the night of October 17-18 due to rain the previous days. The first data were collected during and immediately after placement of the concrete. Figure 5 shows the site of the instrumented slabs prior to concrete placement, and figure 6 shows the completed pad and instrumentation enclosure.

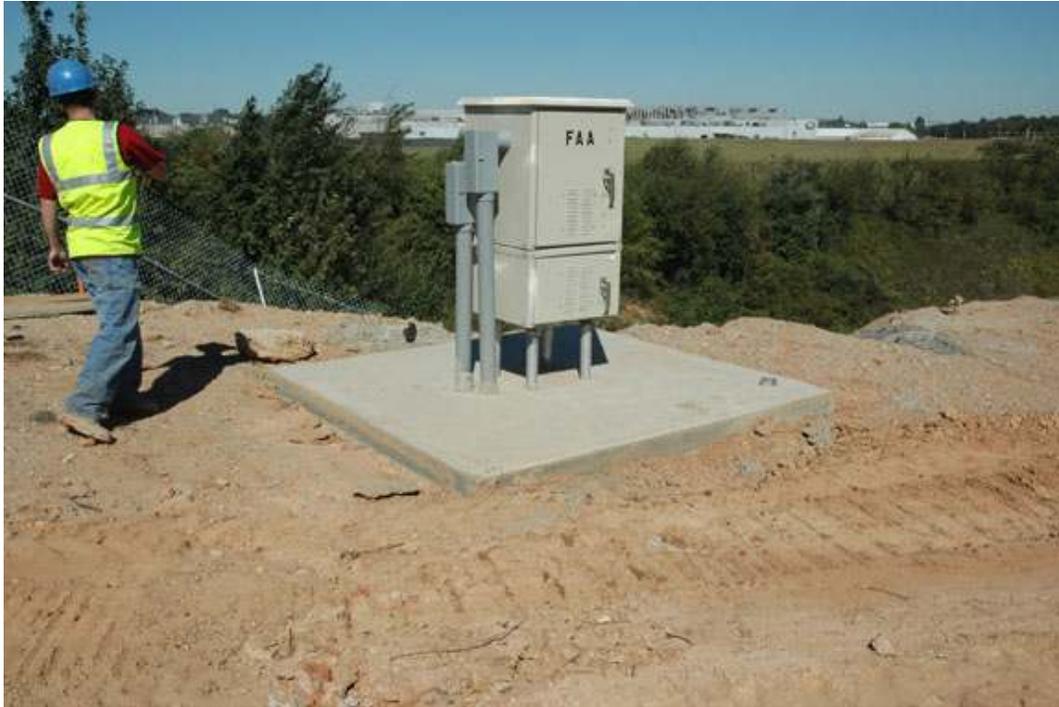
Figure 6. FAA Data Equipment Enclosure.

Three 3-inch (7.6 cm) diameter conduits were installed underground running from the shoulder of the taxiway to the location of the data collection equipment enclosure. The weatherproof enclosure was mounted on four galvanized steel legs. The legs were Schedule 40 2-in. (5.1 cm) diameter pipe placed in concrete. The conduit was then routed up from the ground and into the sides of the cabinet. The final step for this trip was the placement of an 8 × 8 ft. (2.4 × 2.4 m) concrete slab around the cabinet. The slab was placed on September 21.

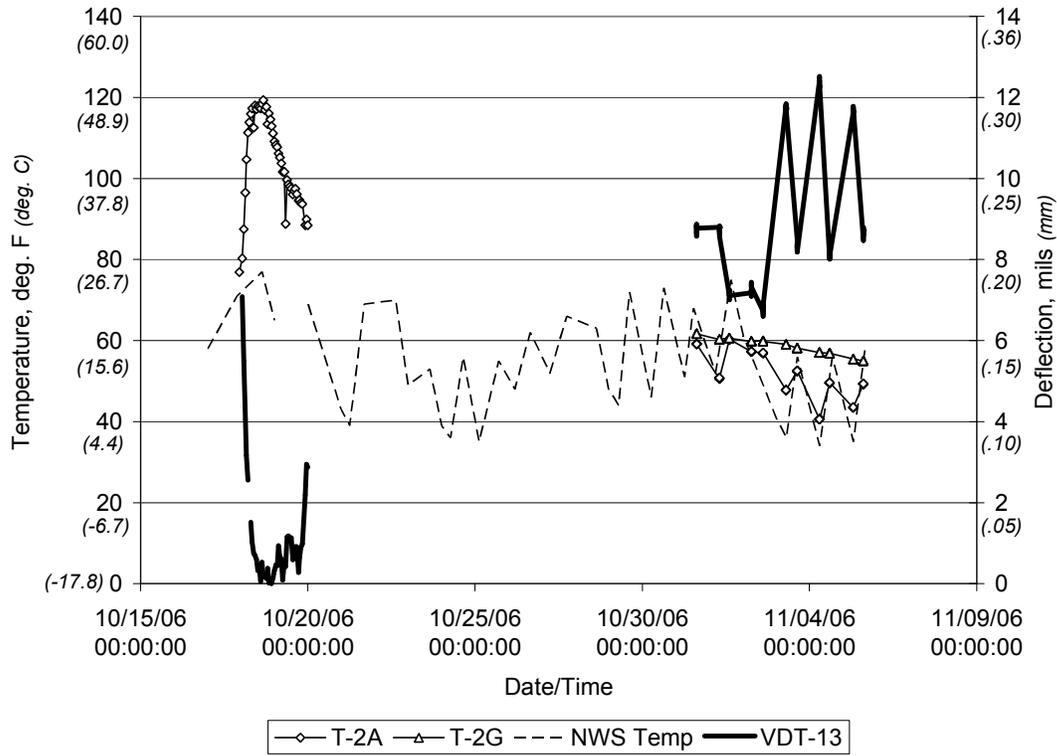
slab), (2) the reading from temperature gage T-2G (bottom of slab), and (3) the minimum and maximum daily temperatures reported at Atlanta HJIA from the National Weather Service (NWS). It is clear from this figure that the response of VDT-13 generally tracks the concrete surface temperature, but trends in the opposite direction. That is, a decrease in the temperature at the surface of the slab corresponds to an increase in the recorded deflection. For the time period observed, the maximum deflection was on the order of 12 mils (0.3 mm) relative to the assumed zero. It remains to be seen whether, as the concrete ages and the slab is subjected to further daily and seasonal temperature cycles, the vertical deflections along the free edge of the slab will increase significantly.

Figure 7. Plot of VDT-13 Response with Temperature.

Figures 7 through 10 contain plots of selected early-age response data. Data were acquired manually for three separate time periods: (1) October 18-19, (2) October 31 - November 5, and (3) December 5-8. During the first time period, readings were taken approximately once per hour over the 48-hour period immediately following concrete placement. This was done in order to capture the rapid changes in temperature and strain that accompany concrete hardening, and in order to locate the minimum deflectometer reading to which subsequent readings can be referenced. During the second and third time periods, readings were taken twice daily, in the early morning and mid-afternoon, when temperatures are expected to be near their daily minimum and maximum values. No data readings were taken for the period October 20-30, or for the period November 5 - December 4, hence there are gaps in the recorded data. Responses have been plotted as a function of time along with available temperature data, in order to better show the variation of the response with temperature. Figure 7 shows the response of deflection sensor VDT-13, which is located along the free edge of slab 2, as shown in figure 3. For clarity, vertical deflections shown in the figure are all referenced to the minimum sensor reading, which occurred for VDT-13 on October 18 at 10:01 PM, about 24 hours after placement, and is assumed to represent the “zero” deflection point. The adjusted VDT-13 response has been superimposed on three temperature plots: (1) the reading from temperature gage T-2A (top of

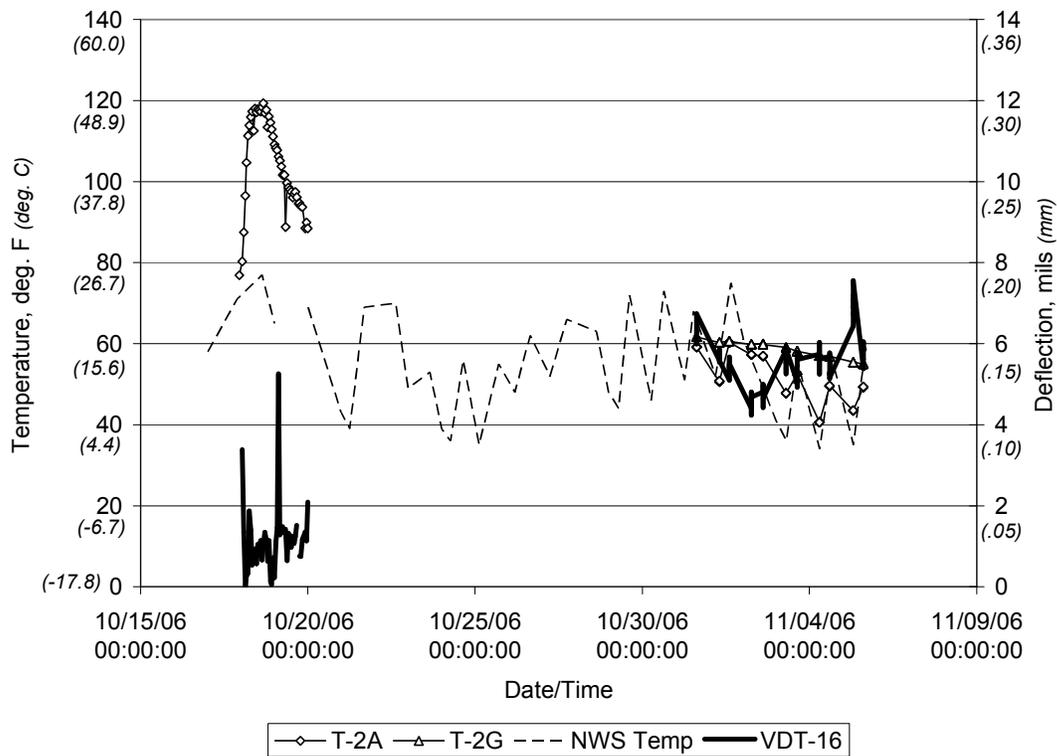
By contrast, the response of sensor VDT-16, located at a corner of slab 3 (figure 8), shows little or no variation in response to temperature changes following the initial set. The deflection remains nearly constant at approximately 6 mils (0.15 mm).

Figure 8. Plot of VDT-16 Response with Temperature.

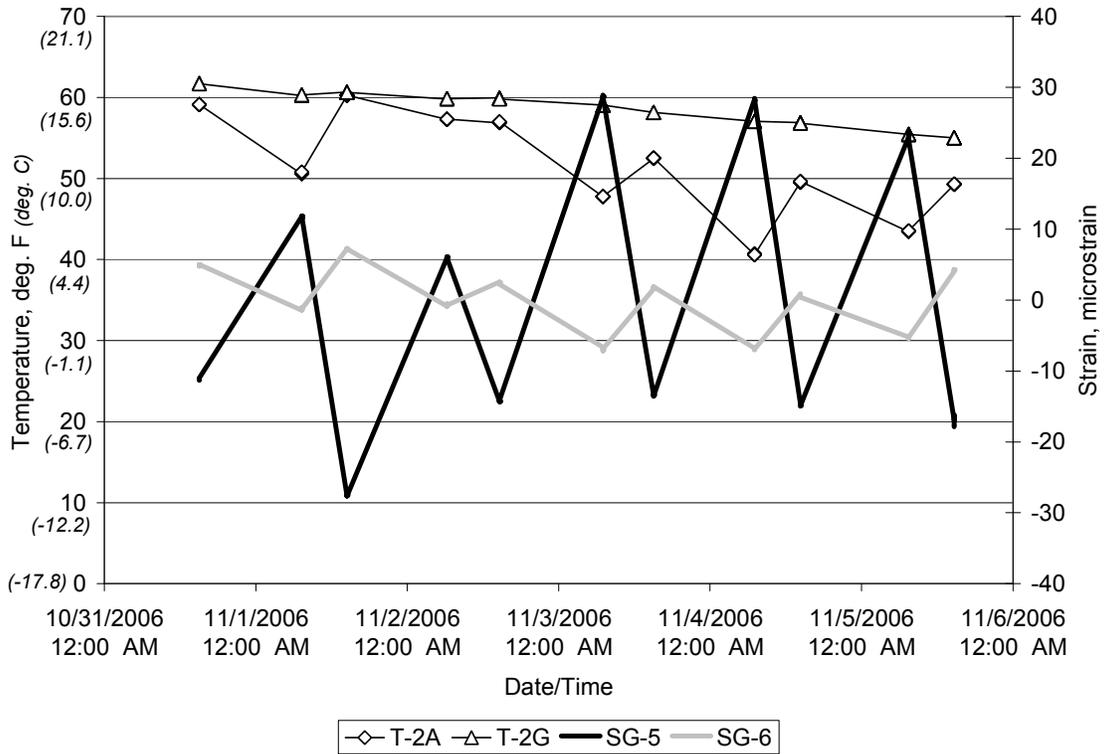
Sample responses from a pair of strain gages, SG-5 and SG-6, are shown in figures 9 and 10. From figure 3, these strain gages are located at the center of slab 1, near the top and bottom of the slab, respectively. Figure 9 pertains to strains collected during the period October 31 - November 1, while figure 10 pertains to the period December 5-8. For convenience, the plotted strain is the difference between the absolute strain gage output (in microstrains) and the mean value of the strain over the period for which measurements were taken. Thus, it is possible to compare strain readings for different gages. It can be seen that the paired strain gages respond differently to the diurnal temperature cycles, with the top gage (SG-5) output in phase with the temperature, and the bottom gage (SG-6) 180 degrees out of phase. Since an increase in temperature causes the concrete material to expand (resulting in positive strain) it might be expected that the SG-5 output would be in phase with the concrete temperature. This is not the case, however, because the CTL strain gages are designed to be temperature-compensating. Disregarding the component of strain due to moisture gradients, which is assumed to be small, the strain gage outputs in figures 9 and 10 represent only the load-induced component of strain arising from the self-weight of the slab. As the temperature falls, and the top surface contracts, the tendency of the slab is to curl upward. However, the slab self-weight counteracts the tendency to curl, inducing a tensile (positive) strain at the top of the slab. This load-induced strain is primarily responsible for the strain gage behavior seen in figures 9 and 10. In addition, it is observed that the response of the gage closer to the surface (SG-5) is significantly more pronounced. The higher amplitude of the top gage relative to the bottom gage is an indication that the neutral plane of the slab is not at mid-slab, but is actually closer to the bottom (due to traction between the concrete slab and the asphalt base).

Figure 9. Plot of SG-5 and SG-6 Responses with Temperature (Oct. 31 - Nov. 5).

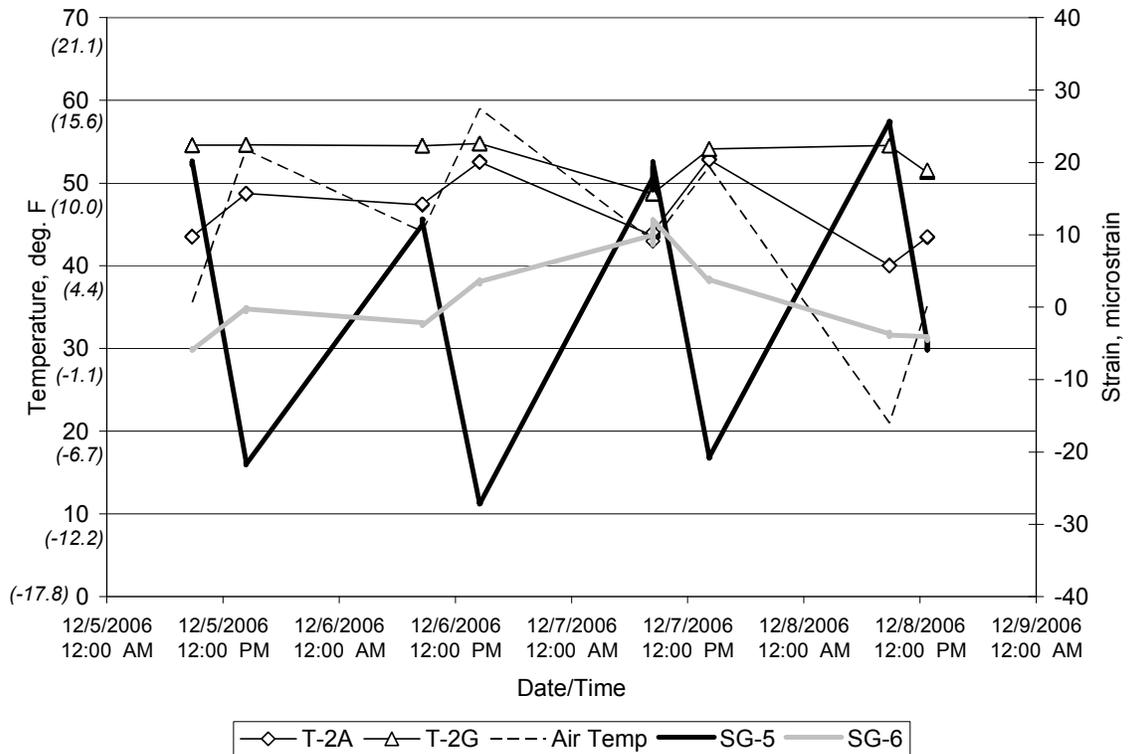
Figure 10. Plot of SG-5 and SG-6 Responses with Temperature (Dec. 5-8).
