**DOT/FAA/TC-13/30**

# **Full-Scale Evaluation of ARFF Tactics for Cargo Fires on Freighter Aircraft**

August 2013

Final Report

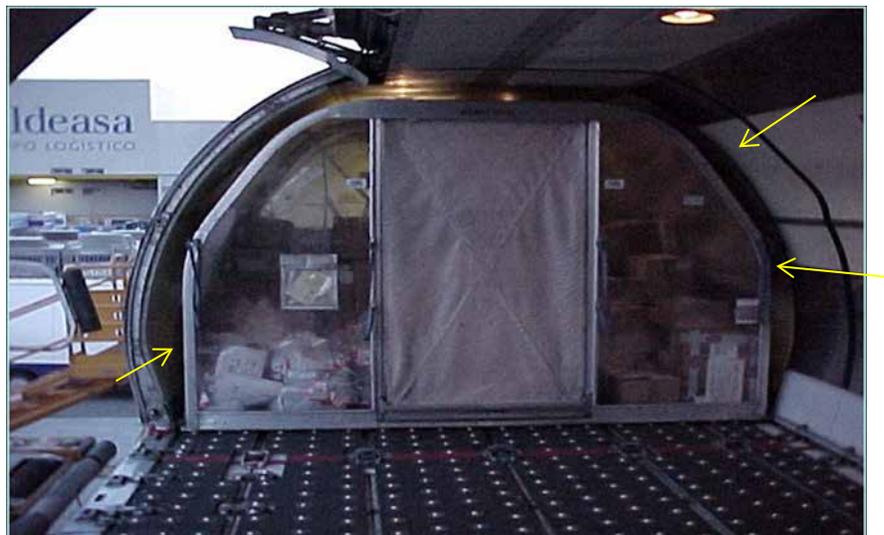
shown in figures 1 and 2, gaining access to a cargo compartment does not usually provide ARFF personnel with the ability to access the location of the fire. Each aircraft and each carrier may use slightly different load configurations. However, in nearly all configurations, fire fighters do not have access to the majority of the cargo on a freighter aircraft. Using the large cargo loading door/hatch does not necessarily provide access for the fire fighters, but does provide a huge influx of oxygen, thereby feeding the fire and increasing the fire intensity, making conditions more dangerous.

Figure 1. Wide-Body ULD Load

Figure 2. Loaded Cargo ULD in Narrow-Body Aircraft

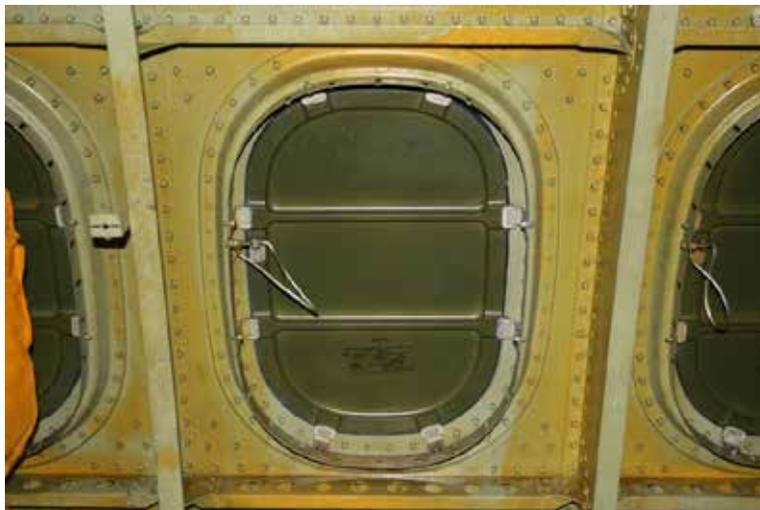
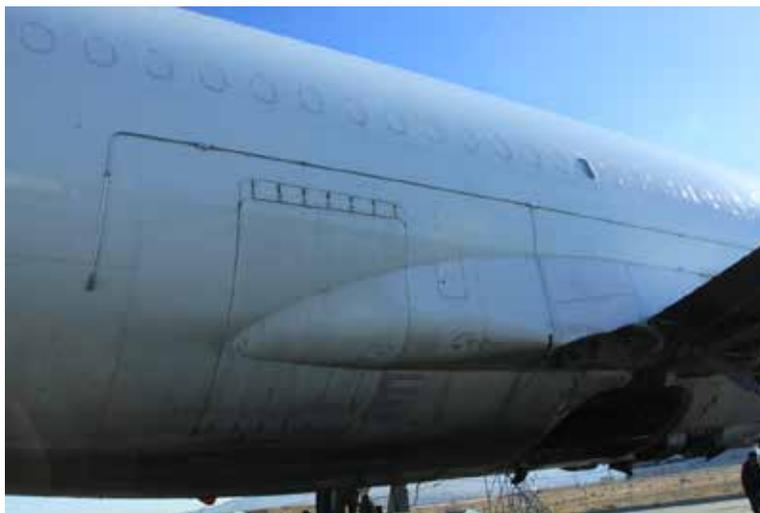
identify, as the window lines are still visible on the aircraft. In most cases, the original windows are replaced with window blanks. Typically, these blanks are clipped in position using similar mounting hardware that was used to mount the windows, as shown in figure 4. Figure 5 shows the appearance of the window blanks from the outside of the aircraft.

Figure 4. Window Blanks in Converted Freighter Aircraft

Figure 5. Exterior View of Window Blanks in Converted Freighter Aircraft

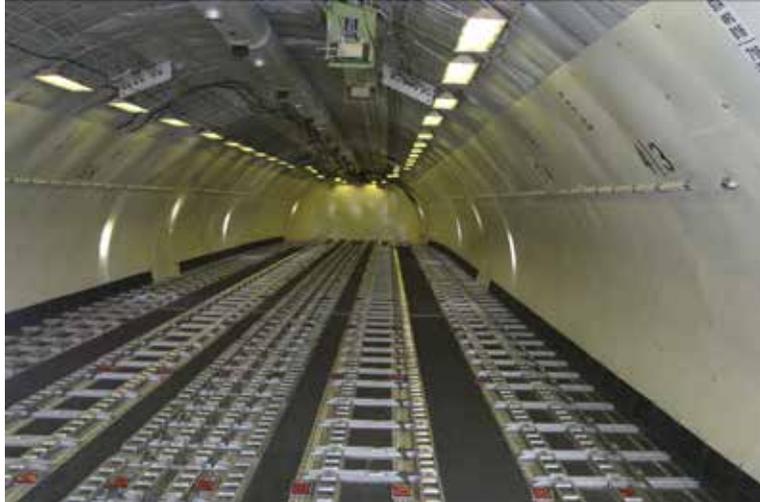
In the interior of the aircraft, insulation and a cargo liner cover the walls, including the window blanks. A cargo liner is a flexible laminate composite used to shield aircraft walls from potential moving containers and to provide fire resistance to the aircraft cargo compartments. Installation of a cargo liner consists of a combination of retaining clips, screws, and Dzus<sup>®</sup> Fasteners. Some windows remain in place to serve as observation points. A removable piece of cargo liner covers these windows so maintenance personnel can gain access. As shown in figure 6, from the interior of the cargo compartment, the unused doors and windows are not visible, and cargo liners cover the walls, leaving clean, smooth surfaces.

Figure 6. Main Cargo Compartment Interior Finish

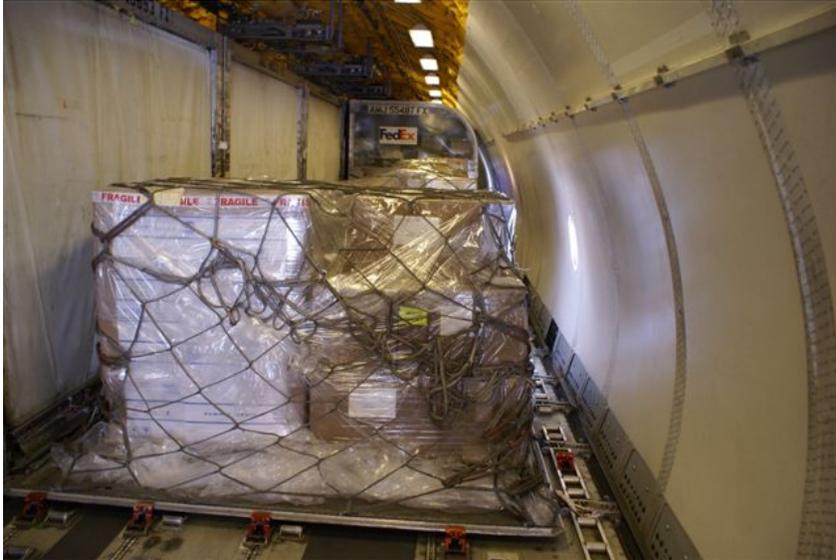
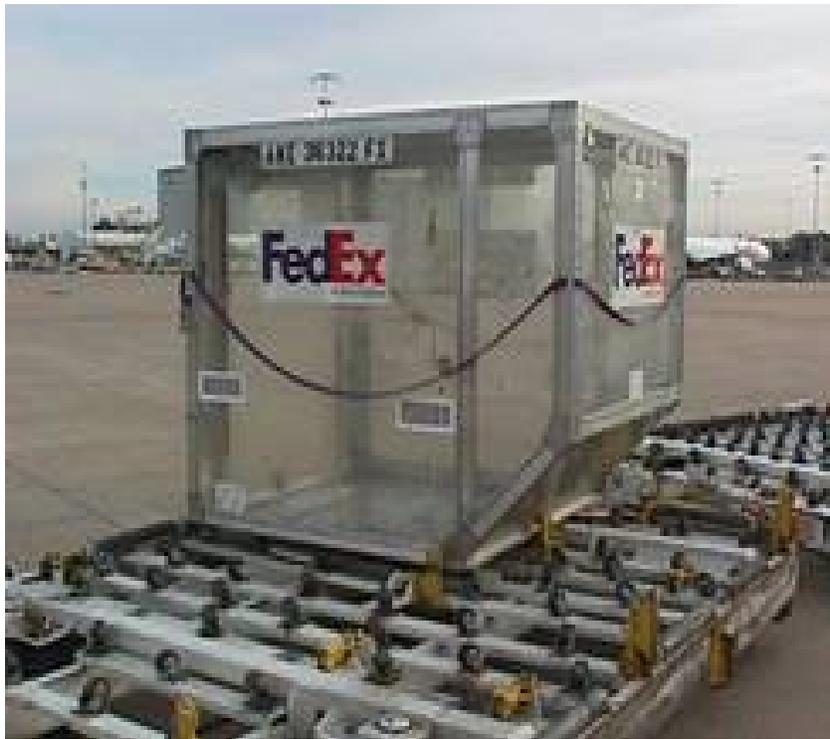
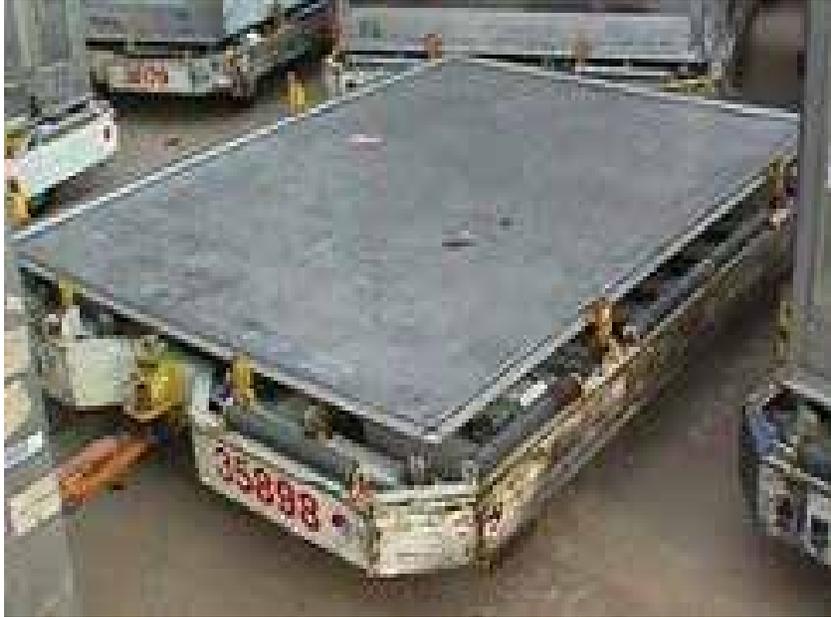
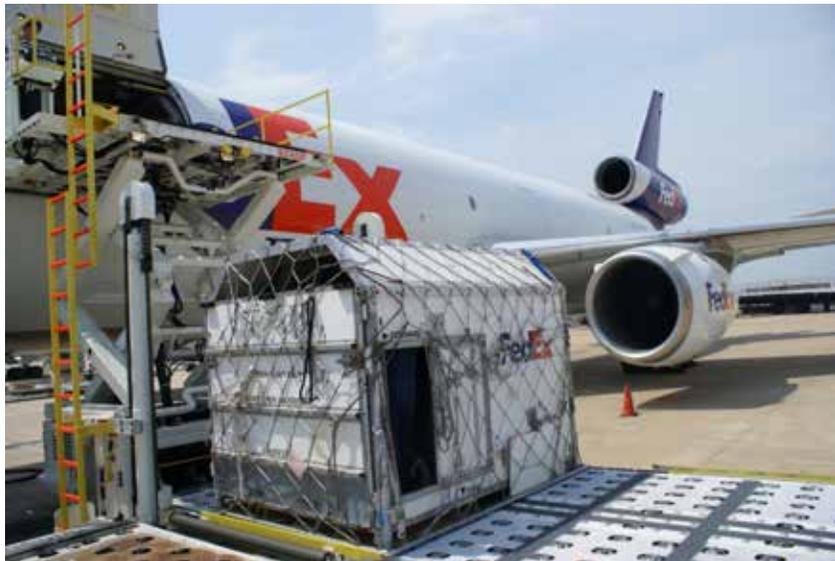
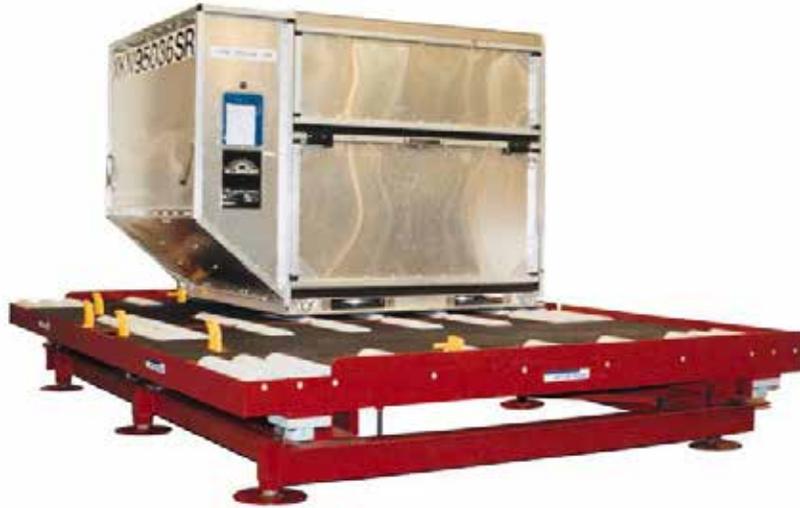
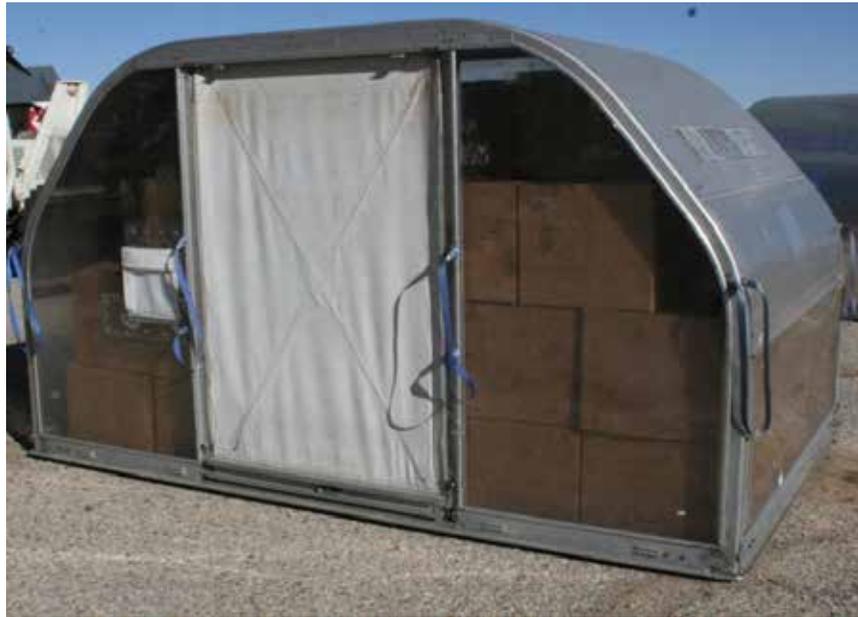
Cargo is transported in ULDs, which most often include pallets or containers. There are also specialized ULDs used to transport livestock, racehorses, and wild animals. The ULD containers are manufactured in a variety of sizes and shapes, designed specifically for particular aircraft and carriers. A single aircraft's load can consist of cans, pallets, or other types of ULDs. Cargo ULDs can range in storage capacity from 153 cubic ft to 775 cubic ft. Pallets can be as large as 8 ft wide and 20 ft long, carrying as much as 25,000 lb. Figures 7 through 12 show a sampling of typical ULD construction. Each ULD is identified by a three-letter classification designated by the International Air Transport Association. The first letter describes the ULD category; the second letter describes the base dimension of the device; and the third letter describes the contour or shape of the ULD, such as curved ceiling or trapezoidal-shaped container. ULDs are constructed with aluminum floors and frames. The skins vary and may be made of aluminum sheets, Lexan™, or a combination of the two. The doors may be aluminum or canvas. Currently, the use of composite materials for skins is in the research stages. The materials used for construction have a significant effect on the amount of time during which the ULD can contain heat and fire.

Figure 7. A ULD Pallet Built up With Freight and Cargo Net

Figure 8. Lexan ULD

Figure 9. Cargo Pallet With no Freight

Figure 10. Livestock ULD

Figure 11. All Aluminum ULD With Aluminum Door

Figure 12. Aluminum and Lexan ULD With Canvas Door

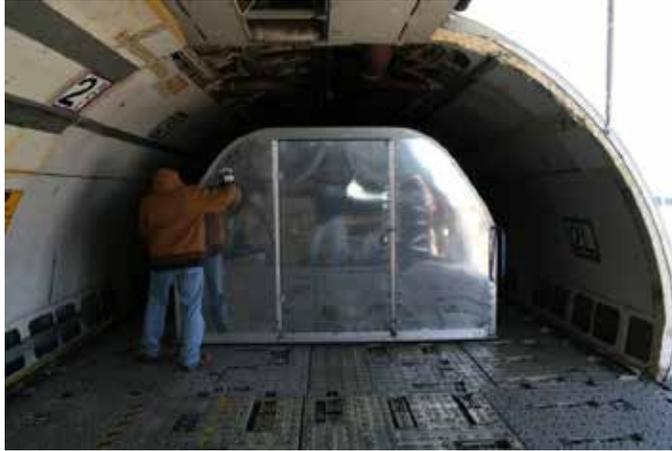
Figure 13. Cargo Compartment Floor With Rollers and Locks

Each ULD is loaded with freight and placed into designated positions in the aircraft to maintain the correct weight and balance for flight. The ULDs are locked into the floor system in the cargo compartments of the aircraft. As shown in figure 13, the aircraft cargo compartment floor is equipped with floor rollers and locks to allow the ULDs to be moved in and out. The locks pop up from the floor system to secure the ULDs and keep the load from shifting in flight.

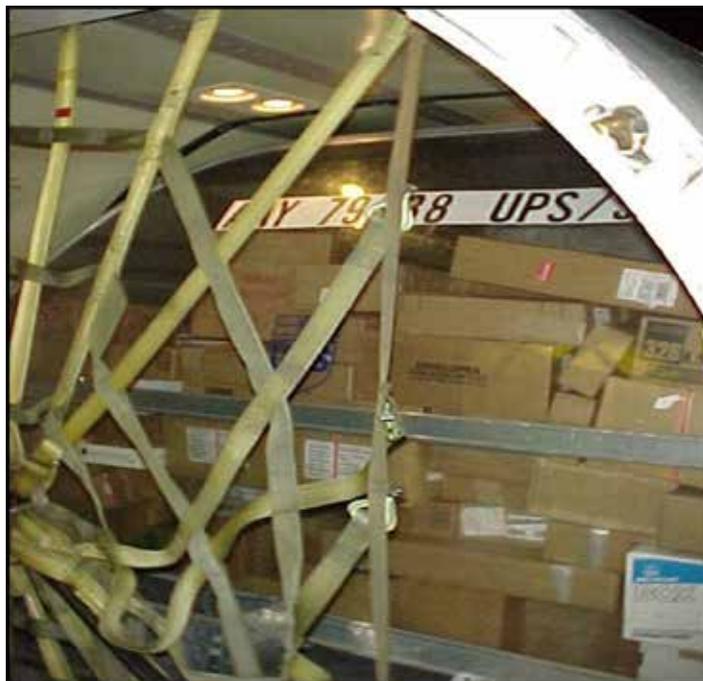
The area between the flight deck and the main cargo compartment will be equipped with either a bulkhead or a 9G net. Both are designed to prevent any load shift in flight from affecting the flight deck. There will also be a smoke curtain meant to isolate smoke in the cargo compartment and prevent travel into the flight deck. All of these points are important to ARFF personnel, as access into the cargo compartment from the L1 door may be necessary. The bulkheads have access doors, and the smoke curtains have zippered or Velcro flaps that need to be opened to gain access. The area directly aft of the bulkhead or 9G net is where the “accessible freight” is located. This often includes hazmat shipments or live animals. Figure 14 depicts a 9G net in the forward portion of a cargo compartment.

Figure 14. A 9G Net

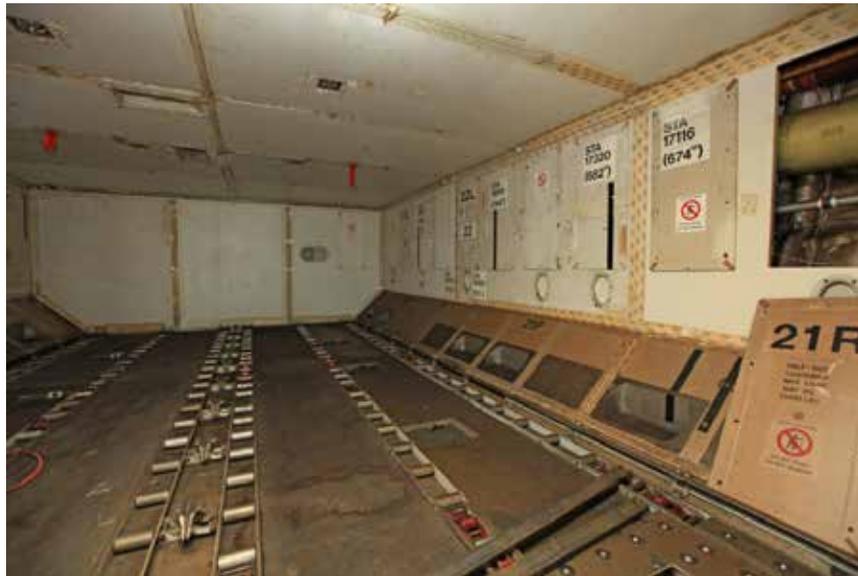
The cheek areas are the voids created in the lower cargo compartment after the vertical bulkheads (walls) are installed to create the cargo compartment. As shown in figure 16, from the inside, the bulkheads and overhead are covered in cargo liner material with tape sealing all the joints.

Figure 16. Forward, Lower Cargo Compartment of A310

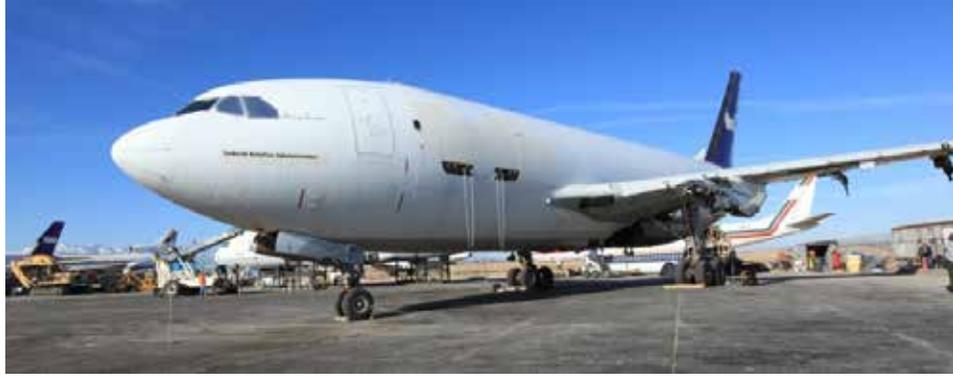
The test aircraft, shown in figure 19, used in all the tests was an Airbus A310-203F donated by FedEx. This aircraft is frame number 254, delivered June 1, 1983, and was originally operated by Lufthansa Airlines as a passenger aircraft. FedEx acquired the aircraft on July 18, 1994, and converted it to a freighter aircraft with tail number N407FE. At the end of the aircraft's flight life, FedEx decommissioned the aircraft and donated it to the FAA for these full-scale fire tests. Due to the salvage operations associated with decommissioning the aircraft, many essential airplane parts, such as aircraft engines and electronics, were absent from the aircraft, but most of the interior of the aircraft remained intact. Because the interior was mainly intact, it was possible to run the fire tests in conditions that were as close to a normal interior environment as possible. The aircraft interior still contained the normal combination of aircraft-grade insulation and cargo liner.

Figure 19. The FAA A310 Aircraft

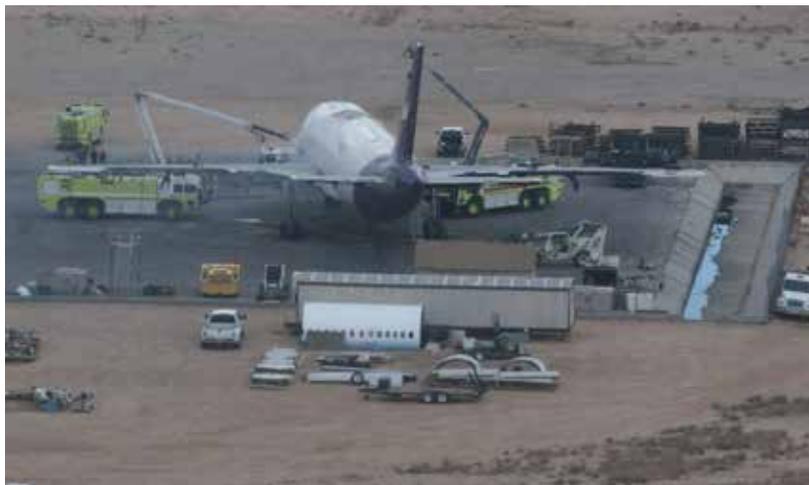
Figure 23. The ARC Aerospace Demolition Pad at SCLA

Aerospace demolition pad is the only place in the region where the test fires can be conducted in compliance with the Superfund Site Ground Water Monitoring Division of the San Bernardino County Fire Department. Figure 23 depicts the test aircraft on the demolition pad.

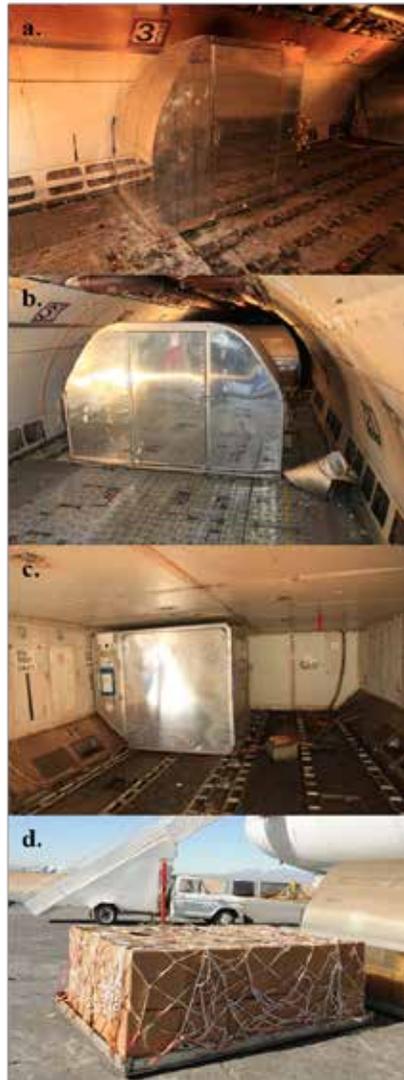
The tests used four different types of ULDs, as shown in figure 24. A modified half section of an AAY\* container simulated a half-width container (figure 24(a)). An intact AAY container represented a full-width container (figure 24(b)). Lower cargo compartment tests used an LD3 container (figure 24(c)). The base of an AAY container represented a pallet ULD (figure 24(d)). Lexan containers with canvas doors have a tendency to breach easily, as shown in figure 25, meaning the container wall damage from the fire test is irreparable (figure 26) and can only be used once. Because it was necessary to use the containers for more than one test, the Lexan walls of the containers were replaced with aluminum sheets. Ventilation holes in the ULDs prevented self-extinguishment and allowed the fire to grow at a controlled rate.

Figure 24. Containers and Pallets Used for the Full-Scale Live Fire Tests (a) Half-Width ULD Container, (b) Full-Width ULD Container, (c) LD3 Container, and (d) Pallet

\* AAY: LD7 container (88" x 125"), 81" tall, contoured for main deck wide-body and narrow-body (aka A2).

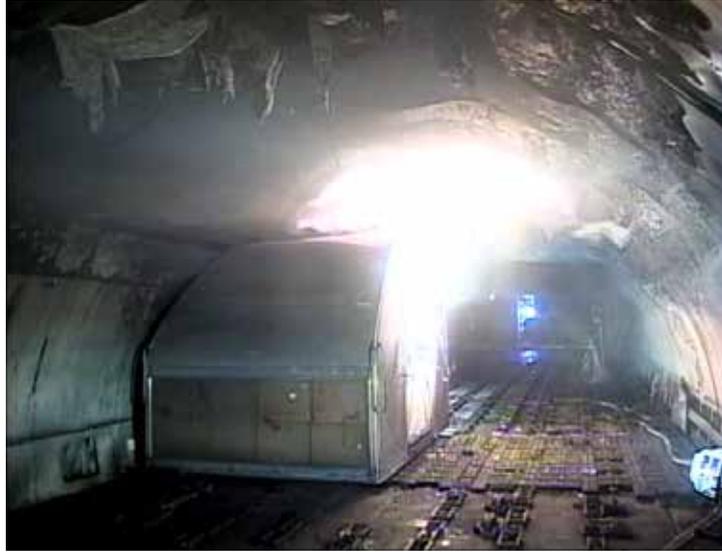
Figure 25. Fire Breaching Lexan Full-Width Container

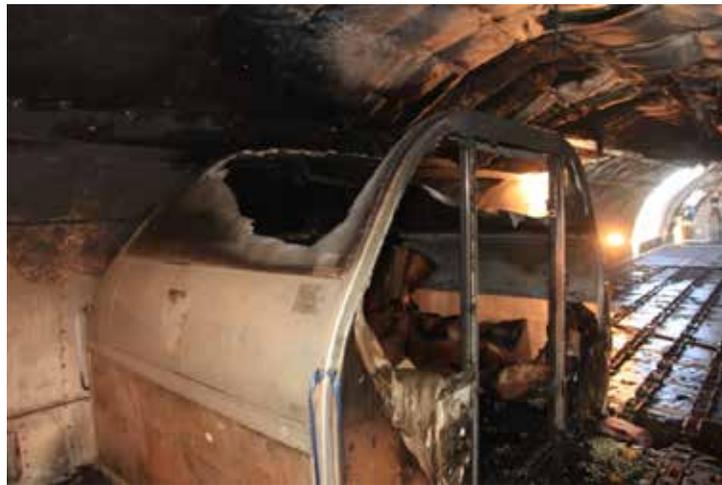
Figure 26. Breached Lexan Container Damage

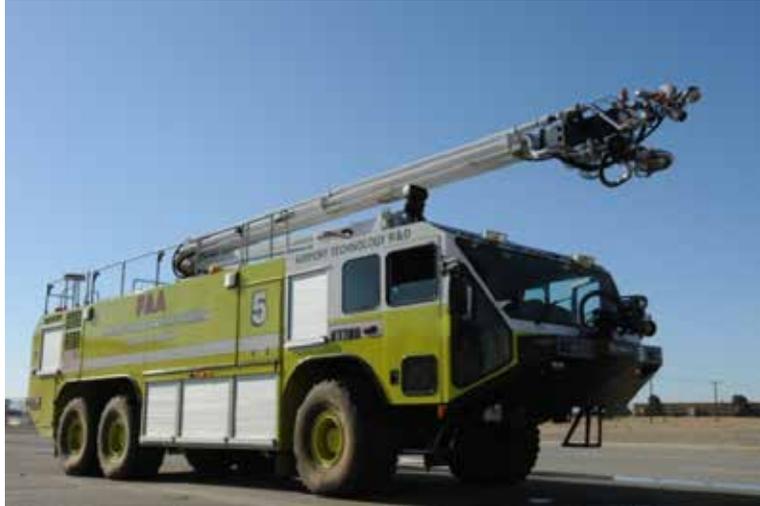
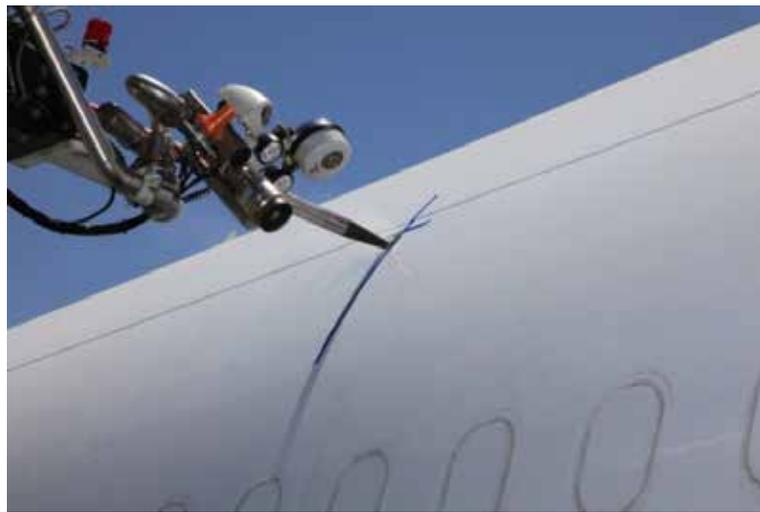
Two different HRET/ASPN technologies were tested and evaluated. The first was the Oshkosh Snozzle<sup>®</sup> 652 HRET system (figure 30). This HRET was on an Oshkosh Striker<sup>®</sup> 3000 ARFF vehicle, shown in figure 30. The Striker<sup>®</sup> has the ability to hold up to 2500 gallons of water and 420 gallons of extinguishing foam. This vehicle also has a fire pump with the ability to pump up to 1950 GPM at 240 psi. The Snozzle<sup>®</sup> HRET consists of a 65-ft boom with two high-flow turrets, a 45-ft horizontal reach, and an ASPN. The ASPN can apply agent at a flow rate of 345 GPM. The standard Snozzle<sup>®</sup> with no extension, as shown in figure 31, has a penetrating depth of 34 inches. With the addition of an extension, it has a penetrating depth of 46 inches.

Figure 30. The FAA Striker<sup>®</sup> 3000

Figure 31. The Snozzle<sup>®</sup> 652 HRET

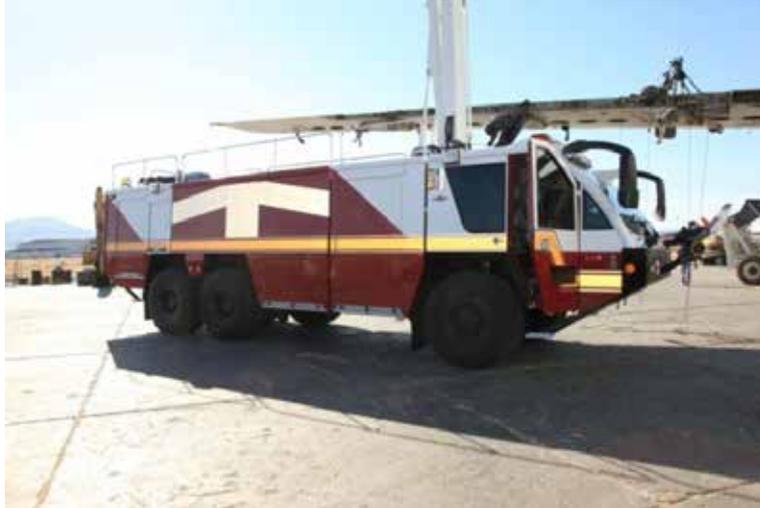
Figure 32. Rosenbauer Panther<sup>®</sup> 6X6

The second was the Stinger<sup>®</sup> HRET system that sits on top of the Rosenbauer Panther<sup>®</sup> 6X6 ARFF vehicle, as shown in figure 32. This vehicle is capable of holding up to 3000 gallons of water and 400 gallons of foam concentrate. The Panther water pump can flow water at rates of up to 1850 GPM. The Stinger<sup>®</sup> HRET is 54-ft boom with a horizontal reach of 37.5 ft. It also has an ASPN attached to a piercing lance. According to the manufacturer, the piercing lance works as follows:

“The piercing lance shall be retracted inside a tube when not in use to protect the piercing tip. The lance shall be hydraulically fired with amplified hydraulic flow from the three 3,000 PSI (210 bar) hydraulic accumulators for maximum piercing velocity and impacts” [6].

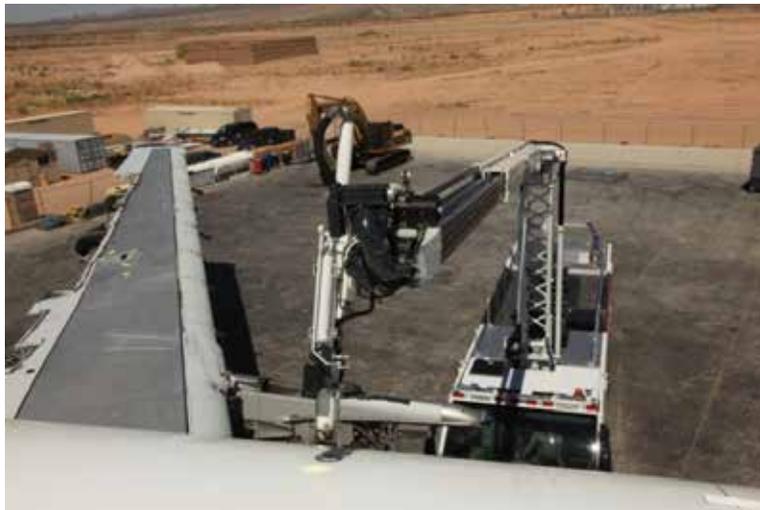
The Stinger<sup>®</sup> ASPN creates a 250-GPM, fan-shaped spray pattern. Figure 33 show how the Stinger<sup>®</sup> ASPN penetrates an aircraft.

Figure 33. Rosenbauer Stinger<sup>®</sup> HRET

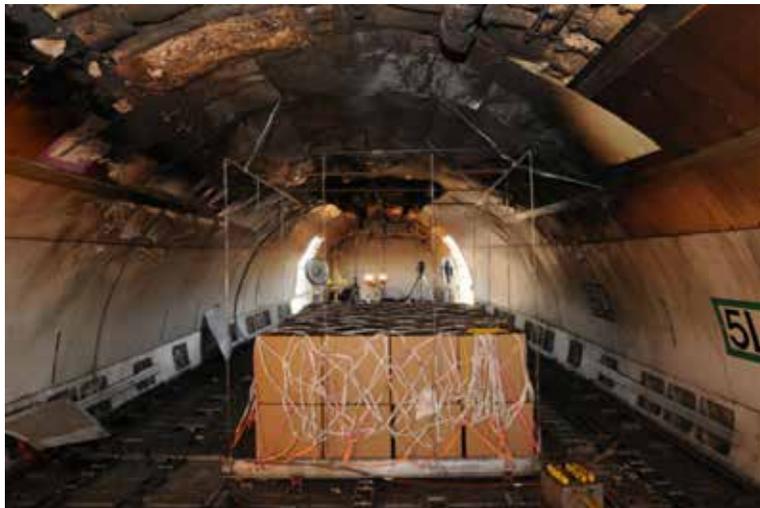
To collect temperature data from each test, the containers were instrumented with thermocouples. The thermocouples used were 20-gauge K-type thermocouples with fiberglass insulation. Container-type ULDs had the thermocouples attached evenly onto the walls of the container with the intention of tracking the fire inside the container. The locations of the thermocouples varied due to the different types of containers. Appendix B provides the exact location of the thermocouples for each type of container. Figure 34 shows a thermocouple tree fabricated to map the intensity and behavior of pallet fires. The thermocouple tree consisted of a steel frame hung from the ceiling with multiple sash chains hanging from the frame. The sash chains located thermocouples at specified heights around the pallet. Appendix C provides a map of the thermocouple locations on the thermocouple tree. The graphing software Tecplot<sup>®</sup> 10 created surface temperature contour graphs of the containers from the thermocouple data.

Figure 34. Thermocouple Tree for Pallet Fires

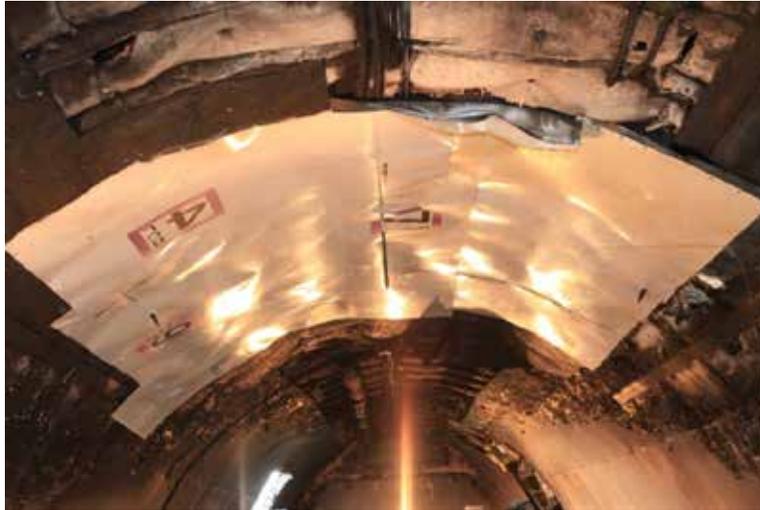
The ceilings of wide-body aircraft like the A310 are not always completely protected by a cargo liner. In the test aircraft, only a layer of thermo-acoustic insulation covered the ceiling. Part of the indirect attack test called for the use of breached containers, increasing the potential of direct fire impingement on the aircraft's ceiling and increasing the chance of a fuselage breach. Since maintaining structural integrity was a main priority, a fire barrier using a combination of high-temperature ceramic insulation and a cargo liner, as shown in figure 35, covered the ceiling of test Zone 2. This was effective in preventing fire from prematurely breaching the fuselage.

Figure 35. Fire Barrier in Test Zone 2

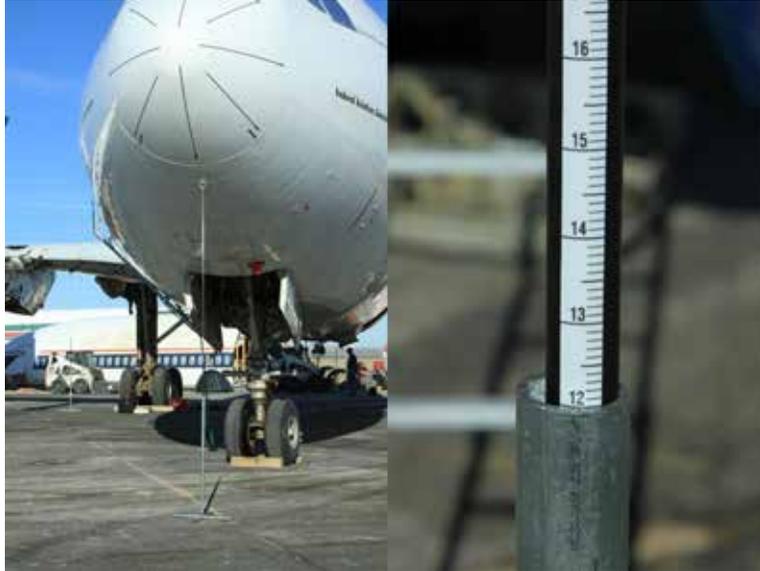
The A310 is a tail-heavy aircraft, and the removal or loss of the aircraft engines increases the chances of altering the aircraft's balance. For this reason, four sets of chains and ruled pipes, as shown in figure 36, were hung from the aircraft to measure the vertical displacement of the aircraft as the weight changed. The chains were connected from each wing, the tail, and the nose below the lower part of the cockpit. The bottom of the chain was fitted with a pipe labeled with a measuring tape that fit into a larger pipe, creating a gauge. As the level of the aircraft changed, the readings from each pipe would change.

Figure 36. Weight and Balance Measuring Chains

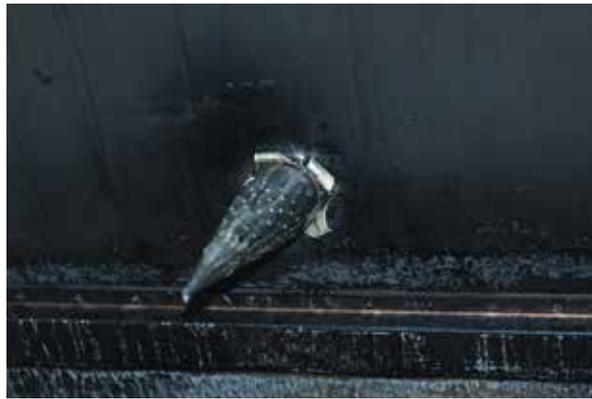
The first penetration test scenario consisted of piercing the modified half-width container with a standard Snozzle<sup>®</sup> ASPN. Each container was filled with a fire load of 35 boxes and burned for a period of time until the fire had grown to a considerable size. Once the container was penetrated, agent discharge continued until it was determined that most of the fire had been extinguished. The Snozzle<sup>®</sup> ASPN successfully pierced through the container, and all the ASPN holes were inside the container by 2 or more inches. Figure 40 shows the extent of penetration into the container. Because the ASPN's holes remained near the back wall, most of the water spray wrapped around the container walls and did not directly contact the fire.

Figure 40. Snozzle<sup>®</sup> ASPN Penetrating the Half-Width Container

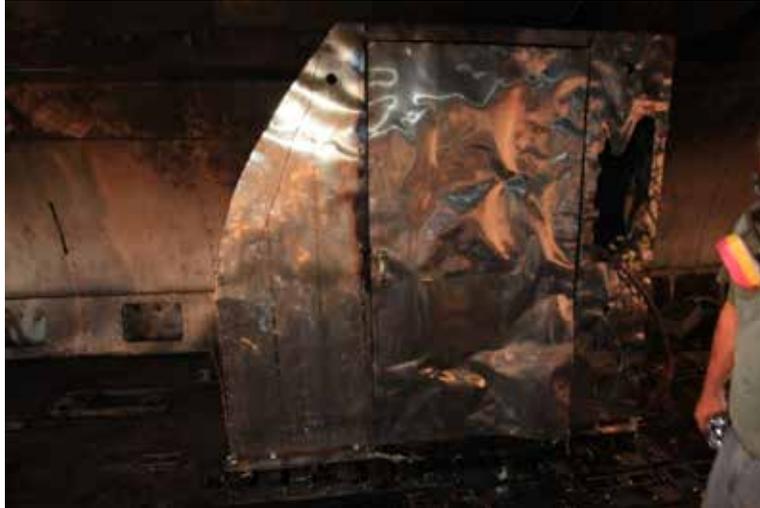
Figure 43. Breached Wall After Penetration Test

The third test run for this scenario (see test number 2.3 in table 2) ran for 18 minutes and 58 seconds before ARFF personnel entered the aircraft. After ignition, the fire grew for 15 minutes and 16 seconds before discharge began. When the discharge began, container ceiling temperatures were above 400°F, with a maximum reading of 931°F. Door temperatures reached as high as 987°F. After penetrating the container, the ASPN sprayed water into the container for 1 minute and 30 seconds—meaning approximately 518 gallons of water entered the container. As discharge occurred, the container door opened and some of the water sprayed out of the container. Ten seconds into the discharge, the highest ceiling temperature was 789°F. When discharge ended, the container ceiling temperatures ranged from 93° to 252°F. Two minutes after the discharge ended, the highest ceiling temperature dropped from 252° to 226°F. When ARFF personnel inspected the container, they found that only smoldering boxes remained inside the container. A breach was present in the right side of the container, as shown in figure 43. The high-pressure spray from the ASPN may have caused the breach. It is likely that the spray blew through the aluminum, which softened from the heat of the fire. The test consumed approximately 75% of the fire load.

Overall, a standard Snozzle<sup>®</sup> ASPN displayed the ability to penetrate through the aircraft wall, cargo liner, and container wall with relative ease. Once it penetrated the container, the ASPN successfully extinguished and/or controlled most of the fire. It should be noted that the ASPN's water had enough strength to create holes in the heat-softened container walls.

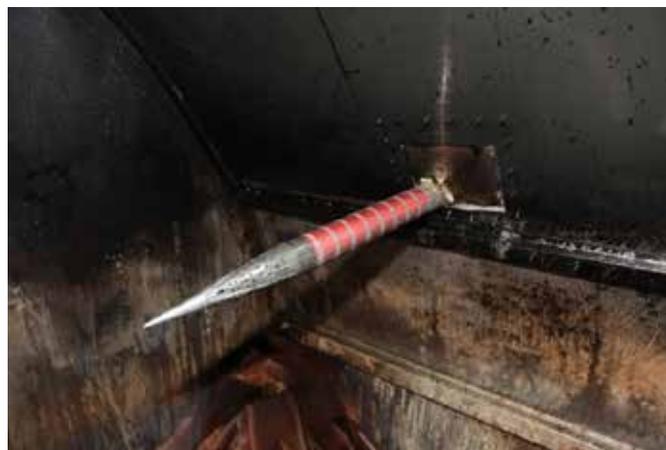
The second penetration test scenario consisted of piercing a modified half-width container with a Snozzle<sup>®</sup> ASPN fitted with an extension tube. As in the first scenario (see section 7.2.1), the container was filled with a fire load of 35 boxes and burned until a robust fire was present inside the container. Figure 44 shows the Snozzle<sup>®</sup> ASPN (fitted with extension) piercing through a half-width container that was located next to the fuselage wall. When using the Snozzle<sup>®</sup> ASPN with an extension, the ASPN tip penetrated further into the container; with the extension, the ASPN can penetrate 14 inches inside the container versus an approximate 2 inches without it. This promoted effective container fire extinguishment.

Figure 44. Snozzle<sup>®</sup> ASPN With Extension Penetrating the Half-Width Container

These test results provide evidence that the Snozzle<sup>®</sup> ASPN with the extension provided better control of the fire inside the container, while using less water, compared to the standard Snozzle<sup>®</sup> ASPN. This could be because the extension allowed the ASPN to be closer to the fire source. This increased the effectiveness of potential extinguishment. In addition, the tests showed the interaction of hot metal and cold-water spray caused cracks in the container.

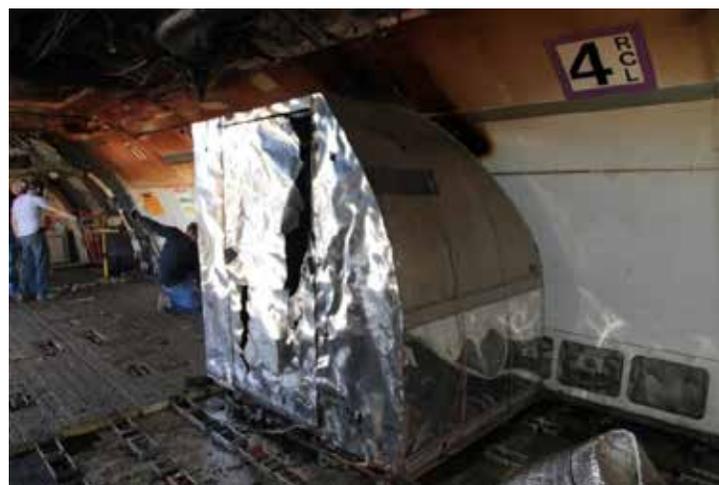
Figure 46. Breached Door of Half-Width Container After Penetration Test

The third test run for this scenario (see test number 3.3 in table 2) ran for 25 minutes and 47 seconds before ARFF personnel entered the aircraft. Figure 45 shows the temperature contours from the time the discharge began until 2 minutes after discharge ended. For this test, the fire grew for 21 minutes and 20 seconds before attempting to extinguish the fire. When the ASPN pierced the container, it sprayed water into the container for 1 minute and 5 seconds, applying approximately 374 gallons of water. From the thermocouple data recorded at the time discharge began (figure 45(a)), the container ceiling temperatures ranged from 600° to 864°F. The highest temperature readings were located close to the container door, where temperatures ranged up to 989°F. Figure 45(b) shows that 10 seconds after discharge began, most of the container ceiling temperatures had already dropped below 200°F, except for a ceiling thermocouple near the container door that read 486°F. At the same time, the container door still had a hotspot of 952°F present. Most of the heat was concentrated in the front of the container and not the back. When discharge was complete, all ceiling temperatures had dropped below 90°F (figure 45(c)). The hotspot at the container door was still present at the end of discharge, but its temperature dropped from 952° to 191°F. After 2 minutes, the hotspot dropped to 128°F. The remaining container temperatures evened out but were no higher than 120°F. When ARFF personnel inspected the container, they only found approximately 15% of unburned fire load. Inspecting the container showed that cracks in the front of the container and a large breach hole were present, as shown in figure 46. Again, the cracks were likely from quenching and contraction of the aluminum wall.

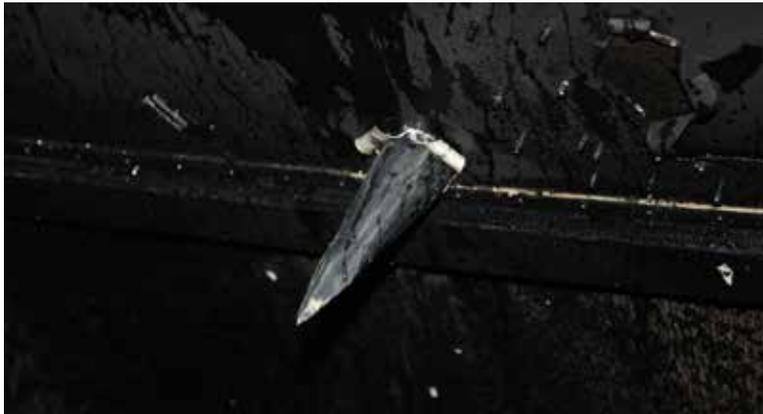
Figure 47. Stinger<sup>®</sup> ASPN Penetrating the Half-Width Container

The third penetration test scenario consisted of using the Stinger<sup>®</sup> ASPN as the penetrating device. As in the previous two scenarios (see section 7.2.1 and 7.2.2), the test articles were modified half-width containers and filled with 35 boxes of fire load. Once a robust fire was present, the ASPN pierced the container, and water discharge was attempted. The ASPN penetrated the container but only three of the four rows of holes in the ASPN made it through the container wall, as shown in figure 47. This indicated that when attempting to extinguish the fire, not all of the water would make it into the container, meaning longer discharges would be needed to extinguish the fire.

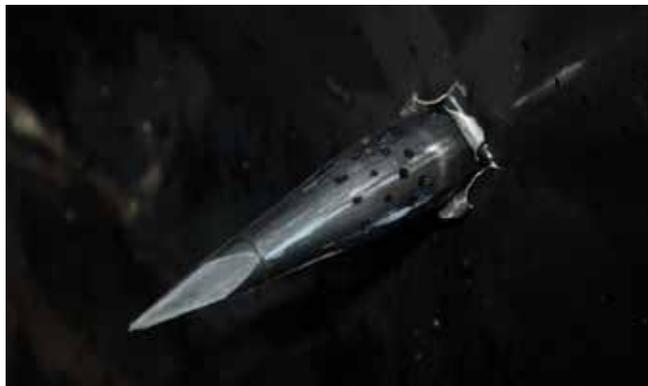
Figure 49. Stinger<sup>®</sup> ASPN Penetrating the Full-Width Container

The first full-width container penetration test scenario consisted of penetrating the AAY container with the Stinger<sup>®</sup> ASPN. The test used full-width containers, filled with 70 boxes of fire load. When the Stinger<sup>®</sup> ASPN pierced the full-width container, the holes of the ASPN barely passed through the container wall, as shown in figure 49. Compared to the half-width container tests, this penetration was more successful because all the ASPN holes made it through the container.

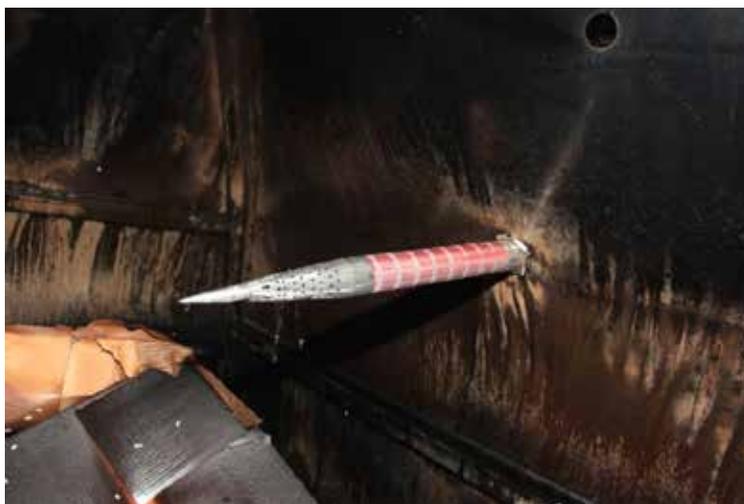
Figure 52. Snozzle<sup>®</sup> ASPN With Extension Penetrating the Full-Width Container

The second full-width container penetration test scenario used a Snozzle<sup>®</sup> ASPN with an extension attachment. The full-width container had a fire load of 70 boxes. The extended Snozzle<sup>®</sup> ASPN successfully penetrated the container, as shown in figure 52. Because the Snozzle<sup>®</sup> ASPN had an extension attached to it, the Snozzle<sup>®</sup> ASPN was able to penetrate nearly to the center of the container. This meant that if the seat of the fire was in the center of the container, the water spray would travel through less debris.

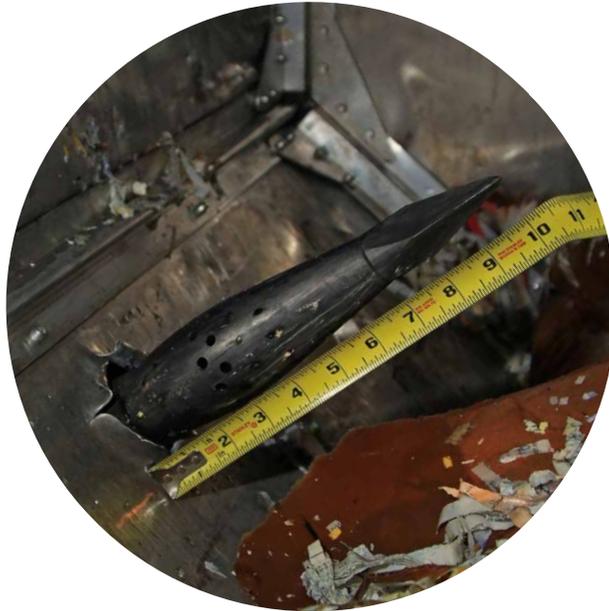
Figure 54. An LD3 Container Penetration Using the Stinger<sup>®</sup> ASPN

This test scenario examined the tactic of using a Stinger<sup>®</sup> ASPN to penetrate an LD3 container located in the lower cargo compartment. To properly position the Stinger<sup>®</sup> ASPN to pierce this container, the Stinger<sup>®</sup> ASPN was at a 7 o'clock position to the aircraft fuselage. Piercing the fuselage at that angle avoided the cheek area in the lower cargo compartment and improved the chances of penetrating the container. After positioning the HRET to the specified angle, the Stinger<sup>®</sup> ASPN penetrated the LD3 container through the slanted side of the container. Figure 54 shows the Stinger<sup>®</sup> ASPN penetrating an LD3 container. When the Stinger<sup>®</sup> ASPN pierced the container, all the holes from the Stinger<sup>®</sup> ASPN were able to pass through the container wall and the last row of the Stinger<sup>®</sup> ASPN holes were 2.5 inches away from the wall.

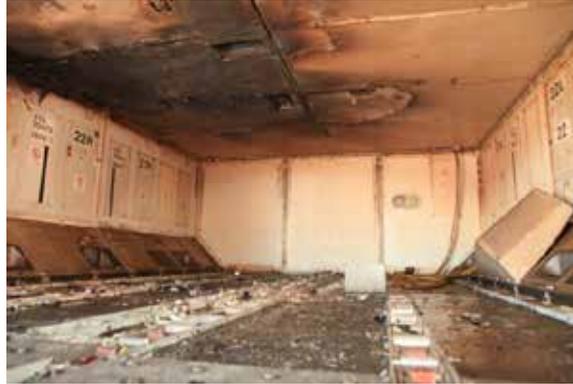
Figure 56. Ceiling Damage After LD3 Penetration Test

The second test run for this scenario (see test number 7.2 in table 2) ran for 35 minutes and 56 seconds before ARFF personnel entered the aircraft. After ignition, over 27 minutes passed before a fire of sufficient size was present inside the container. Similar to the previous test run, the length of time to obtain a good robust fire depended greatly on the ventilation of the container. When the Stinger<sup>®</sup> ASPN penetrated the container, it introduced water for 2 minutes (500 gallons). Some of the water from the Stinger<sup>®</sup> ASPN sprayed outside the container. When discharge began, temperatures were over 800°F on the ceiling of the container and the right corner of the container wall. The maximum temperature was 875°F. When the discharge ended, a hotspot located in the lower right corner of the container was 850°F. After 2 minutes of discharge, the hotspot was 636°F. Temperatures around the container door and ceiling were above 300°F. When ARFF personnel opened the container, fire was still present near the container door. When inspecting the surroundings, the ceiling above the container was charred even though there was no breach in the container. Figure 56 shows the extent of the damage in the lower cargo compartment.

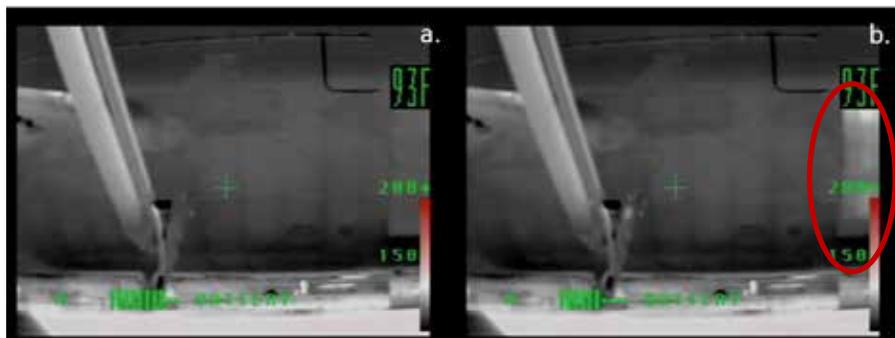
Figure 57. The TIC Temperature Measurements at (a) Ignition  $t = 0$  s and (b) Water Discharge  $t = 909$  s

The third test run for this scenario (see test number 7.3 in table 2) ran for 25 minutes and 36 seconds before ARFF personnel entered the aircraft. It took 15 minutes and 39 seconds to have a robust fire inside the container. The fire grew faster in this test than the previous two tests because of the additional ventilation holes to the container. Figure 57 shows TIC temperature variations for this test run at the time of ignition and the time of water discharge. The container was located in the area of the ASPN in this figure; however, the hotspot is visible at the lower compartment door (right side of figure 57(b), below temperature reading). This was due to the cargo door not having insulation, which caused it to heat up faster. After the Stinger<sup>®</sup> ASPN penetrated the container, it released 750 gallons of water during a 3-minute spray into the container. The container exhibited temperatures of over 600°F throughout the center and right side of the ceiling when water discharge was about to begin. A 922°F hotspot was present in the top right side of the container door. Ten seconds into discharge, the water spray did not strongly affect the temperature contours of the container. Like the previous tests, not all the water made it inside the container. When the discharge ended, the container still had a hotspot in the top right corner of the door with a temperature of 737°F. Near the container door, temperatures ranged from 90° to over 600°F. Two minutes after the discharge ended, the temperature of the hotspot reduced to 590°F. Another hotspot of 586°F appeared in the lower right corner of the door, meaning that a small fire developed in that area. A large portion of the container still had temperatures over 300°F. When ARFF personnel inspected the container, they found a significant-sized fire still present in the container toward the right side of the door.

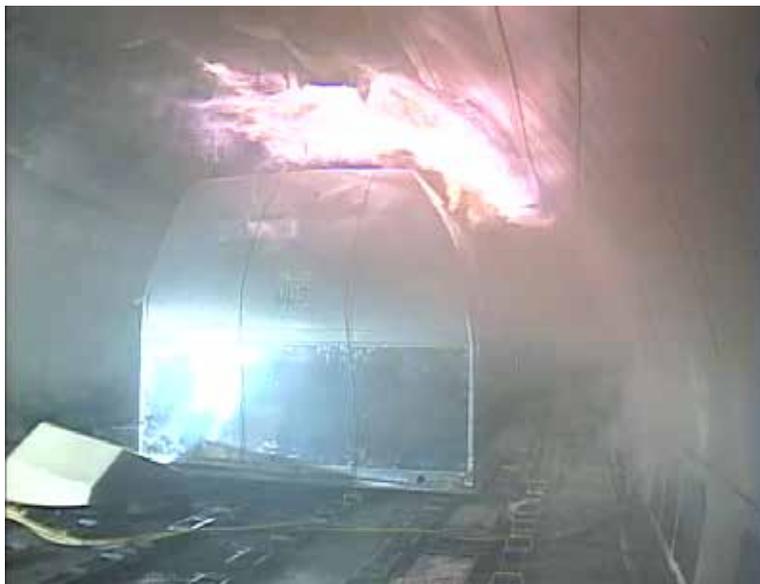
Figure 58. Fire Growing Through Breached Hole of an AAY Container

Since a breached container was desirable for the indirect attacks, an elliptical-shaped hole was cut out of the back wall of some of the AAY containers. This ensured that a predictable breach in the container was always present and would allow the fire to grow faster. Figure 58 shows that the fire inside the container impinged against the aircraft wall. Monitoring the ceiling temperature of the aircraft during each test helped ensure that no potential fuselage breach conditions were present.

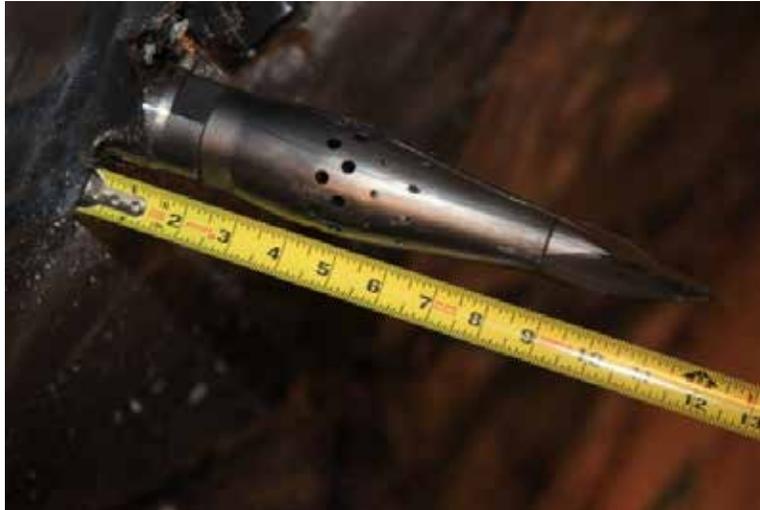
Figure 59. Penetration Depth of Stinger<sup>®</sup> ASPN

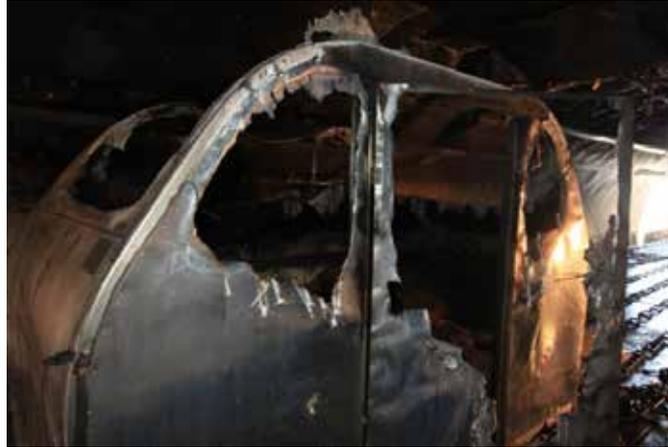
Figure 60. Container Breach During Indirect Attacks

The first test run for this scenario (see test number 8.1 in table 2) ran for 6 minutes and 9 seconds before ARFF personnel entered the aircraft. Between the time of ignition and the beginning of discharge, the fire grew for 3 minutes and 54 seconds. During the fire growth, the fire breached the ceiling of the container, which caused aircraft ceiling temperatures to reach as high as 1620°F. When the Stinger<sup>®</sup> ASPN penetrated the aircraft, water flowed into the aircraft for 1 minute and 35 seconds. When discharge began, the container ceiling temperatures ranged from 911° to 1767°F. By the time discharge began, the container ceiling had already melted away, and most of the fire was concentrated to the right side of the container. Ten seconds into discharge, the ceiling temperature dropped to between 838° and 1036°F, while other temperatures throughout the container remained relatively unchanged. When the discharge ended, the ceiling temperatures dropped to between 115° and 661°F. Most of the container had cooled, but a small hotspot of 689°F was present in the right top corner of the container. Two minutes after the discharge ended, the hotspot remained but dropped to 485°F. Additionally, the ceiling temperatures above the container door remained at 490° and 512°F. When ARFF personnel inspected the container, they found only smoldering boxes inside the container. Figure 60 shows the damage to the container.
