**DOT/FAA/TC-13/30**

# **Full-Scale Evaluation of ARFF Tactics for Cargo Fires on Freighter Aircraft**

August 2013

Final Report

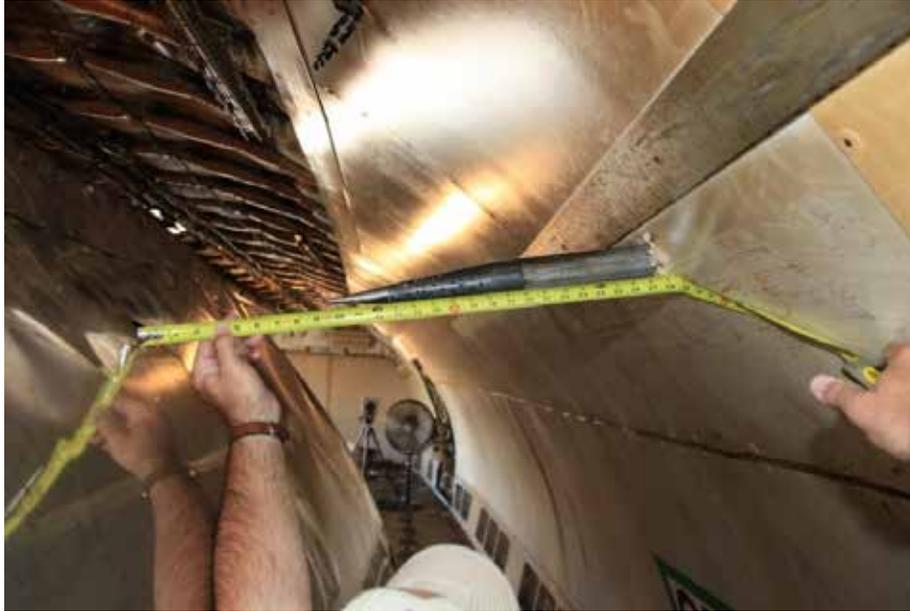
Figure 62. Measuring the Distance Between the Container and the Aircraft Wall

This test scenario examined an indirect discharge tactic using an AAY container as the test article and using a standard Snozzle<sup>®</sup> ASPN with no extension to extinguish the container fire. When the Snozzle<sup>®</sup> ASPN penetrated the aircraft wall, the tip reached 18 inches away from the wall. The container was 38 inches away from the base of the aircraft wall, and the container top was 9 inches away from the tip of the Snozzle<sup>®</sup> ASPN, as shown in figure 62. Similar to the full-width container penetration test scenarios, the container consisted of 70 boxes of fire load.

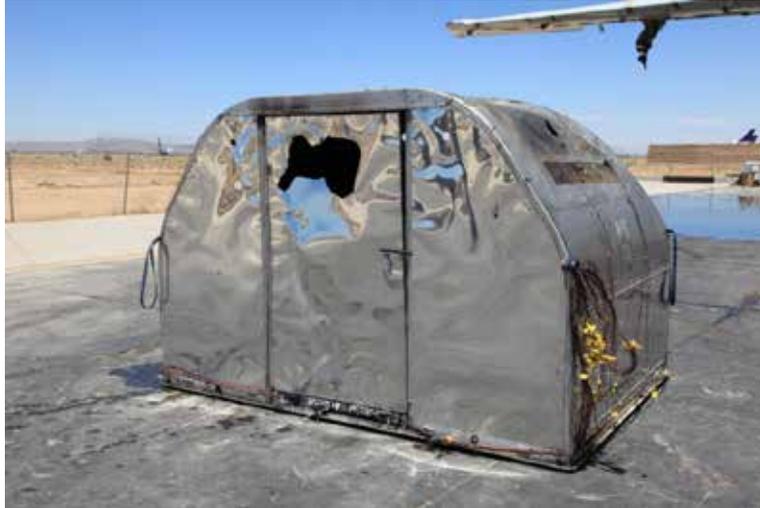
Figure 64. Breach on the Top of the AAY Container Door

The second test run for this test scenario (see test number 9.2 in table 2) ran for 6 minutes and 17 seconds before ARFF personnel entered the aircraft. After ignition, the fire grew for 3 minutes and 43 minutes before discharge began. For this test, only one discharge was performed. This attack continued for 2 minutes, causing approximately 690 gallons of water to enter the main cargo compartment of the aircraft. By the time discharge into the container began, temperatures at the aircraft ceiling were as high as 1485°F. The container ceiling temperatures ranged from 346° to 1013°F. Ten seconds into discharge, the temperature of the container ceiling ranged from 131° to 484°F. When discharge into the container ended, the container ceiling temperatures dropped to between 109° and 459°F. Although the container ceiling temperatures dropped, a hotspot of 833°F appeared in the container. Two minutes after the discharge ended, the container ceiling temperatures rose to between 586° and 830°F. This meant that a fire still existed inside the container. ARFF personnel confirmed this when they inspected the test container. Approximately 70% of the fire load was consumed during the test and, again, a breach was found in the top section of the container door, as shown in figure 64.

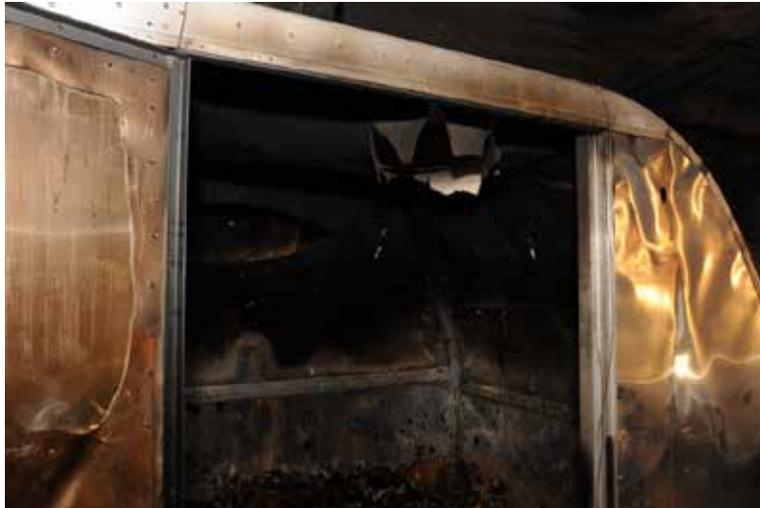
Figure 69. Ceiling Breach in the AAY Container After Indirect Attack

The second test run for this scenario (see test number 10.2 in table 2) ran for 6 minutes and 6 seconds before ARFF personnel entered the aircraft. After ignition, the fire grew for 3 minutes and 9 seconds before discharge began. When the prototype ASPN penetrated the aircraft, aircraft ceiling temperatures were as high as 1512°F. Immediately before discharge, the highest reading recorded from the container thermocouples was 1070°F. Similar to the previous test run, the fire was mostly concentrated at the back of the container. Ten seconds into discharge, the container ceiling temperatures ranged from 197° to 266°F. At that time, a small hotspot of 599°F was present in the top right side of the container. When the discharge ended, the temperatures around the container ranged from 95° to 182°F. Two minutes after the discharge ended, the container temperatures rose, and the highest temperature was 482°F. When ARFF personnel inspected the container, a small fire still existed inside the container. Approximately 40% of the fire load remained inside the container, and a breach existed in the container ceiling, as shown in figure 69.

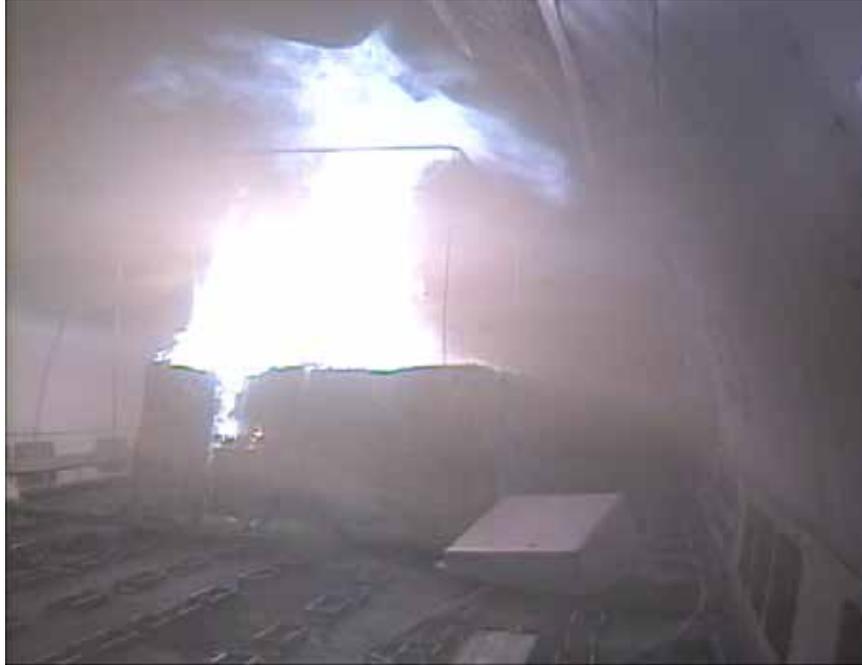
Figure 70. Pallet Fire Inside the A310

For pallet fires, a ULD base was used as a modified pallet and was placed in Zone 2, which is in the rear of the aircraft. Each pallet carried 48 boxes secured to the pallet with a cargo net. Small gaps existed around the boxes to allow the fire to breathe and grow at a rapid rate. The fire inside the pallet continued to grow until approximately 80% to 85% of the boxes were involved, as shown in figure 70. The aircraft ceiling temperatures were monitored during the fire growth stage to ensure that the fuselage interior conditions reach a temperature that could cause a fuselage breach. For this test, a Snozzle<sup>®</sup> ASPN was used to extinguish the fire.
