DIGITAL DISTRESS SURVEY OF AIRPORT PAVEMENT SURFACE

PRESENTED FOR THE 2002 FEDERAL AVIATION ADMINISTRATION AIRPORT
TECHNOLOGY TRANSFER CONFERENCE

This paper also presents a recent data collection and analysis effort for two runways of the Hartsfield Atlanta International Airport. The analysis was conducted with the PAVER method and PCI values were calculated based on the FAA guide for pavement surface distress survey.

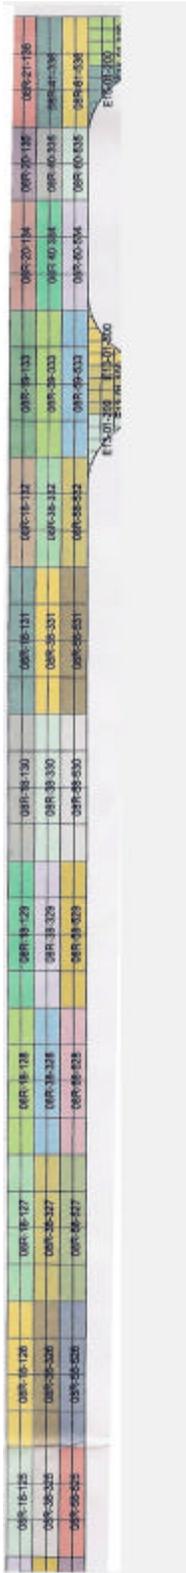
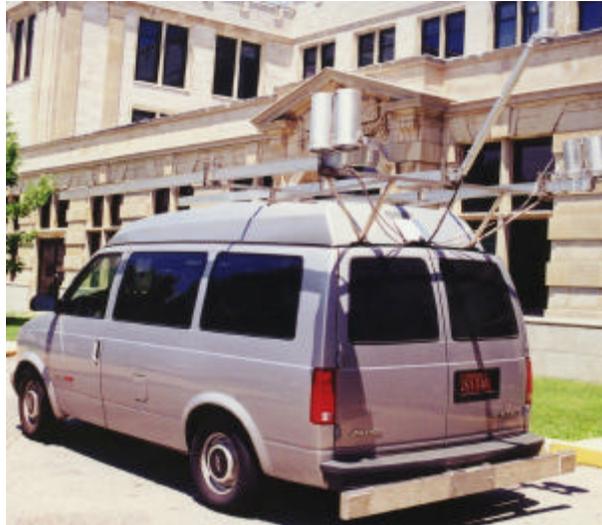
Figure 4 The Data Vehicle for the Runway Survey
