SATISFACTORY AIRFIELD PAVEMENT PERFORMANCE IS NOT A FOREGONE
CONCLUSION

PRESENTED FOR THE
2007 FAA WORLDWIDE AIRPORT TECHNOLOGY TRANSFER CONFERENCE
Atlantic City, New Jersey, USA
April 2007

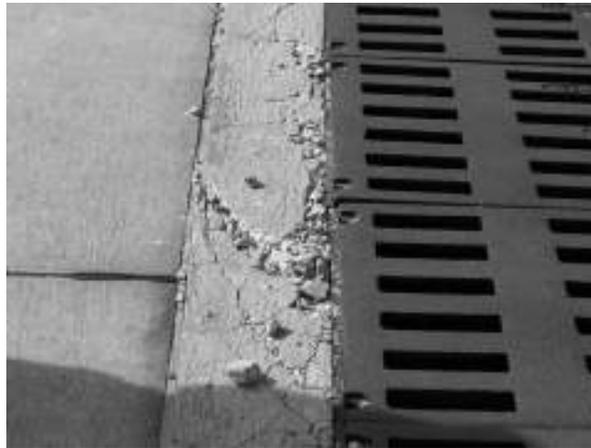
Let us look at an example. Some nine years after construction of a 12-in. thick concrete parking ramp at an Air Force base in the southeastern US, there was extensive damage to a major trench drain (Figure 2). Damage included surface spalling, cracking approximately 15-in down in the concrete trench walls, broken trench anchor bolts, surface unevenness, and jammed grates. A structural engineer from the original design agency visited the site and concluded the damage was due to (1) excessive loads being applied by the surrounding concrete ramp, (2) too stiff of a joint filler in the expansion joint between the trench and the ramp that allowed these loads to be transferred, and (3) use of the ramp by occasional C-130 and C-5 aircraft that overloaded the trench drain.

A USAF pavement evaluation team later took cores of the joint and found a much simpler explanation. The coring found that the expansion joint material extended to only a depth of 12 in. and not the full depth of 15 in. The joint at the trench edge was a thickened edge joint 15-in. thick, and it appears the contractor had procured expansion board material appropriate for a 12-in. thick pavement used through most of the ramp. Neither the designer, contractor, construction crews, or agency inspectors noted this discrepancy during construction, or they failed to recognize its significance. In effect, there was no expansion joint as the ramp concrete

Figure 2. Example of damage to nine-year old trench drain in a USAF ramp.

bore directly on the trench drain at the lower depths and the damage is consistent with a missing or ineffective expansion joint. There are other examples at USAF bases where coring has found the expansion joint did not extend full depth of the pavement, and similar damage has arisen in those cases also.

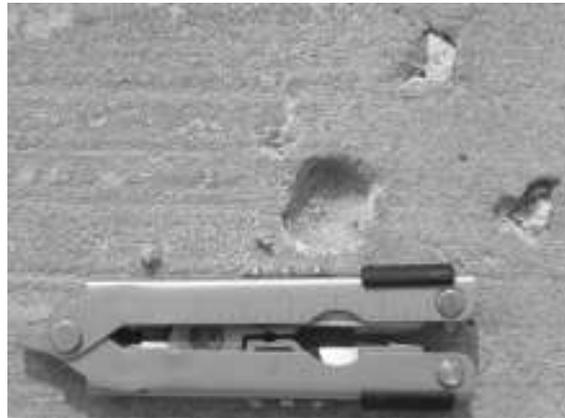
However, shortly after placement major popouts began appearing (Figure 3). As Murphy's law would dictate, the aircraft models slated to use the ramp in upcoming operations were those that are the most susceptible to foreign object damage (FOD) from ground debris such as these popouts.

Figure 3. Example of Extensive Popouts on a New Airfield Ramp in the Middle East.

An examination of the aggregate used in this construction found it to be totally unsuitable for use in concrete. The rapid appearance of the popouts was foreordained by the use of a substandard local aggregate. It had been deemed more convenient to use the local aggregate and avoid the delay of shipping in appropriate quality aggregate to the locale. After all, this was a rush expedient military construction job. However, the headaches these popouts caused the USAF proved to be far greater than any savings in time or money that had been realized.

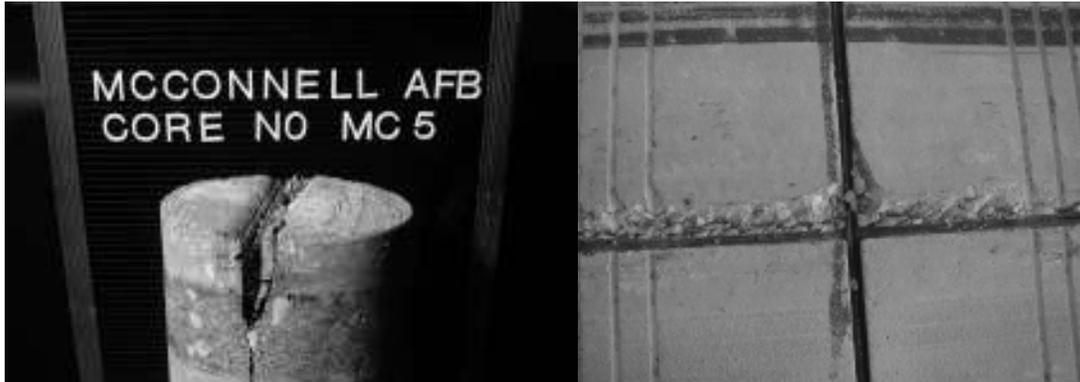
The USAF has had an inordinately large number of portland-cement concrete pavement projects that developed spalling at early ages. This spalling developed anywhere from a few days to within a year of placement and varies from extensive large spalls to thin raveling-type spalls (Figure 5). The flyers consider debris from pavement spalls a serious source of potential foreign object damage to jet aircraft engines so development of spalling is a major safety concern in the USAF.

A review of 12 different incidences of early age spalling on USAF airfields found the predominant cause was poor construction techniques that may be augmented by contributions from poor materials, inadequate curing, or operational activities [8]. Typical construction techniques leading to spalling problems include hand repair of excessive edge-slump during slipforming, adding water to the surface to ease finishing, and excessive finishing of the surface. Such activities lead to nondurable paste being left on the pavement surface and to elevation differences between adjacent slabs. Then traffic, environmental effects, snow clearing, etc. rapidly develop spalling on the new pavement.

Figure 5. Examples of Early-Age Spalling at USAF Airfields (Left: Core from Runway Joint at McConnell AFB, KS, Right: Runway Centerline Cannon AFB, NM).

practices in the project specifications will not be effective unless embraced by the paving crew in the absence of government oversight. The USAF has mandated use of well-graded aggregate gradations in their airfield portland-cement concrete pavements hoping that requiring use of a mixture that is more easily placed, consolidated, and finished will lead to fewer poor construction practices in the field. The Air Force Institute of Technology has annual classes for USAF civil engineering personnel on pavement design and construction, and the causes of early-age spalling are presented to students. In a parallel effort, the Army Corps of Engineers Transportation Systems Center of Expertise has been conducting workshops for government inspectors and contractor personnel immediately prior to major airfield paving projects. These workshops include discussions of the early-age spalling problems and the role of proper construction practices in avoiding them. Some engineers have begun mandating beveled joint edges hoping to reduce the incidence of spalling, but opinions on the efficacy of this beveling remain mixed. Early-age spalling has been reduced by these various efforts, but the problem continues to reoccur and has not been solved.
