Polyurea Paint Marking Material Study

October 2006

DOT/FAA/AR-TN06/46

U.S. Department of Transportation
Federal Aviation Administration

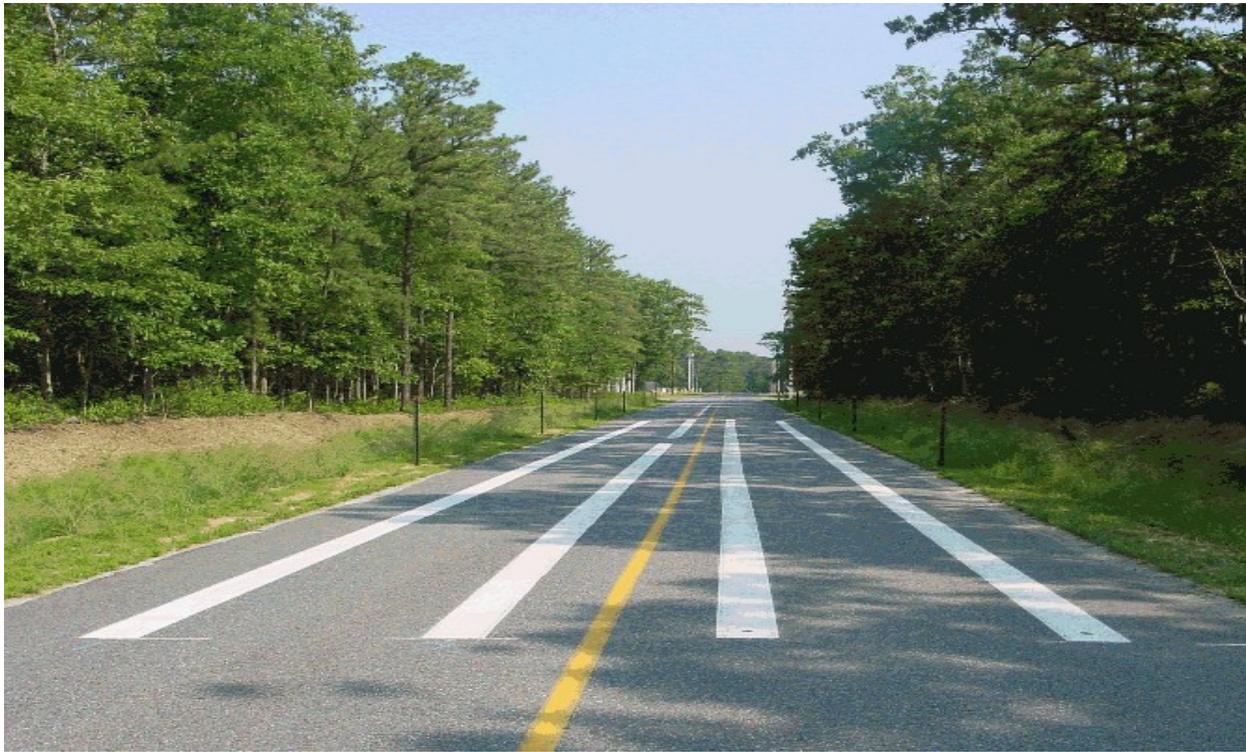
FIGURE 1. FOUR WHITE CENTERLINE STRIPES ON HOT-MIX ASPHALT AT THE FAA WILLIAM J. HUGHES TECHNICAL CENTER

In addition to the tests stated in table 1, different application methods were evaluated on glass beads. When applying glass beads to pavement marking material, it is common practice for airports to not sieve (unsieve) the beads before application. Unsieved glass beads apply different sized beads to the pavement marking material. Using this method gives better IOR readings and maintains the retro-reflectivity longer. In this study, a sieved application was evaluated to determine if beads in the same size range resulted in a better retro-reflectivity performance. The size of the beads for unsieved ranged from 0.4-3 mm, and sieved were 0.4-1.25 mm. Only the Plus 9 beads were applied sieved and unsieved (see figure 1).

Surface Material	Color	Beads	Sieved/Unsieved	Tests Conducted	Seal Coat
Hot-Mix Asphalt	Four White Centerline Markings (figure 1)	Plus 9	Sieved	Chromaticity, retro-reflectivity, outflow water meter, 2-liter water recovery, pull-off strength, friction, and baseline test	None
		Plus 9	Unsieved		
Concrete*	White	Type III		Chromaticity, retro-reflectivity, outflow water meter, and pull-off strength	None
	Yellow	Type I			None
	Black	No beads			None

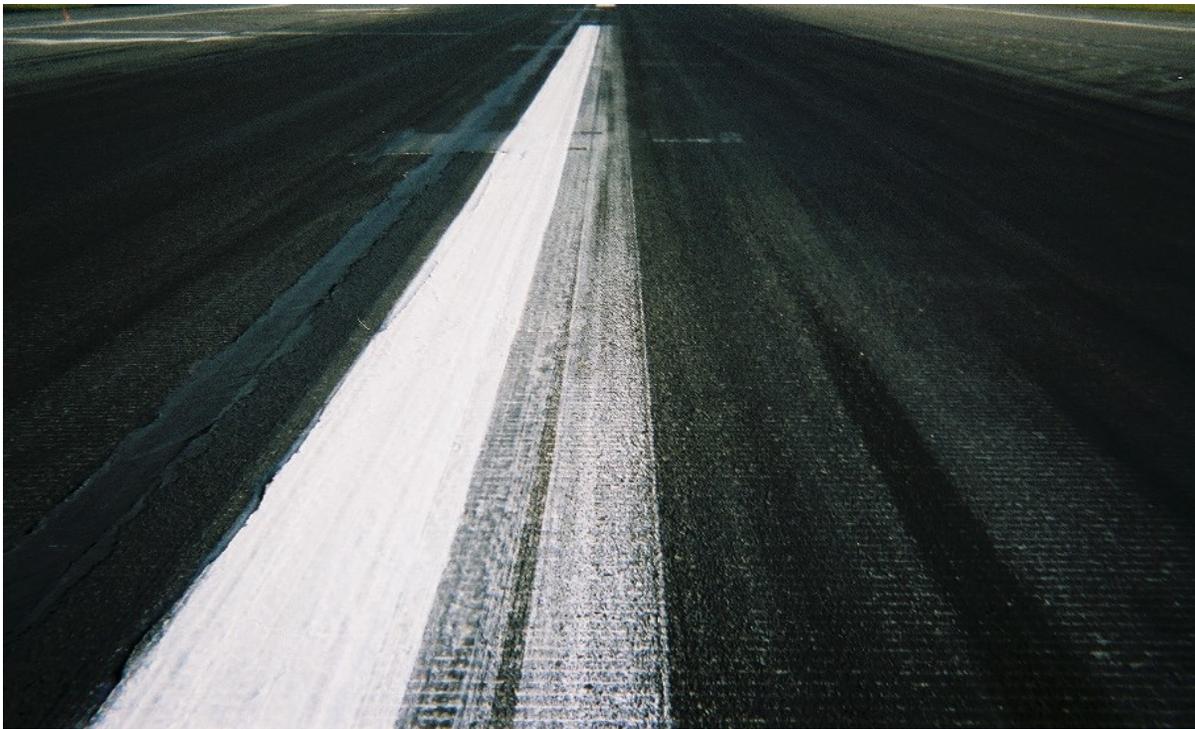
FIGURE 2. NEWARK LIBERTY INTERNATIONAL AIRPORT
RUNWAY 4R CENTERLINE

Surface Material	Color	Beads	Tests Conducted	Seal Coat
Runway 4R (asphalt) (figure 2)	White Centerline	Type I, Ceramic	Chromaticity, retro-reflectivity, and baseline test	None
Taxiway Y (asphalt) (figure 3)	Yellow, Black	Type I, Type III, Ceramic	Chromaticity, retro-reflectivity, pull-off strength, and baseline test	Half of hold bar had seal coat
Taxiway J (asphalt) (figure 3)	Yellow	Type I, Type III	Chromaticity, retro-reflectivity, pull-off strength, and baseline test	Half of hold bar had seal coat

The polyurea marking material at EWR was removed from taxiway J and Y after 6 months and from runway 4R after 3 months. The reason for removal at taxiway J and Y was due to poor bonding on the asphalt seal coat side of the installation. The reason for removal at runway 4R was due to lose of beads since it was a high-traffic area. The evaluation was suppose to last 1 year, thus insufficient data was collected during the test. The only markings that remained for the 1-year evaluation period were located at the FAA William J. Hughes Technical Center.

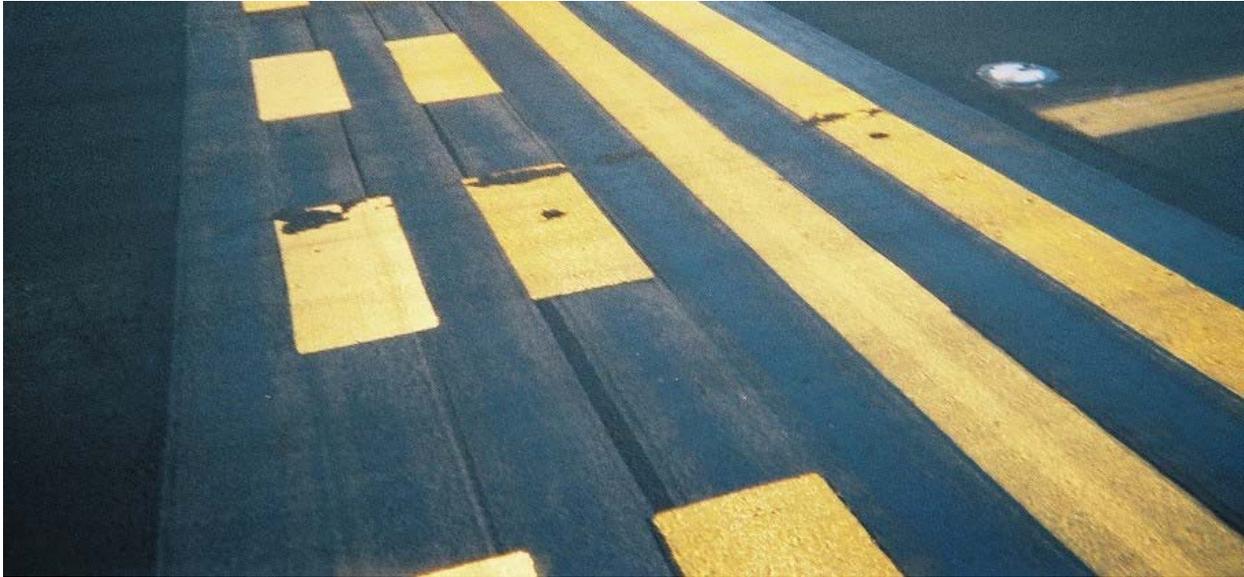
FIGURE 3. NEWARK LIBERTY INTERNATIONAL AIRPORT TAXIWAY WITH POLYUREA MATERIAL, RIGHT SIDE OF CENTERLINE SEAL COATED AND LEFT SIDE OF CENTERLINE NOT SEAL COATED

Due to heavy traffic flow, all three manufacturer’s products (A, B, and C) were applied at the locations stated in table 2. On some portions of taxiways Yankee (Y) and Juliet (J), asphalt seal coat was applied prior to the installation of the polyurea marking material. Asphalt seal coat is used to prevent cracking of the asphalt pavement. Applying the asphalt seal coat before the paint

is not a common practice for airports; usually the paint marking is applied, then a seal coat goes around the paint. This particular test was done to see how the marking material bonded to the pavement if the seal coat was applied first. However, after 3-6 months of in-service testing, the markings with the seal coat came up in big sheets and were replaced with standard paint material.

- It was not recommended that an asphalt seal coat be applied prior to the application of the polyurea marking material. Areas where the asphalt seal coat was applied before the polyurea marking material prevented the polyurea marking material from adhering properly to the pavement, which caused the polyurea marking material to come off in sheets.
