Evaluation of Trapezoidal-Shaped Runway Grooves

May 2012

DOT/FAA/TC-TN12/7

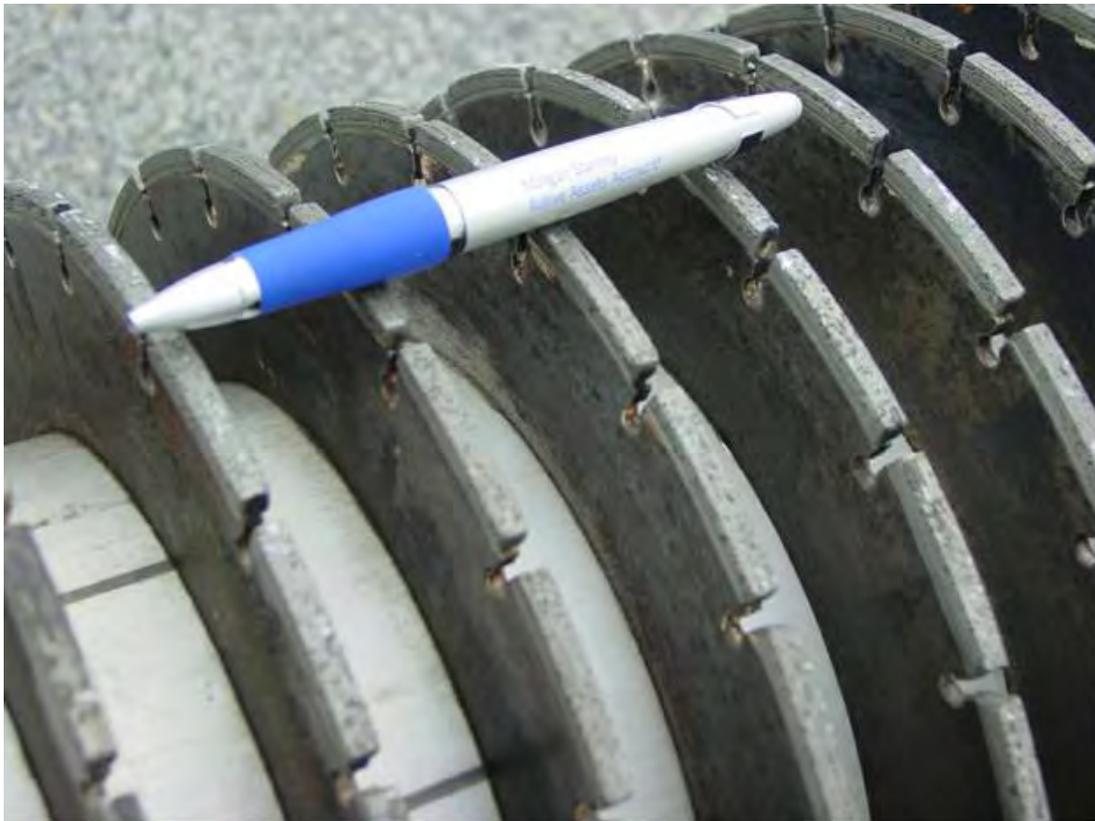
Figure 2. Blades for Standard Grooves

demonstrated that the grooving configuration can be cut repeatedly without the blade integrity deteriorating. In earlier attempts to develop a trapezoidal-shaped blade, it was found that the blade would quickly wear and lose its ability to maintain a trapezoidal-shaped groove after just a few passes across a runway. At the time, blade manufacturing technology and the lack of a properly designed cutting segment did not allow for a blade tip that could resist wear and maintain its trapezoidal shape after repeated cuts. The contractor cited that these issues had been resolved and that they had a blade that would wear much slower and more proportionally than earlier blade designs. Figure 2 shows the blades for cutting standard grooves, and figure 3 shows the blades for cutting trapezoidal-shaped grooves.

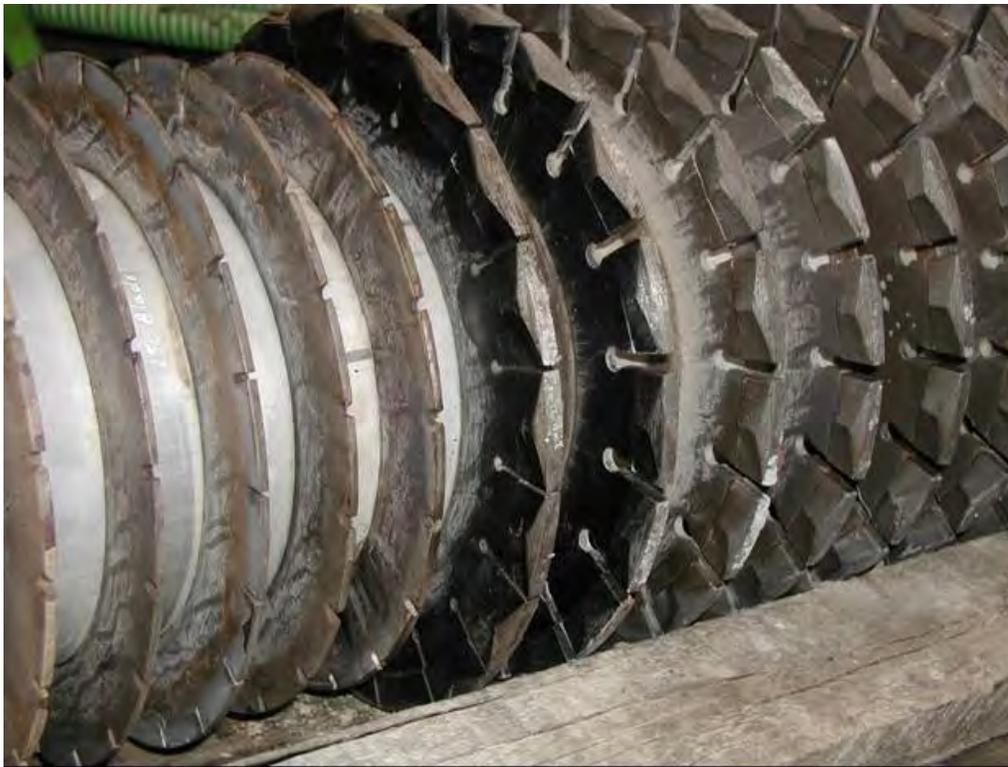
Figure 3. Blades for Trapezoidal-Shaped Grooves (Spacers at Left)

As a note, the contractor proposing the new trapezoidal-shaped groove holds a patent on the way the special blade segment that they developed is shaped, not on the pattern that is cut. There are several other blade segments available in the public domain that are capable of producing the same trapezoidal-shaped groove.

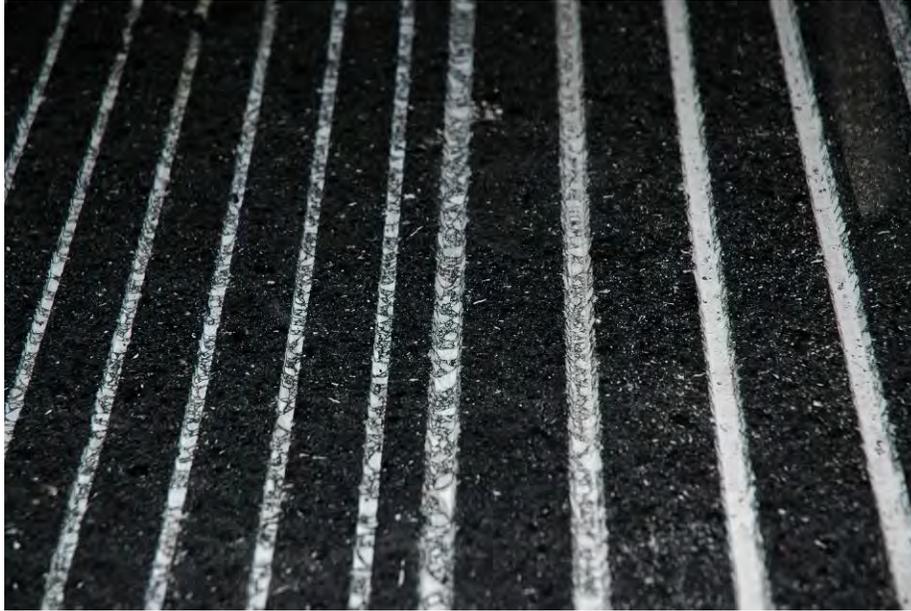
Figure 9. Standard (Left) and Trapezoidal (Right) Grooves Side by Side

Therefore, each 20-ft-wide transition included 10 ft of standard grooves and 10 ft of trapezoidal-shaped grooves. Figure 9 is a photograph of the center portion of T5, which shows the two groove types side by side. In the photograph, the grooves on the right are the trapezoidal-shaped grooves, and the grooves on the left are the standard grooves.

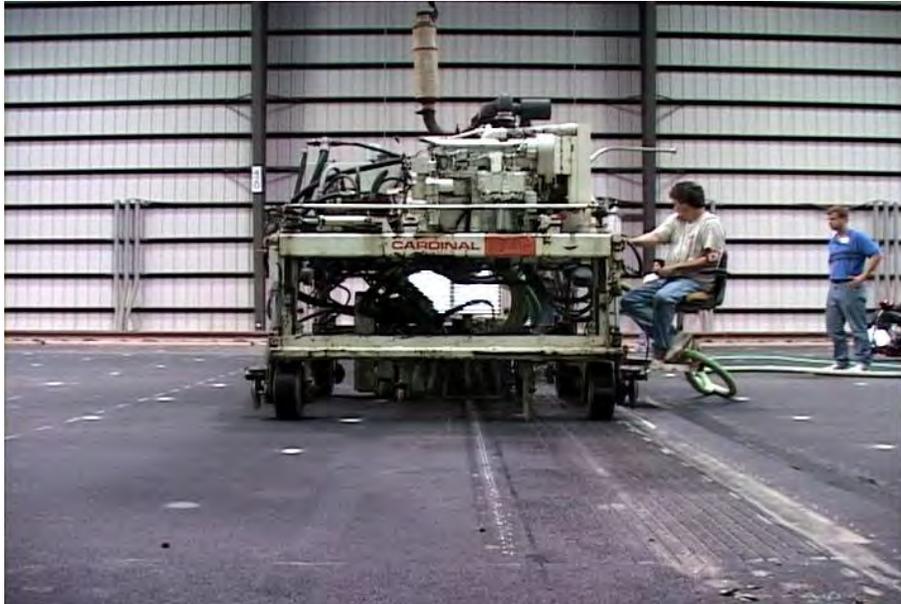
Figure 10. Bridge-Deck Groove-Cutting Machine

CONSTRUCTION PROCESS. One of the objectives of the project was to compare the construction methods, resources, and requirements between the trapezoidal-shaped and the standard grooves. With the grooving operation at the NAPTF, project personnel were unable to identify any differences in the construction process. In fact, both sets of grooves were installed with the same machine and labor effort. The blade mechanism was the only difference between the process of cutting standard grooves and trapezoidal-shaped grooves. A bridge-deck groove-cutting machine was used for this operation, as shown in figure 10. This was because for this particular project, there was limited space at the end of each groove lane for use of a larger runway-scale groove-cutting machine. The bridge-deck groove-cutting machine is typically used for bridge-decks and locations that offer limited maneuverability. On a typical runway groove installation, a much larger machine would be used.

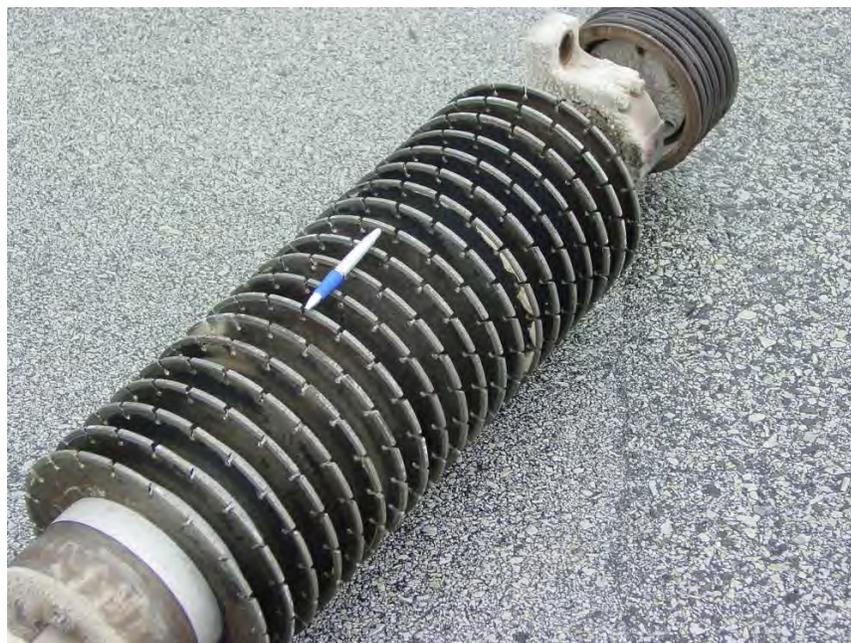
Figure 11. Rotary Drum With Standard Groove Blades

The groove-cutting machine uses a series of circular saw blades arranged side by side on a rotating drum. The blade arrangement for standard grooves, shown in figure 11, consisted of 20 blades spaced 1 1/2 in. on center for a total cut width of about 30 in. Figure 12 shows the blade arrangement for the trapezoidal-shaped grooves in which the drum was fitted with ten circular blades spaced 2 1/4 in. on center, for a total cut width of about 22 in. Because this was a demonstration of the proposed trapezoidal-shaped groove shape, the manufacturer had not yet fabricated enough trapezoidal blades for a full drum arrangement.

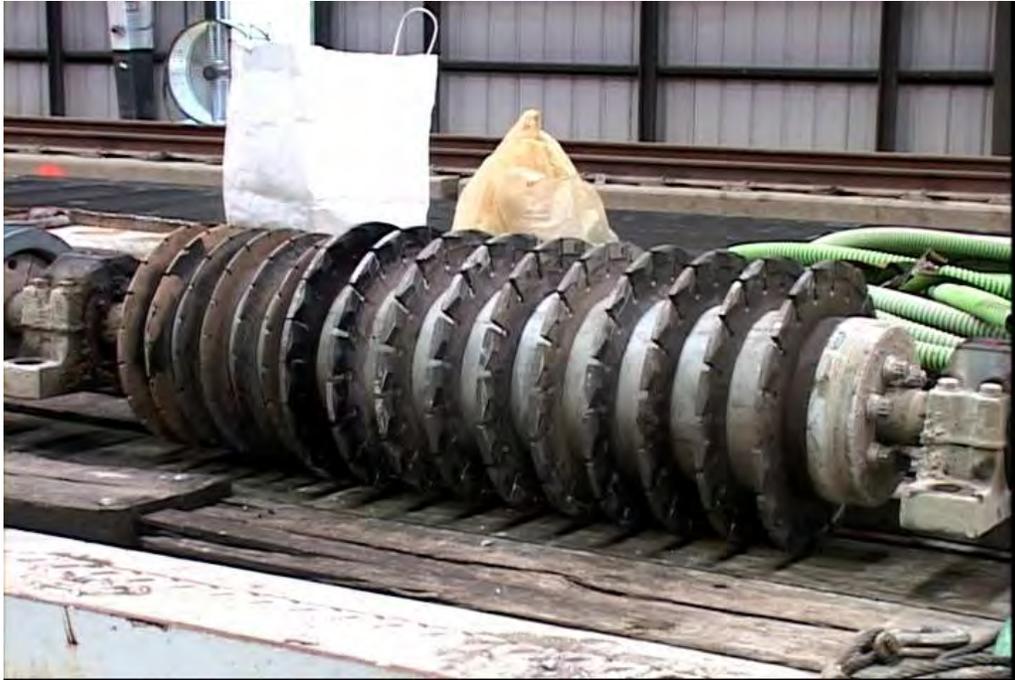
Figure 12. Rotary Drum With Trapezoidal-Shaped Groove Blades

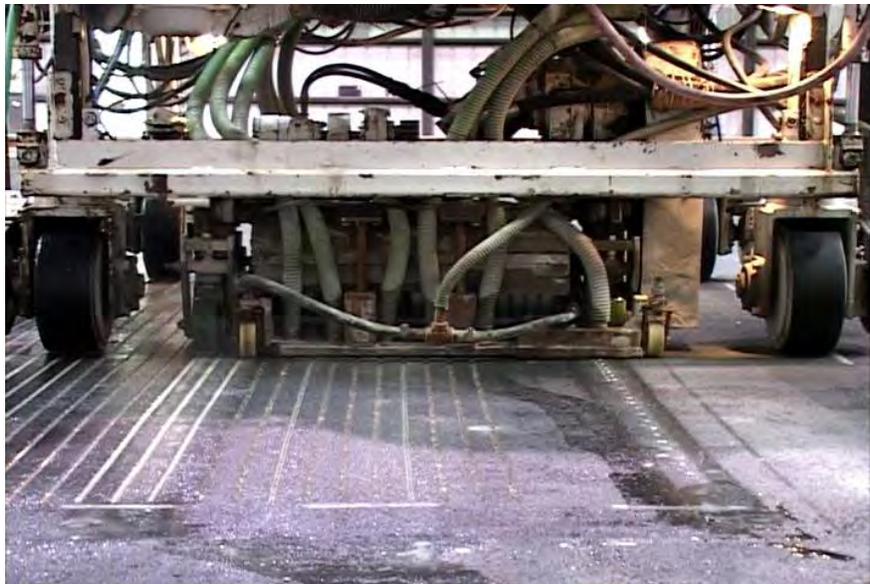
Figure 13. Trapezoidal-Shaped Grooving Using Bridge-Deck Machine

The grooving process uses a stream of water to cool the blades as they cut through the pavement. As the blades rotate, the machine moves forward slowly in the direction of the groove. A driver steers the machine to keep the groove lane straight. A vacuum system sucks most of the excess water and waste material into a collection tank located on the back of a support truck. Figure 13 shows the cutting of a new groove lane with the trapezoidal setup (machine is moving away in this picture). Some of the water used in the cutting process is visible in the right foreground.

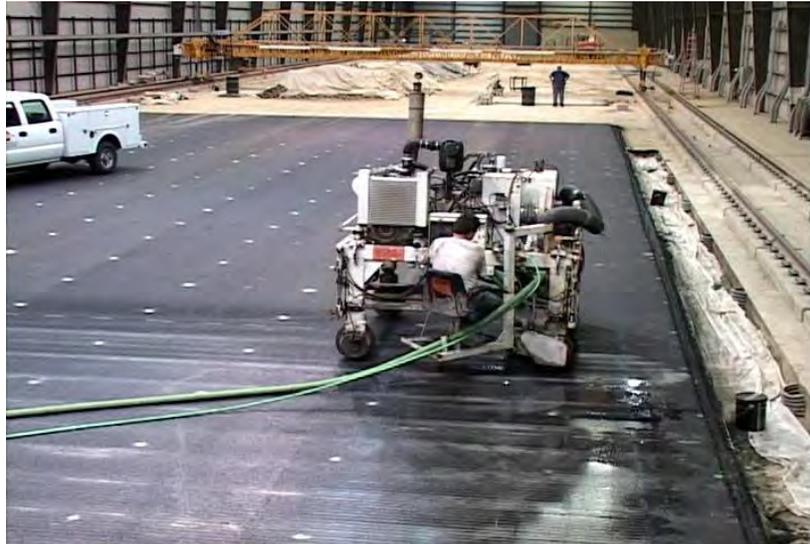
Figure 14. Groove-Cutting Machine With Water Supply Hose

In figure 14, the water source hose and waste collection hose are visible as the machine begins a new groove lane.

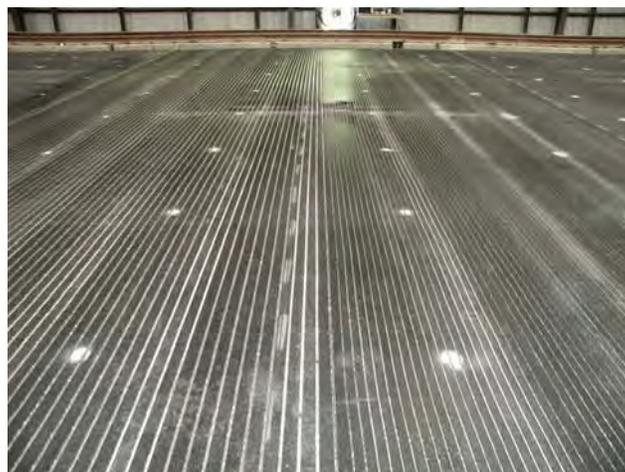
Figure 15. Trapezoidal-Shaped and Standard Grooves in Asphalt Pavement at NAPTF

Cutting the grooves was performed in a south-to-north direction only. In figure 15, south is to the right and north to the left for reference. Each lane measured 55 ft in length. At the end of each run, the machine lifted the blade mechanism and stopped the flow of water. The vehicle then reversed direction and traveled back to the south side of the pavement. The driver aligned the machine for the next lane cut making sure to space the blades appropriately from the last groove in the previous lane. Cutting each groove lane, i.e., 55 ft in length, took about 4 1/2 minutes including return travel to the south side. The average cutting time was the same for both the trapezoidal-shaped grooves and the standard grooves at a rate of about 32 ft per minute. The contractor explained that the speed was faster than expected when cutting older pavement, as the pavement in the NAPTF was softer and much easier to cut.

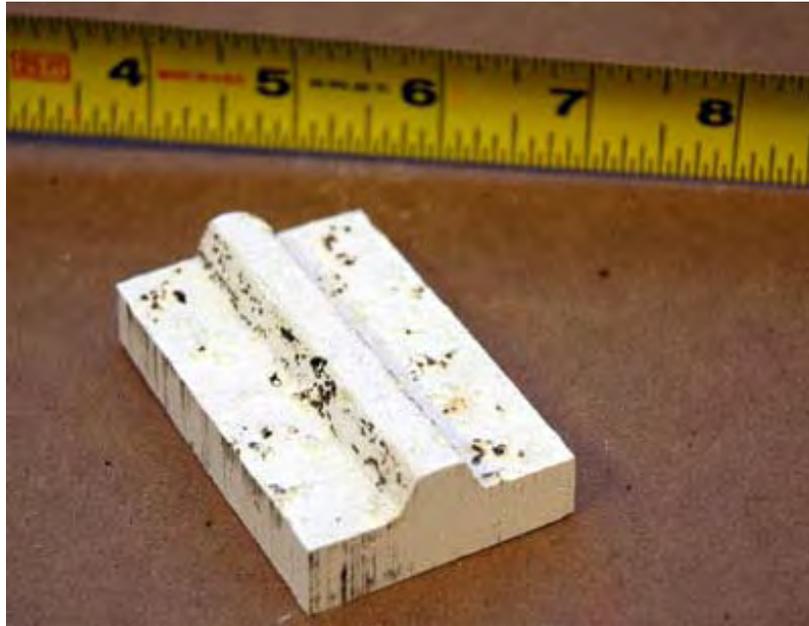
Figure 16. Plaster Mold of Trapezoidal-Shaped Groove

All construction operations were completed within one workday. After the cutting operation was complete, molds were taken of the untrafficked trapezoidal-shaped grooves. A forensic evidence collection kit typically used by law enforcement for capturing accurate positive molds of tire tracks and footprints was used. The plaster is specially formulated to cure rapidly without expansion or shrinkage. Figure 16 is a photograph of one of the molds.

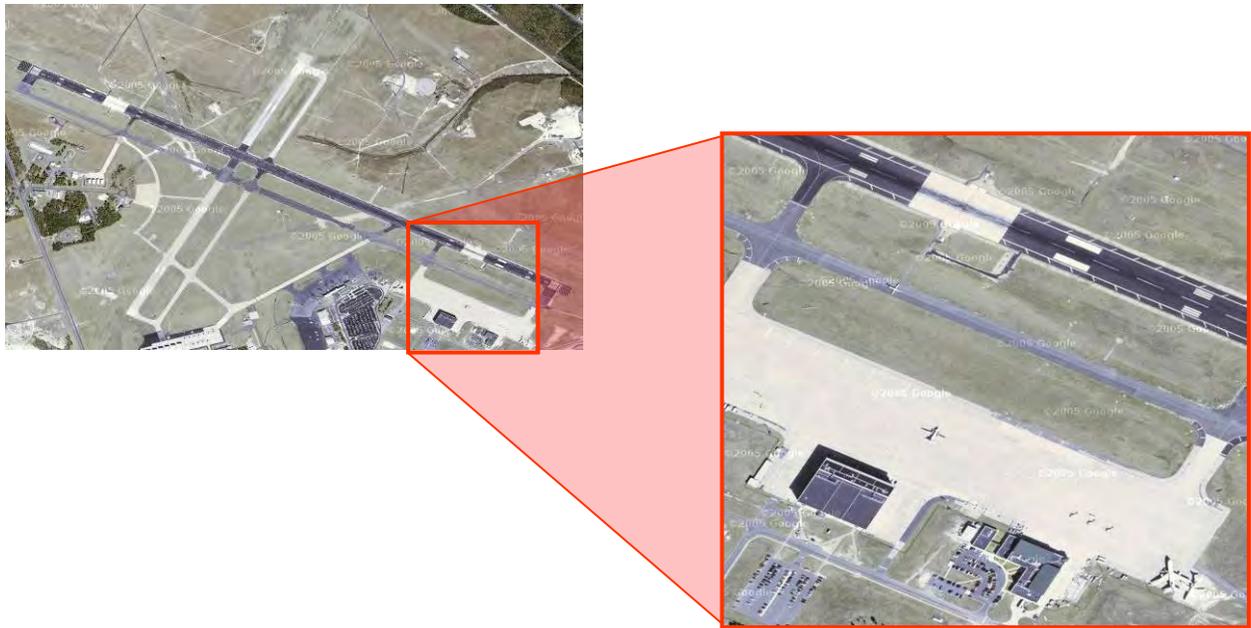
Figure 21. Location of Trapezoidal-Shaped Groove Test Area

DISCUSSION. This portion of the research effort represents a larger test site phase of the evaluation. This was conducted at ACY, on Taxiway Bravo between the intersections of Juliet and Kilo; closer to Taxiway Kilo and the threshold of Runway 31. A diagram of the airport illustrating the location of the test section is shown in figure 21. Taxiway Bravo is a 75-ft-wide taxiway, constructed of asphaltic concrete pavement. ACY is a medium-sized airport that services light commercial aircraft. The groove test area, starting from the intersection of Taxiways Bravo and Kilo, consisted of a 148-ft-long by 75-ft-wide test pavement area that was grooved with standard grooves, followed by a 52-ft-long by 75-ft-wide section of nongrooved pavement, and then a 365-ft-long by 75-ft-wide section of trapezoidal-shaped grooves, as shown in figure 22.

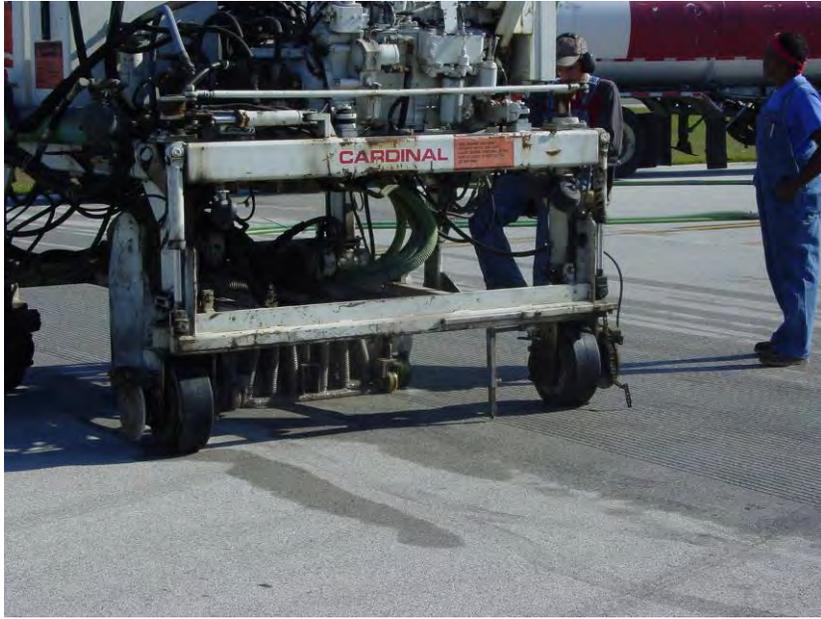
Figure 23. Bridge-Deck Groove-Cutting Machine in Position on Taxiway Bravo

For this particular project, there was no shoulder on the taxiway so the groove-cutting machine had limited space at the end of each groove lane for repositioning. The machine used for this installation was a bridge-deck unit typically used for highways and locations that lack adequate shoulders for larger equipment, so it was able to groove the taxiway surface without the need to depart from the pavement. In a runway environment, there would typically be a paved shoulder that would support the load of a larger groove-cutting machine and allow it to cut the full width of the pavement surface. The groove-cutting machine used the same series of circular saw blades arranged side by side on a rotating drum that was used in the NAPTF installation. Grooves were cut in a south to north direction, starting with the standard grooved section. Figure 24 shows the standard groove installation, and figure 25 shows a portion of the trapezoidal-shaped groove installation.

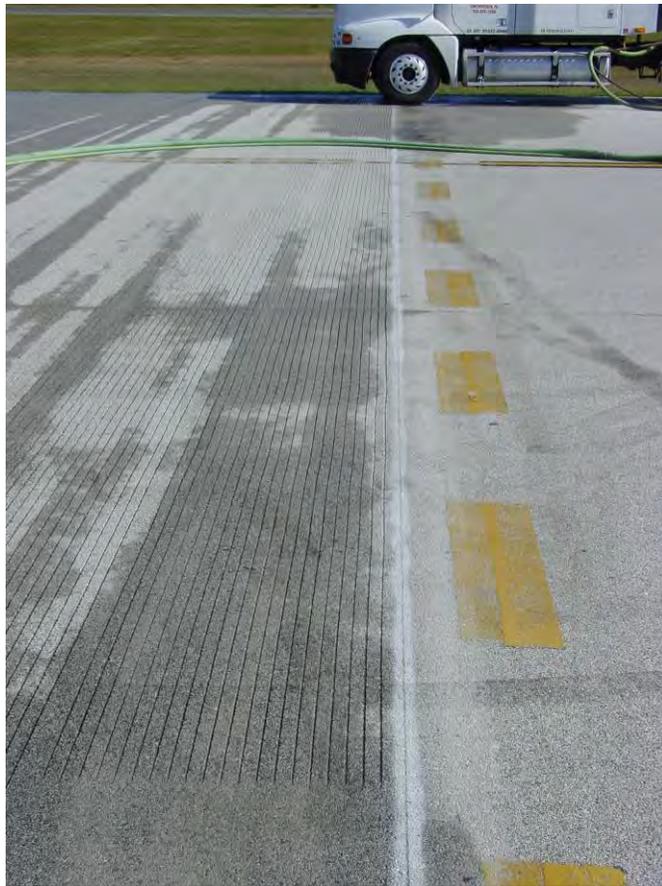
Figure 24. Standard Groove Installation on Taxiway Bravo

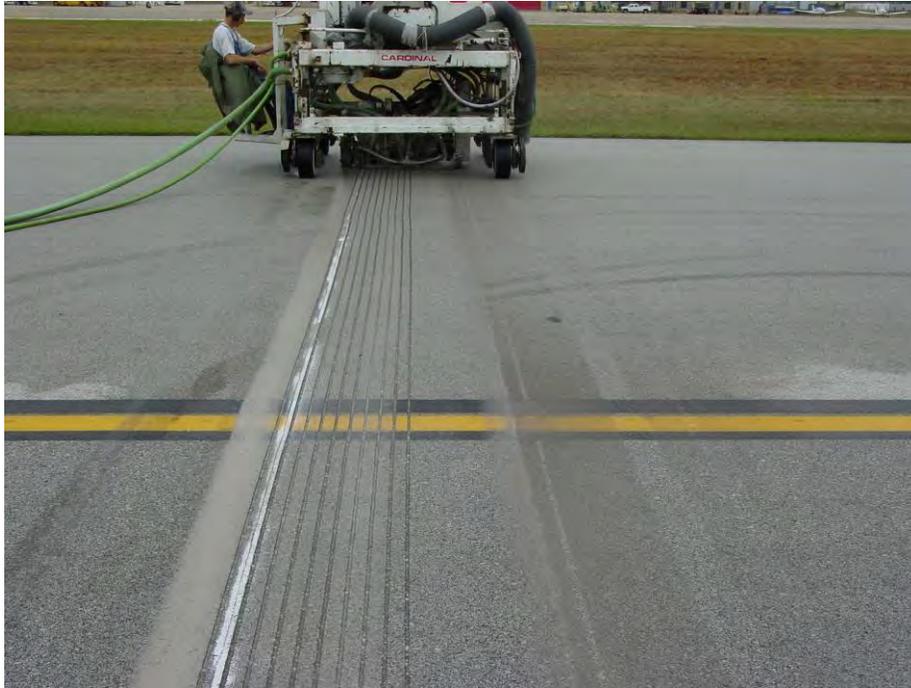
Figure 25. Trapezoidal-Shaped Groove Installation on Taxiway Bravo

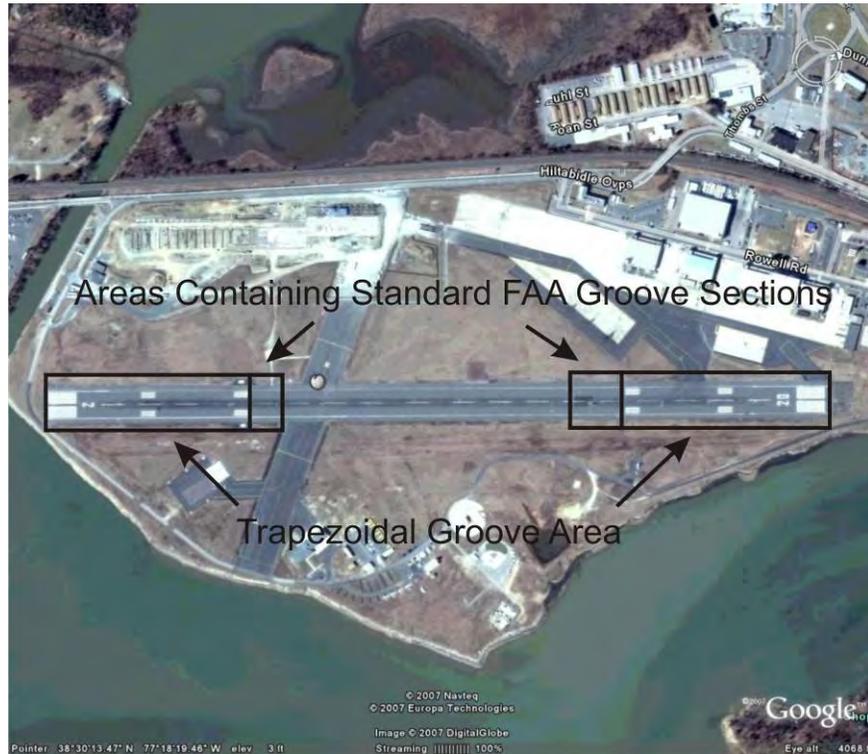
Figure 26. The MCAF Quantico Test Area

TEST SITE 1—MARINE CORPS AIR FACILITY MCAF QUANTICO. MCAF Quantico is a United States Marine Corps airfield that is located in Quantico, Virginia. Runway 02-20 at MCAF Quantico is mostly made of concrete and is 4237 ft long and 200 ft wide. As part of Phase Four, researchers were able to coordinate the installation of the standard and trapezoidal-shaped groove test sections with the airport manager immediately after the runway was resurfaced. This provided researchers with a brand new concrete surface to serve as the first large-scale test area. Runway 02-20 is divided into three sections: the first third of the runway (section 1) is concrete; the second third (section 2) is asphalt, and the last third (section 3) is also concrete. Section one (from Runway 2 threshold), which is 1300 ft long by 130 ft wide, and section three, which is 1540 by 130 ft wide, were grooved with a total of six, equally spaced, 15-ft-long by 130-ft-wide sections of standard 1/4- by 1/4-in.-square grooves, as shown in figure 26. The remaining area within section one was grooved with trapezoidal-shaped grooves. Details of the standard and trapezoidal-shaped groove areas are shown in figure 27. The total grooved area, including both the trapezoidal-shaped and the standard grooved sections, was estimated to be 41,167 square yards. This arrangement allowed researchers to conduct a large-scale evaluation of the trapezoidal-shaped groove sections and provide a side-by-side comparison against the smaller standard groove sections. The center asphalt section of the runway was not grooved but did contain surfaces with various textures. This center section was not evaluated as part of this research effort.

The location of the test areas on Runway 02-20 at MCAF Quantico were optimal for allowing researchers to observe the construction process in an actual airport environment, specifically on a concrete surface. In addition, this location was optimal because it was in close proximity to the

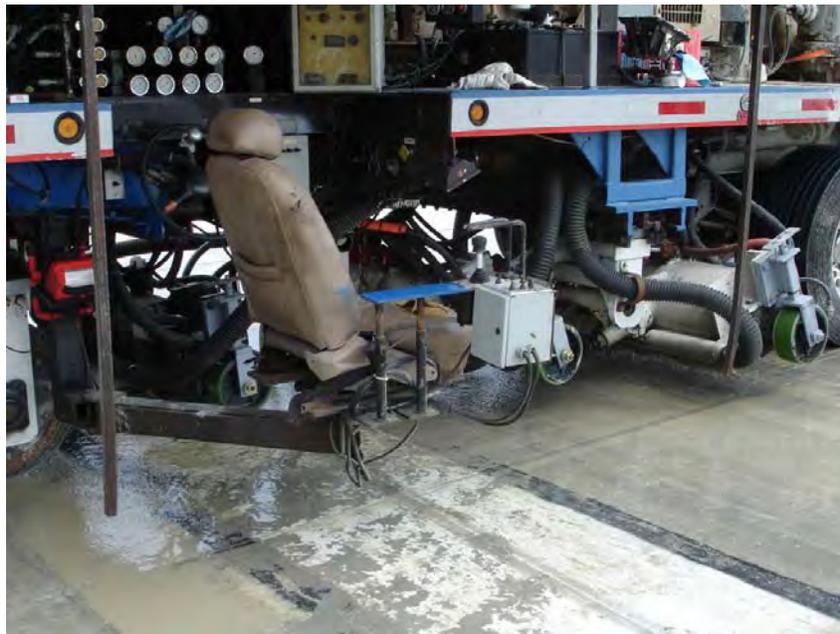
Figure 28. Full-Size Groove-Cutting Machine at MCAF Quantico

In July 2007, researchers initiated the installation of the grooves on Runway 02-20 at MCAF Quantico. The contractor was able to mobilize all of the grooving equipment necessary to perform the installation from their facility in Pennsylvania. The manpower, cutting equipment, supplies, water trucks, sweepers, and vacuum equipment used for the installation were the same equipment that would be used for a typical grooving job at any airport; the only exception was that the groove-cutting machine was fitted with the uniquely shaped blades that create the trapezoidal-shaped groove. For this installation, the contractor used a full-sized groove-cutting machine that was equipped with three cutting drums, as shown in figure 28.

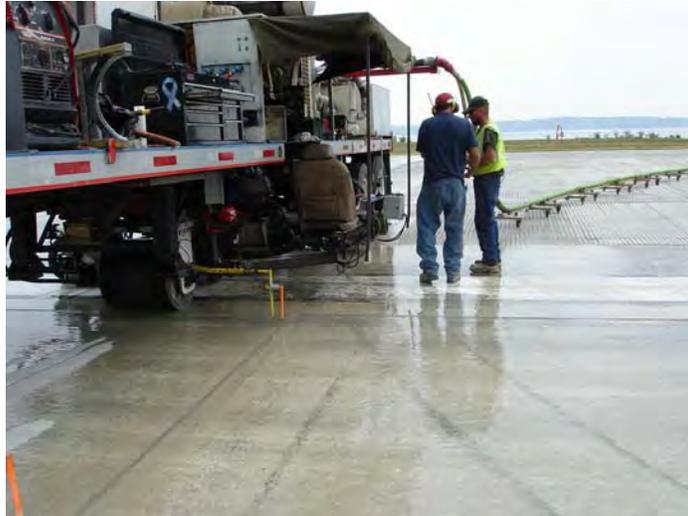
Figure 29. Large Groove-Cutting Machine Finishing a Pass on Runway 02-20 at MCAF Quantico

Similar to the groove installations at the NAPTF and ACY, the only noticeable issue was the time it took for the contractor to change the cutting blades on the groove-cutting machine when it was time to switch to a different groove pattern. As mentioned earlier in this report, this step would normally not occur in the real installation as the contractor would not be switching between the standard and trapezoidal blades. Figure 29 shows a different view of the groove-cutting machine that was used for this installation.

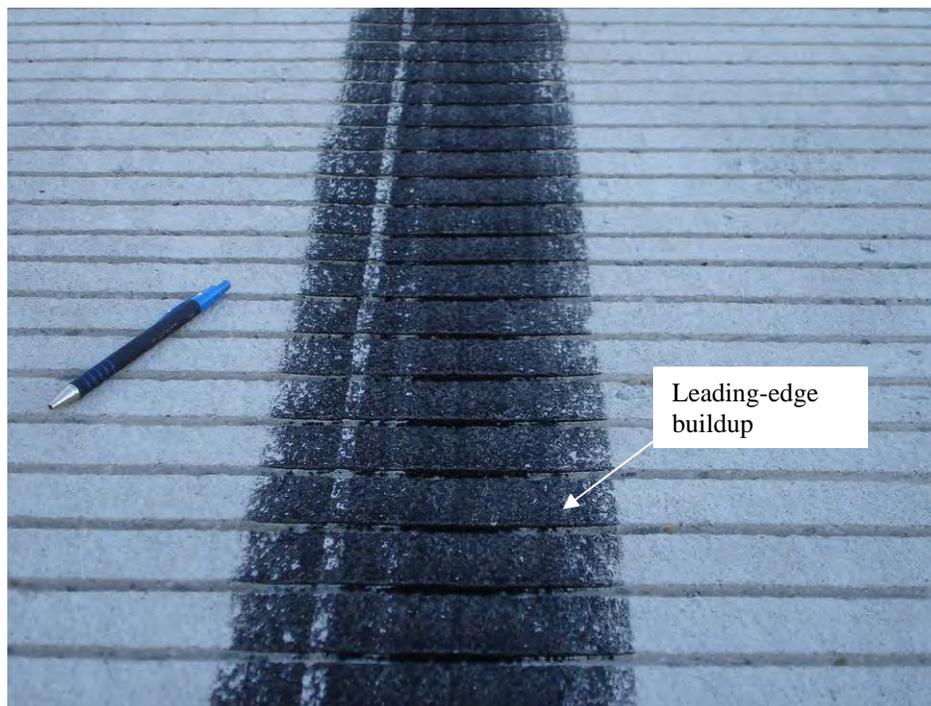
Figure 31. Rubber Contamination at MCAF Quantico—Standard Groove

Approximately 5 months after the groove installation was completed at MCAF Quantico, researchers returned to the airport to conduct their first evaluation. It was noted that there was a difference in the amount of rubber contamination on the two types of grooves. There was less rubber buildup on the top edges of the trapezoidal-shaped grooves, whereas the standard grooves collected more rubber on the top edges. Figure 31 shows the rubber contamination on a standard groove area, and figure 32 shows the rubber contamination on a trapezoidal-shaped groove area. Note the increased buildup of rubber on the leading edge of the standard groove sections in figure 31, as compared to the lesser buildup on the trapezoidal-shaped groove shown in figure 32.

Researchers concluded that the difference in the rubber buildup on the leading edge of the grooves was due to the angular differences in the groove design. The standard groove has edges that are 90° , which would be more likely to shave or cut into the aircraft's rubber tire as it passes over it, while the trapezoidal-shaped groove has a slightly flatter angle of 117° . The difference in the sharpness of these edges very likely determines how much rubber is caught on those edges. Researchers observed evidence of this phenomenon at several locations on the runway at MCAF Quantico but decided to wait several more months before making a final determination.

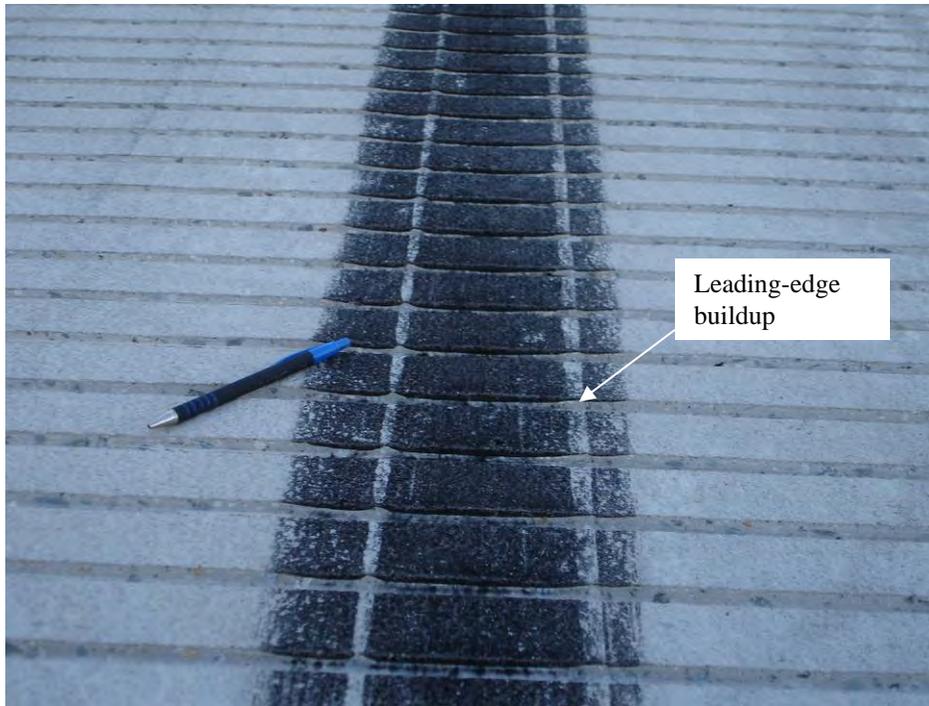
Figure 32. Rubber Contamination at MCAF Quantico—Trapezoidal-Shaped Groove

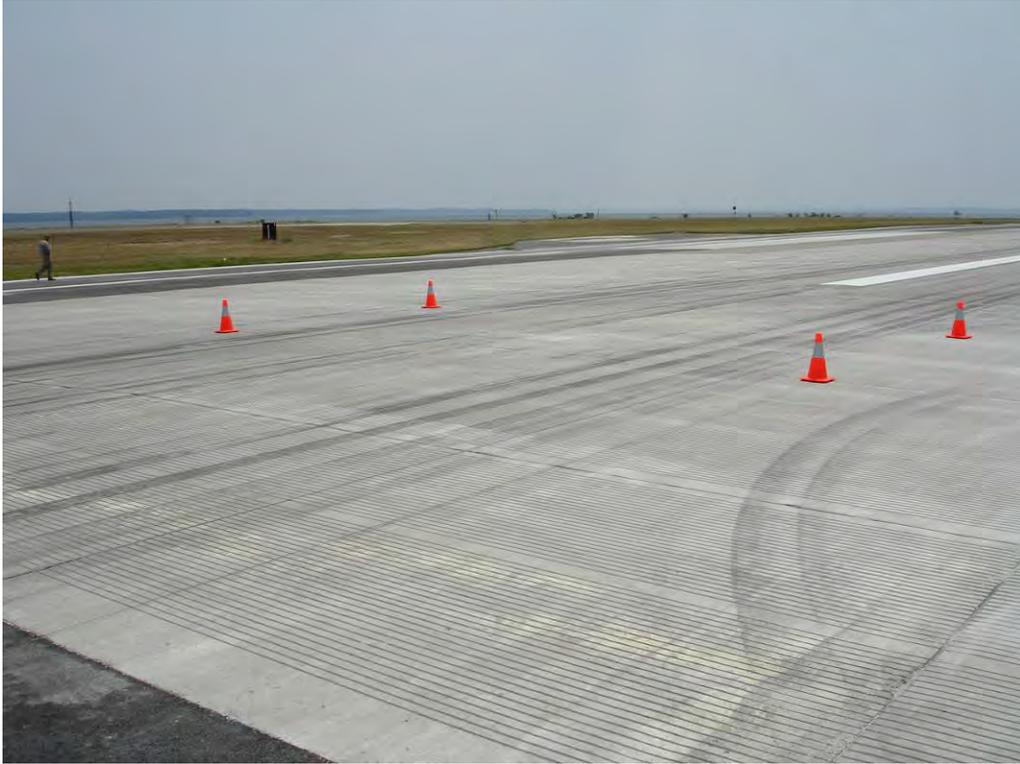
Figure 35. Test Area for Water Dispersal Test

Researchers outlined one standard groove test section with orange traffic cones, as shown in figure 35. An airport fire truck slowly traveled through the test area, along the runway centerline, and dumped a large amount of water on the pavement (figure 36). Within a few seconds after the water was dumped on the pavement, researchers noticed that the pavement areas with the trapezoidal-shaped grooves evacuated the water significantly faster than the areas with the standard grooves. In figure 37, note the area just before the orange cone. The water in this area is higher on the runway than in the areas before and after the cone, which are the trapezoidal-shaped grooved areas. The flood line for the standard grooves, which is the point at which the grooves are completely filled with water, can be observed to lag behind the flood line for the trapezoidal-shaped grooves.

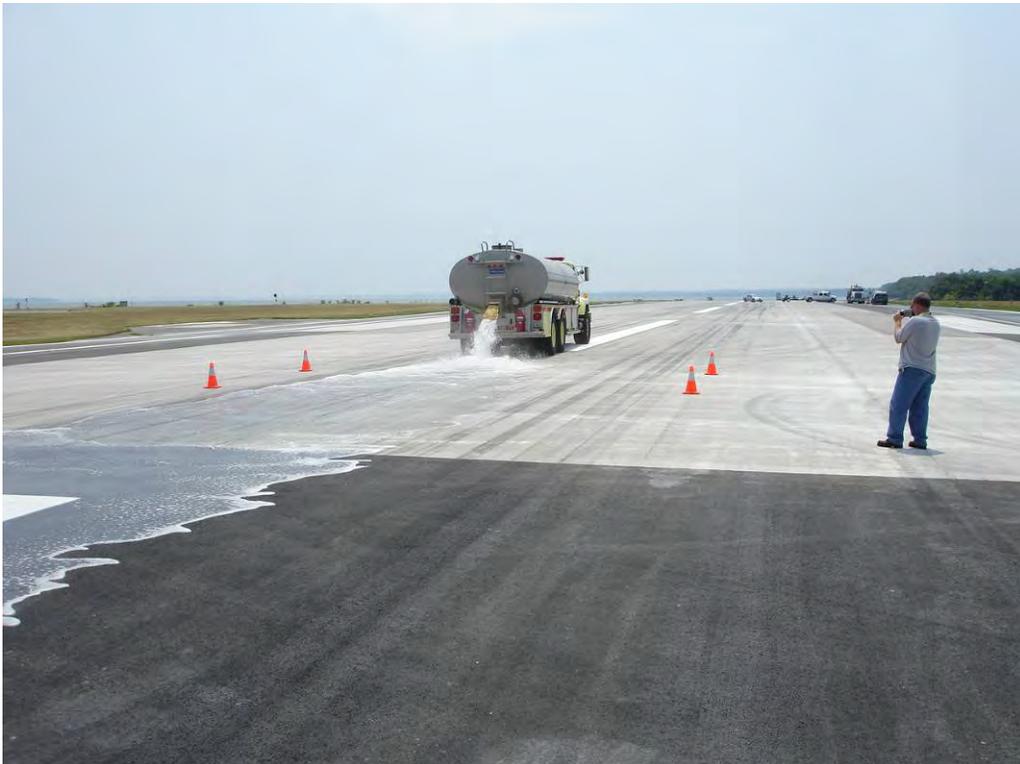
Figure 36. Airport Fire Truck Dispensing Water on Test Area

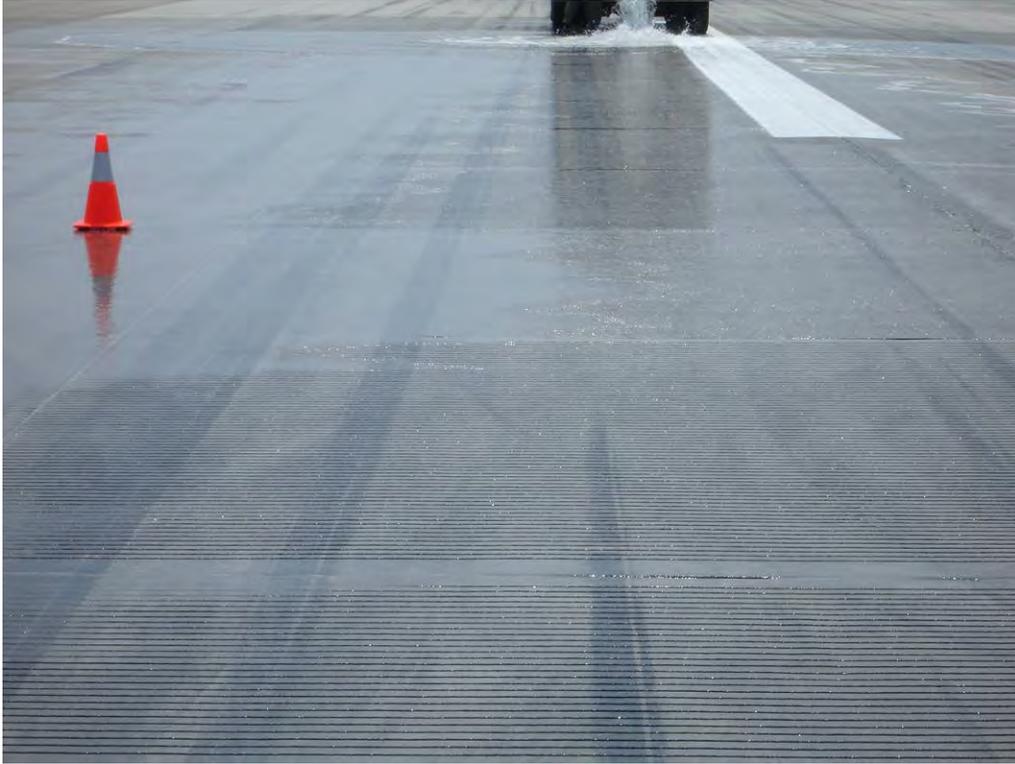
Figure 37. Illustration of Water Dispersal Difference

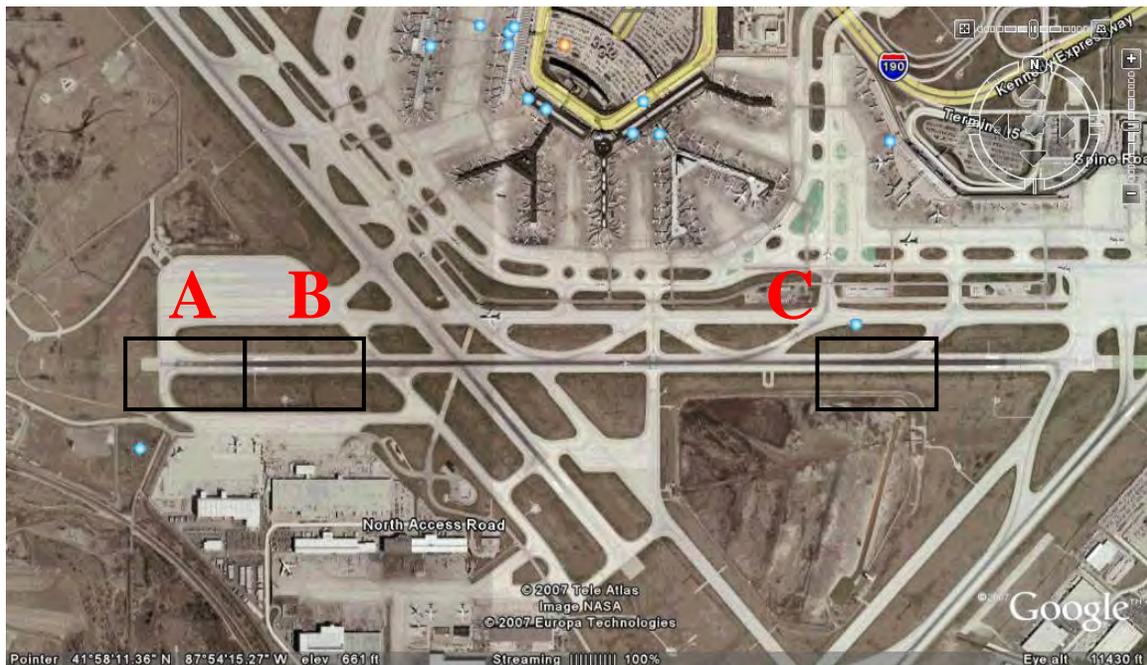
Figure 42. The ORD Test Area

- Runway 10 Threshold Area. The first test area began at the threshold of Runway 10, shown as block A in figure 42. From that point, the 750-foot-long test section began with 250 ft of trapezoidal-shaped grooves, 250 ft of standard grooves, and finally 250 ft of trapezoidal-shaped grooves. This test section ended approximately 750 ft from the threshold of Runway 10. This area was selected to capture landing traffic on runway 10. Details of the area are shown in figure 43.

- Runway 10 Touchdown Area. The second test area began 1000 ft from the threshold of Runway 10, shown as block B in figure 42. From that point, the 750-foot-long test section began with 250 ft of trapezoidal-shaped grooves, 250 ft of standard grooves, and 250 ft of alternative grooves. This test section ended approximately 1750 ft from the threshold of Runway 10. This area was selected to capture the touchdown area where the heaviest rubber contamination may be experienced as the aircraft touchdown on the pavement. Details of the area are shown in figure 43.

- Runway 10 Rollout Area. The third test area began 7711 ft from the threshold of Runway 10, shown as block C in figure 42. From that point, the 750-foot-long test section began with 250 ft of trapezoidal-shaped grooves, 250 ft of standard grooves, and 250 ft of alternative grooves. This test section ended approximately 8461 ft from the threshold of Runway 10. This area was selected to capture heavy braking and sharp turning from aircraft attempting to exit Runway 10 on Taxiways M6. Details of the area are shown in figure 44.

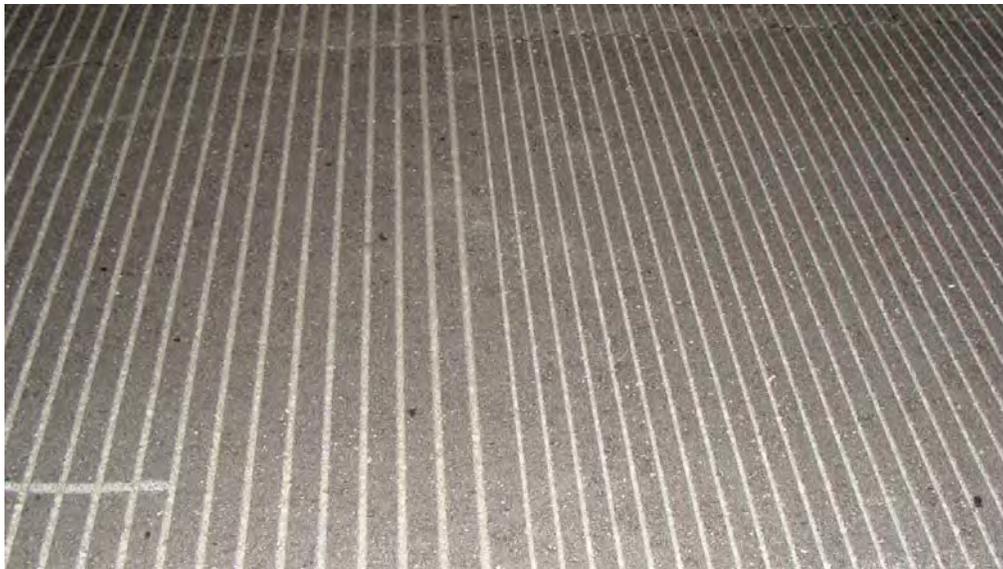
Figure 45. Trapezoidal-Shaped (Left) and Standard (Right) Grooves Installed on Runway 10-28 at ORD

In February 2008, researchers initiated the installation of the grooves on Runway 10-28 at ORD. As with the MCAF Quantico installation, the contractor was able to mobilize all of the grooving equipment necessary to perform the installation from their facility on the east coast. The manpower, cutting equipment, supplies, water trucks, sweepers, and vacuum equipment used for the installation was the same equipment that would be used for a typical grooving job at any other airport; the only exception was that the groove-cutting machine was fitted with the uniquely shaped blades that create the trapezoidal-shaped groove. The same full-sized, groove-cutting machine that was used at MCAF Quantico was used at ORD, as shown in figures 28 and 29. Figure 45 shows a side-by-side comparison of the two grooved sections, as installed at ORD.

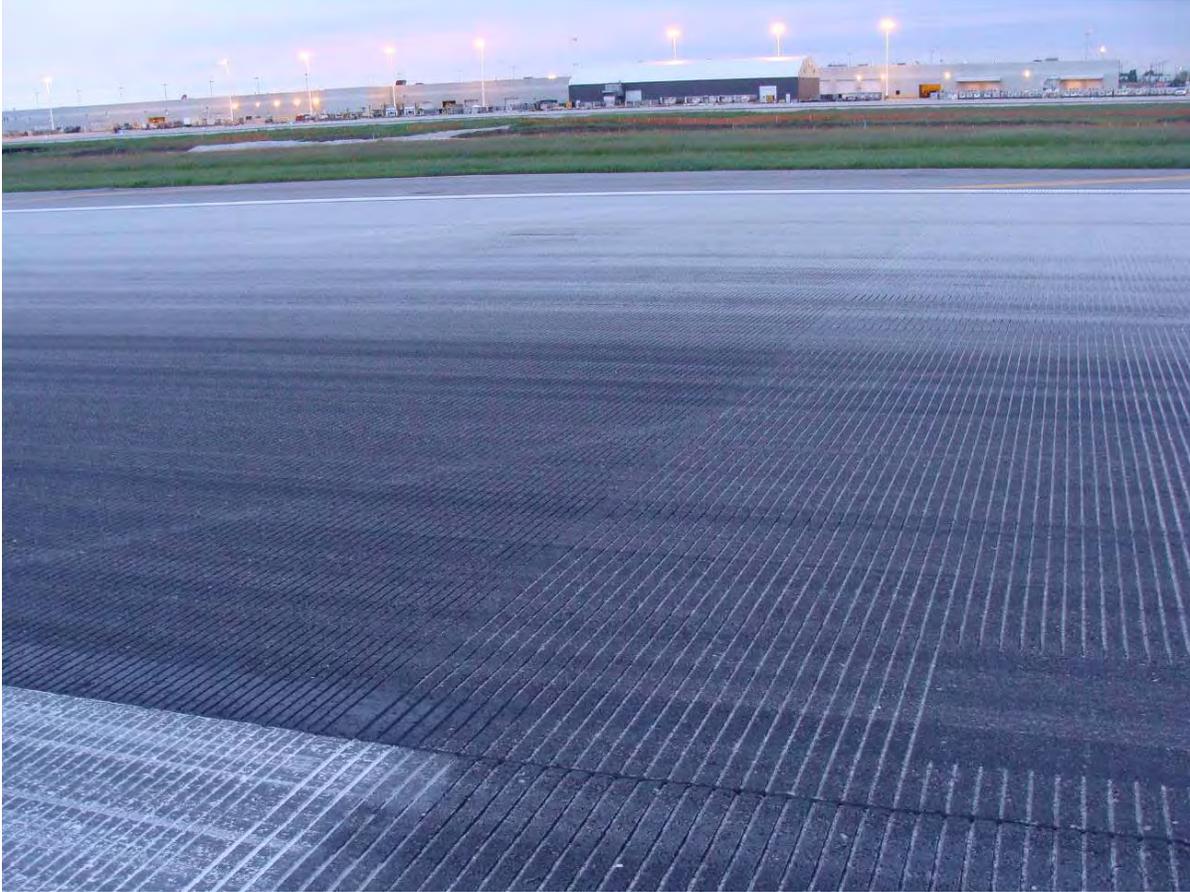
Figure 46. Rubber Contamination at ORD

Approximately 10 months after the groove installation was completed at ORD, researchers returned to the airport to conduct their first evaluation. It was noted that there was a difference in the amount of rubber contamination on the trapezoidal-shaped grooves, just as was observed at MCAF Quantico. Researchers noticed that there was less rubber buildup on the top edges of the trapezoidal-shaped grooves than there was on the top edges of the standard groove. Figure 46 shows a portion of the runway at ORD where the grooves transition from standard to trapezoidal. Note the additional rubber contamination on the standard grooves on the left, versus the trapezoidal-shaped grooves on the right.

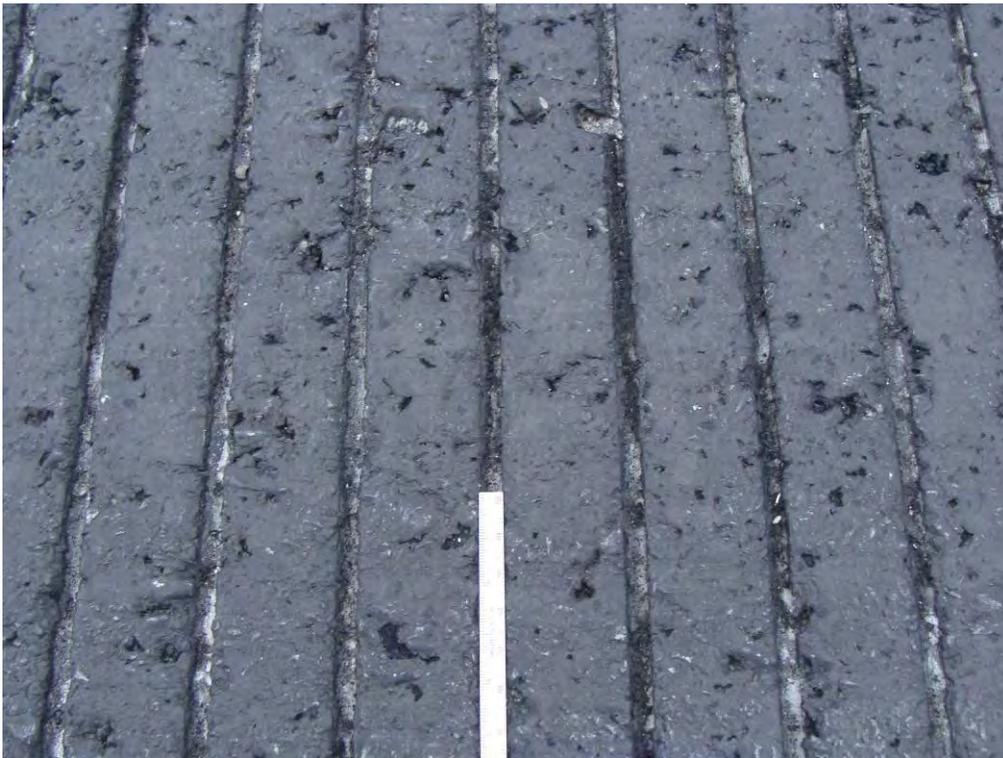
Figure 47. Standard Groove Damage

closing in on the groove. The edges or walls of the trapezoidal-shaped grooves also experienced some disfiguring but still maintained its basic shape. Figure 47 shows a picture of the standard groove with a 1/4-in. measurement ruler placed over the groove, and figure 48 shows a picture of a trapezoidal-shaped groove with the same ruler. Note how the standard groove has closed to less than a 1/4 in., while the trapezoidal-shaped groove has closed slightly but is still fairly close to its original 1/2 in. width. Figure 49 shows a comparison in the amount of damage in a transition area in which the type of groove switches from trapezoidal (on left) to standard (on right). These results validated the data collected earlier during the profiling activity conducted at the NAPTF that showed the trapezoidal-shaped grooves suffered some failure under extreme weight conditions but were still able to maintain a recognizable shape. The standard grooves, however, did not.

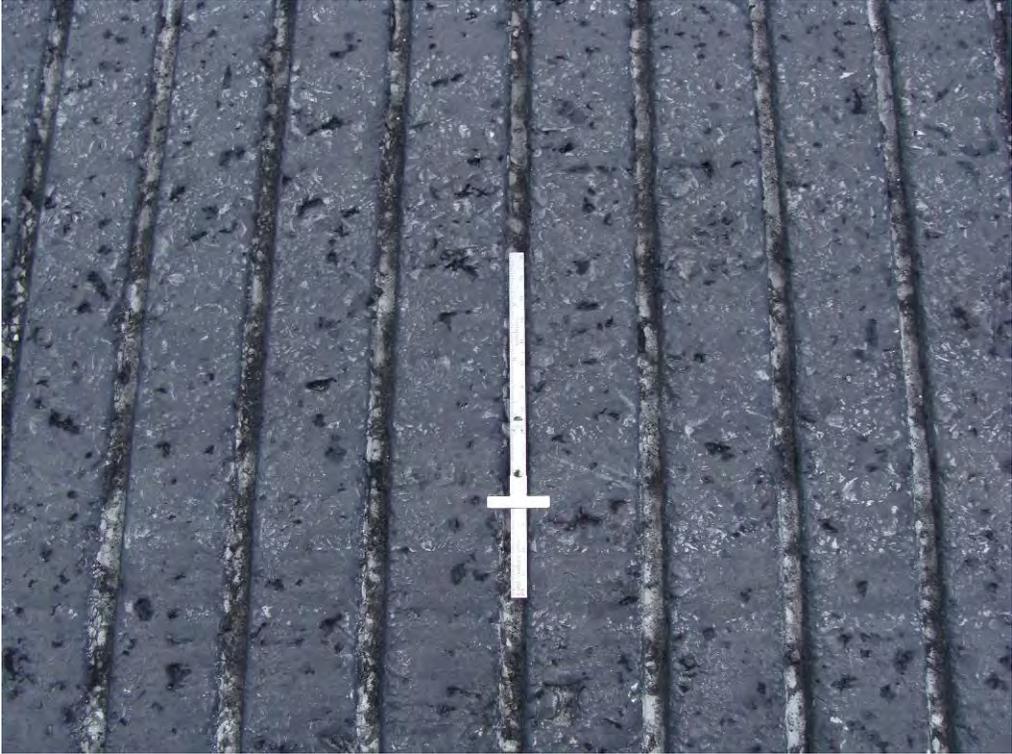
Figure 48. Trapezoidal-Shaped Groove Damage
