Evaluation of Trapezoidal-Shaped Runway Grooves

May 2012

DOT/FAA/TC-TN12/7

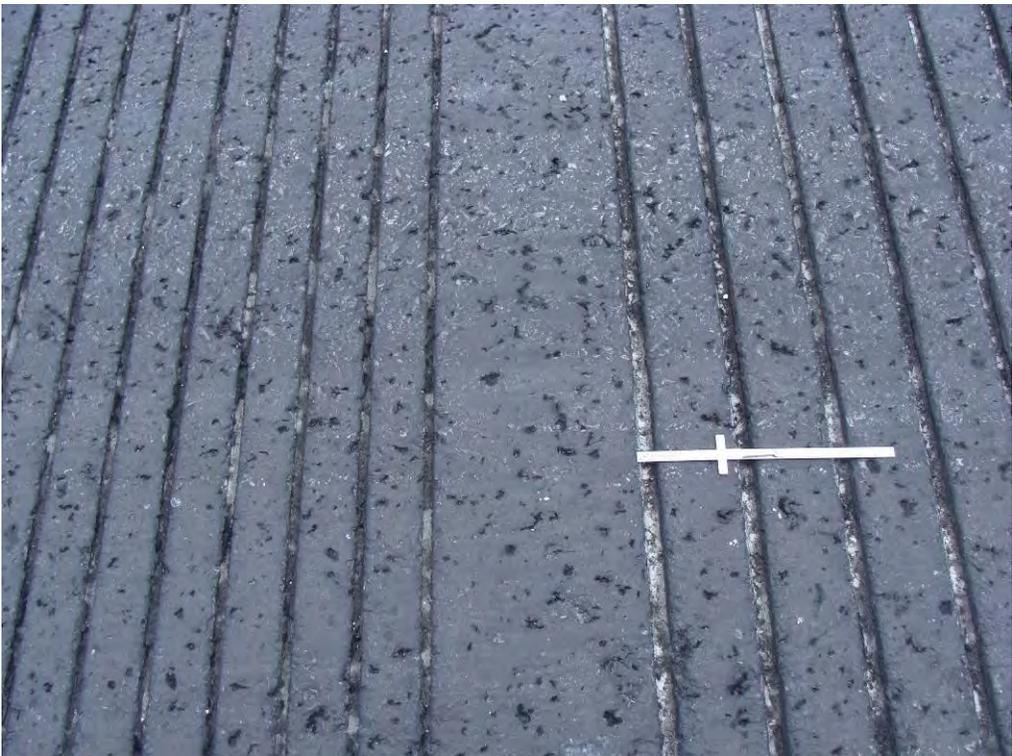
Figure 49. Comparative Damage to Grooves
