Alkali-Silica Reaction in concrete pavement at Gimpo international Airport a maintenance case using HMA overlays

Pyung-Jin Kwak, Tae-Hun Kim, Je-Il Lee, Woo-Yeong Jung

FAA Worldwide Airport Technology Transfer Conference

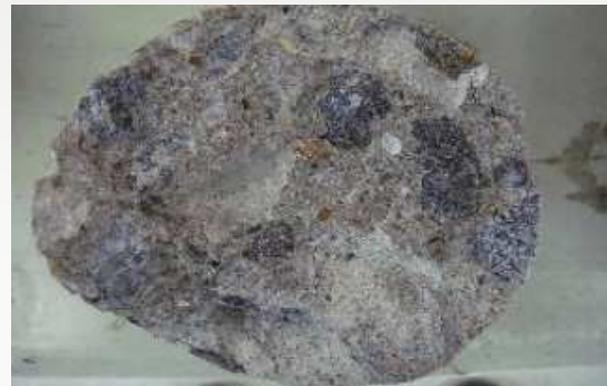
Aggregate reaction product in the parallel crack area

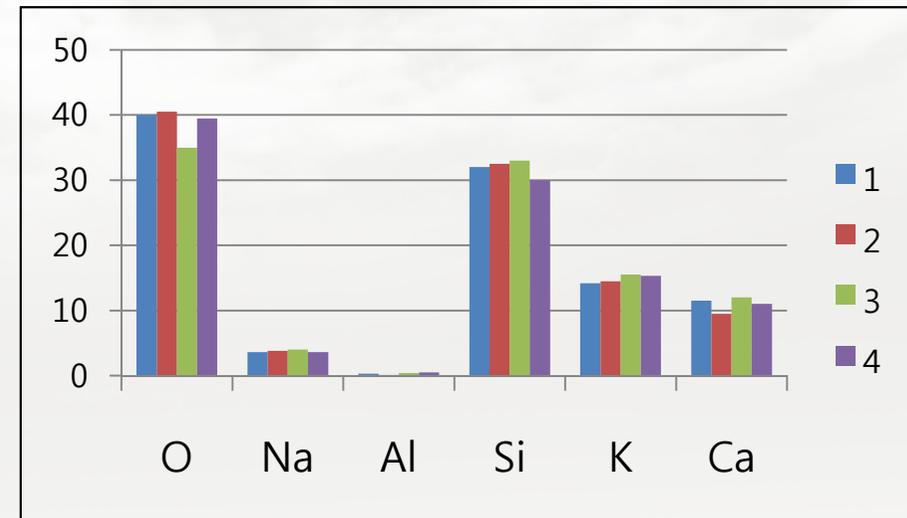
The spectrum of white product

Product order

- $Si > K > O > Ca$

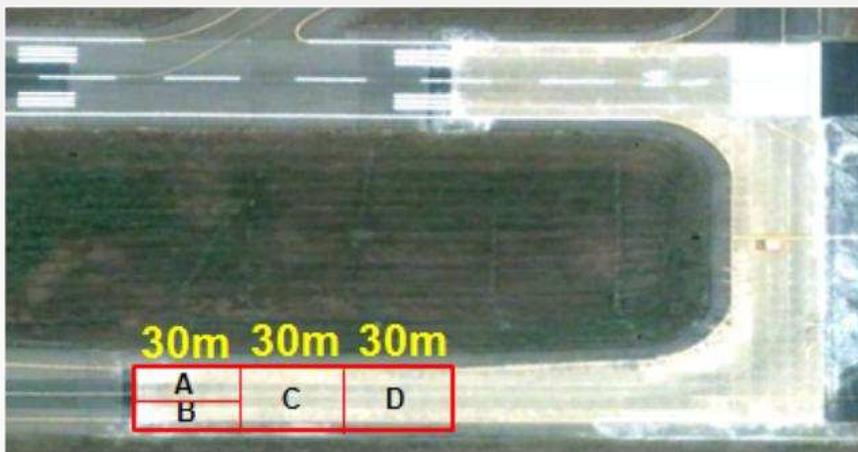
Test construction site

- The elevation differences between site construction and the connected existing taxiway pavement
- The surface of the concrete pavement weakened and was generating F.O.D
- Milling and overlays instead of overlays

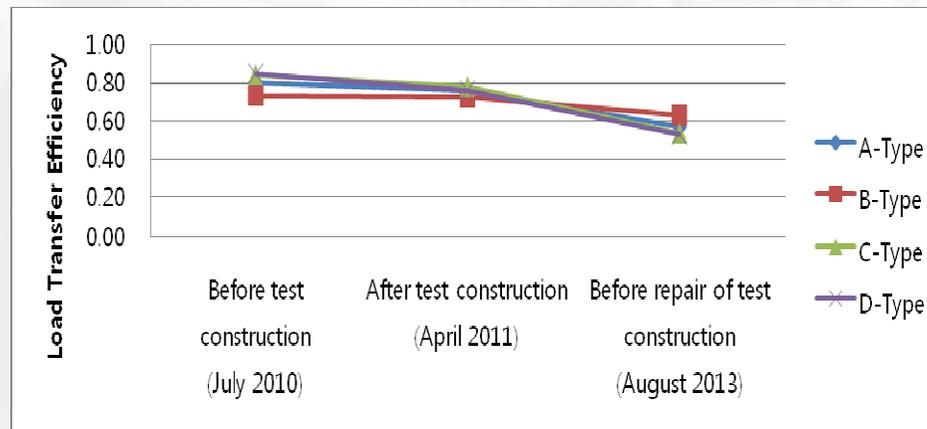
Decline of the load transfer efficiency

- decreased considerably in contrast to the before test construction
- The decline of B-Type was smaller than the other type

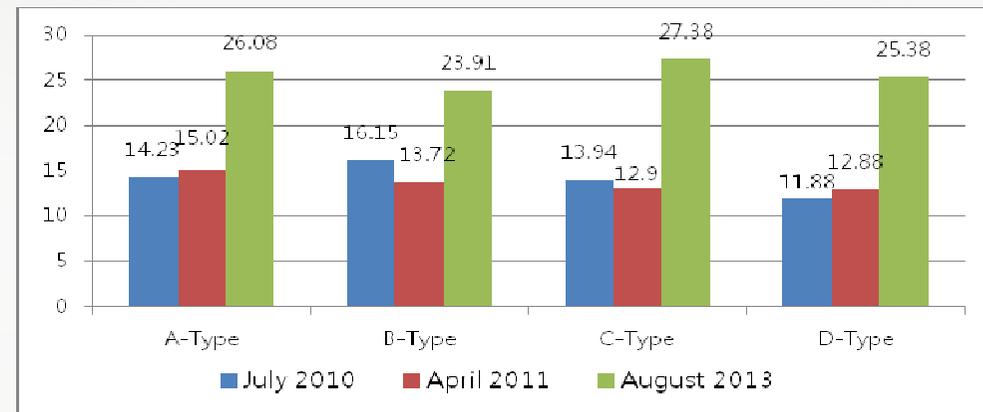
Do deflection data

- B-Type deflection was recorded the highest as 16.15 mils when measuring in April 2011
- The lowest as 23.91 mils when measuring in August 2013

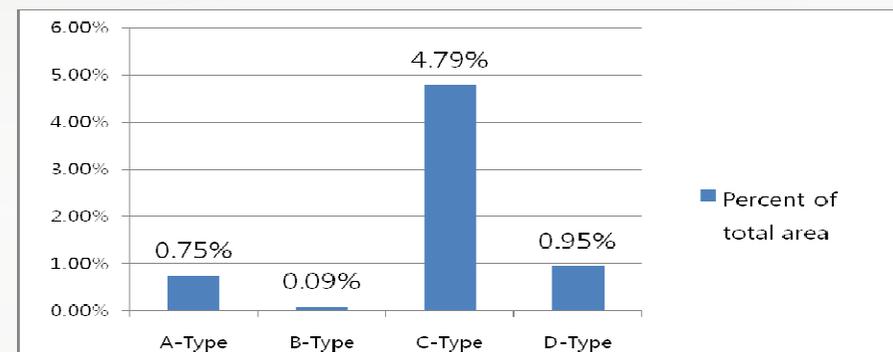
Repair rate in the deteriorated section

- B-type was the lowest repair rate than the others
- B-type strong against rutting and fall slightly against top-down cracks
