ALKALI-SILICA REACTION IN CONCRETE PAVEMENT AT GIMPO INTERNATIONAL  
AIRPORT – A MAINTENANCE CASE STUDY USING HMA OVERLAYS

PRESENTED FOR THE  
2014 FAA WORLDWIDE AIRPORT TECHNOLOGY TRANSFER CONFERENCE  
Galloway, New Jersey, USA

AUGUST 2014

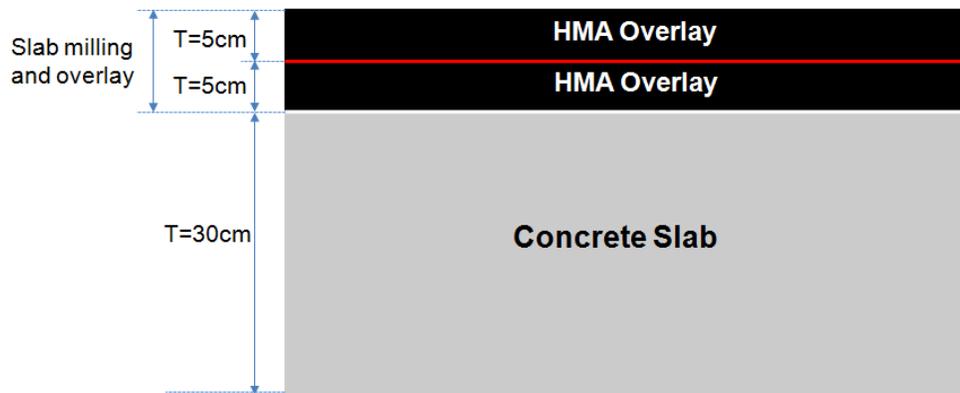
Figure 9. A-Type structure

A-Type test construction was paved and compacted using the general asphalt mixture, adding T=5cm thick pavement twice after milling the existing concrete pavement less than 10cm depth and no additional reinforcing material was used. The airfield lighting was removed before the construction and reinstalled at the designated place after taking coring. B-Type used CRM (Crumb Rubber Modified) asphalt mixture and construction procedure is equal to the A-Type.

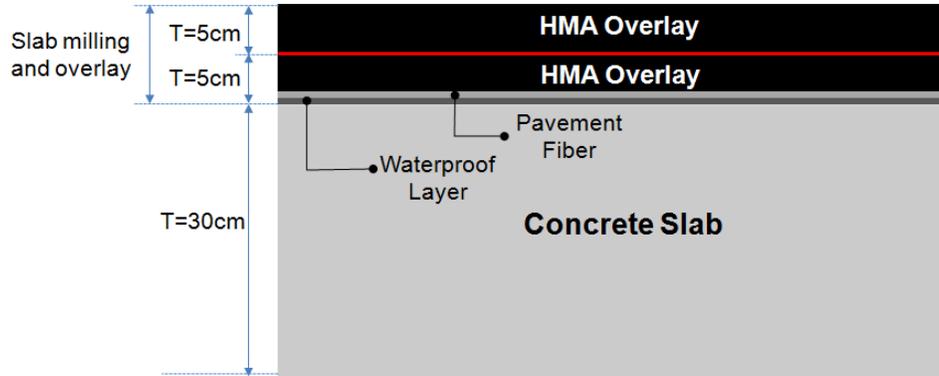
Figure 11. C-Type pavement cross section

C-Type test construction was paved and compacted using the general asphalt mixture, adding T=5cm thick pavement twice after milling the existing concrete pavement as much as 10cm depth and reinforcing material consisting of pavement fibers and waterproof adhesive were used. The C-Type procedures for removing the airfield lighting system, paving asphalt and compacting asphalt are not different from the ones of A-Type.

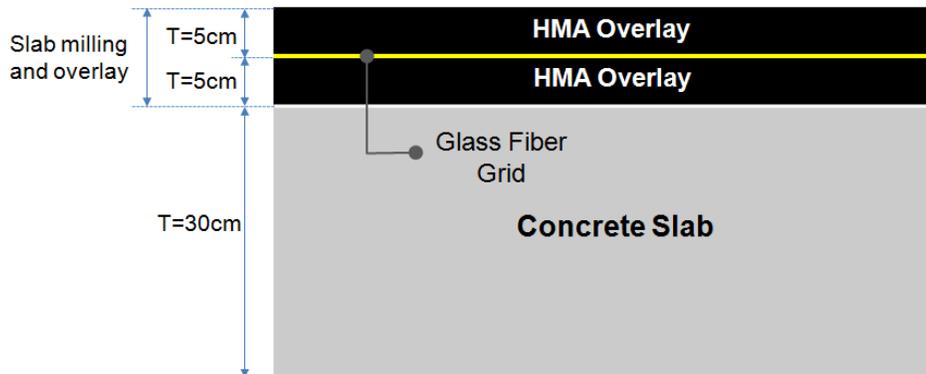
Figure 13. D-Type pavement structure

D-Type test construction was paved with glass fiber Grid within the general asphalt mixture after milling as much as 10cm depth and paving and compacting the first 5cm lift of asphalt mixture and then covered with asphalt mixture and compacted as much as T=5cm pavement thickness. The procedures for removing the airfield lighting system, pave asphalt and compact asphalt are equal to the ones of A-Type.

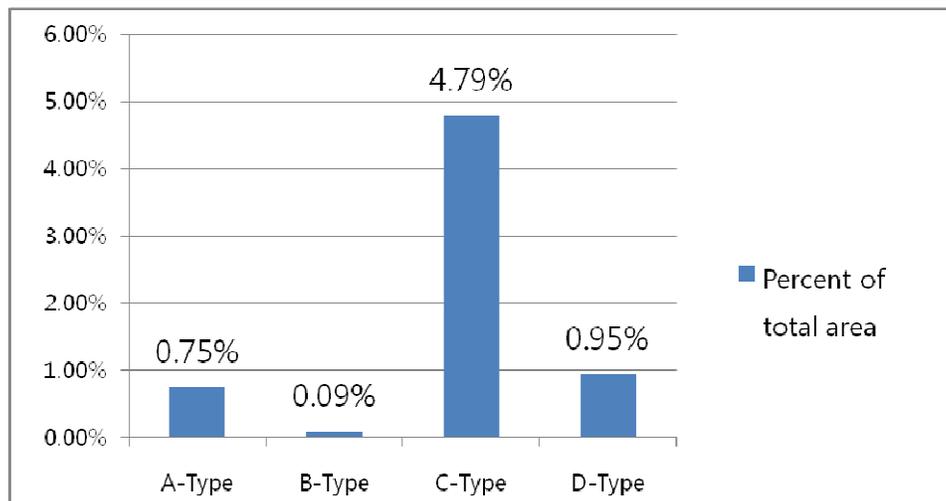
Figure 17. Maintenance area rate at each method within 36 months in service

As for the result of HWD test, Load transfer efficiency was decreased considerably in contrast to the before test construction. The decline of the C-Type and D-Type was larger than the other types, thus requiring a large number of repair works. The decline of B-Type was smaller than the other type, and this type required the least amount of maintenance. According to this result, it is estimated that the damaged slabs around the dowel bar at joints were assumed to be deteriorated further because of the ASR. The discovery that the dowels were too high in the pavement may have lost contact when the slabs were thinned.

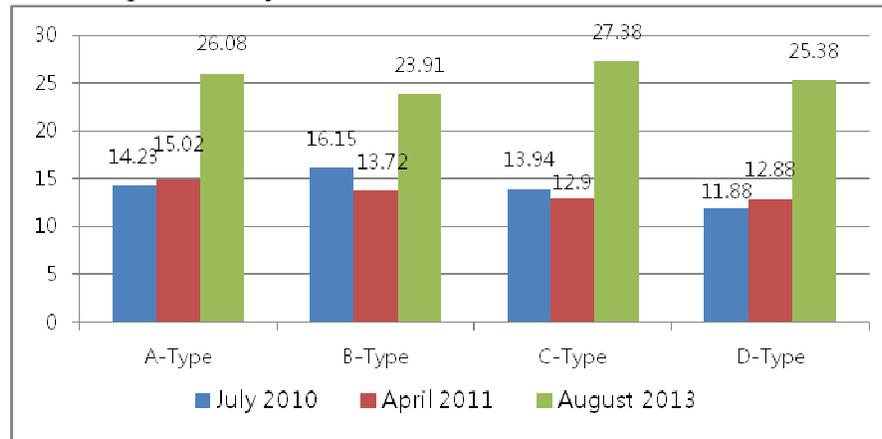
Figure 19.  $D_0$  deflection data (load : 45,399LBS, unit : mils)

On the joints as shown in figure 18, the value of  $D_0$  deflection measured before repair of test construction in 2013 increased far more than before test construction in 2010 after the repair of test construction 2013, B-Type deflection was recorded the highest as 16.15 mils when measuring in April 2011, but the lowest as 23.91 mils when measuring in August 2013. Also the A, C and D-Type recorded relatively high increase rate of deflection when measuring in August 2013 compared with other time. As a result of that, it is assumed that the structural weakened slabs were attributed to developing potholes. In fact B-type area had less longitudinal cracks than other types before the repair overlay.

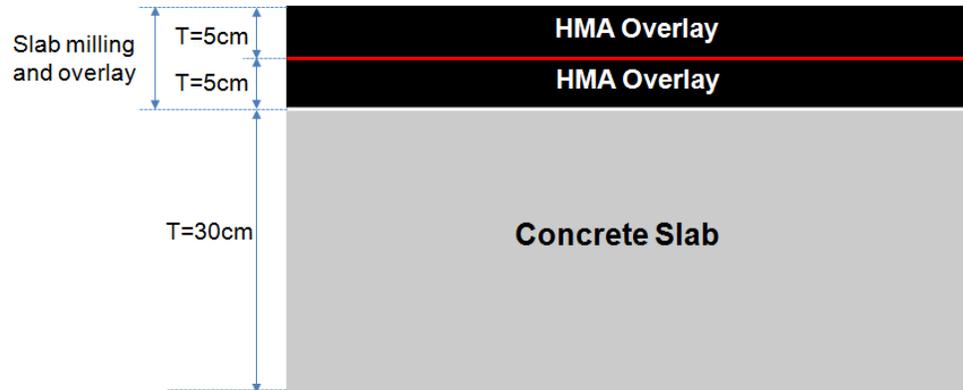
Figure 20. Second Repair pavement structure

As for the main reason of the premature defects, it is estimated that there is a limit for HMA overlay to protect rainfall infiltration. And especially, milling and overlay method on the impermeable concrete slabs will make the occurrence of premature defects inevitable such as the parallel delamination and potholes on the high tire pressure of the aircraft. Therefore, repair work was implemented by using Polymer Modified SMA in September 2013. The Polymer Modified SMA (Stone Mastic Asphalt concrete) can be effective in preventing rutting while reducing air void. The second test construction was paved and compacted using SMA, adding T=5cm thick pavement twice after milling the existing overlay pavement of 10cm depth. The second overlay was each consisted of 13mm and 10mm maximum size of coarse aggregate.

- Asphalt binder: SBS Polymer Modified Asphalt(PG 76-22)
- maximum size of coarse aggregate: 13mm (t=5cm) + 10mm(t=5cm)
- Repair area: width 16m of the wheel path area that have potholes

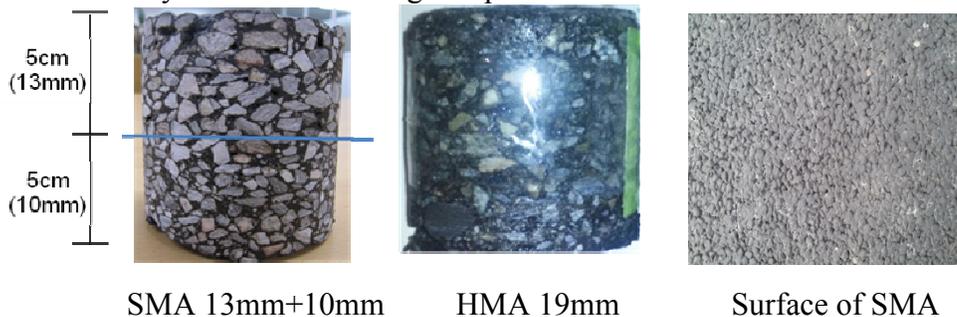
Figure 22. Comparison of core sample with SMA and HMA

In the result of material property test after 3 months of performance period, void of upper SMA 13mm layer was 5.1~6.6% and void of the under layer SMA 10mm was 3.3~3.8%. This result shows that the basic characteristic of SMA material is more resistant to rutting and better prevents rain infiltration from beginning of the construction. Therefore SMA is expected to be more efficient to delay reflective cracking and pothole occurrence.
