**HEAVING OF AIRFIELD PAVEMENT  
AT  
HONG KONG INTERNATIONAL AIRPORT**

Presented for the  
2007 FAA Worldwide Airport Technology Transfer Conference  
Atlantic City, New Jersey, USA

April 2007

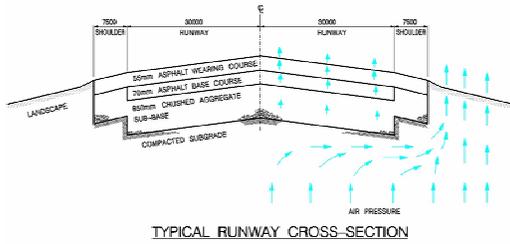
Figure 5 - Air flow during Dry Weather

A detailed review of the tidal record indicated that all of the heaving incidents occurred during a rapidly rising “ Spring” tide and after continuous heavy rainfall for a few days. Spring tides are associated with either a full moon or new moon and are the highest tides of the monthly cycle. A high tide is associated with a rapid rate of rise tide approximately 3 hours before the actual high tide. Site measurement revealed that the water level during a rising tide was almost 5 meters below the pavement surface, the heaving caused by direct tidal water force was also ruled out. After review of the combined tide and rainfall record, followed by site measurement and laboratory soil testing, the investigation concluded that the pavement heaving was caused by the build-up of air pressure underneath the pavement due to the rising tide and blockage of free air flow in the saturated capping sand layer. Under dry weather, a rising tide would push the air in the void below the geotextile up through the relatively permeable sand capping and this air would escape slowly through the pavement layers or through the landscaped areas. (Figure 5) During periods of heavy rain a perched water table built up within the sand capping layer directly above the geotextile and the soil in the landscape area was saturated with rainwater. The air permeability in the saturated soil was reduced. [1]

The wetting of the surface of the MAWC also reduced the air permeability of the asphalt pavement and its ability to dissipate air pressure. The rapidly rising tide pressurized the trapped air in the air voids in the granular layer beneath the pavement and caused the heaving. (Figure 6) Calculations indicated that a pressure of 3 kPa would lift a 125 mm full thickness pavement (wearing course and base course) and a pressure of 1.2 kPa would lift a 55 mm pavement. (debonded wearing course or shoulder pavement)
