**POLYMER CONCRETE MICRO-OVERLAY
FOR FUEL AND ABRASION RESISTANT SURFACING:
LABORATORY RESULTS AND FIELD DEMONSTRATIONS**

**By
Kent Newman, PhD
and
James E. Shoenberger, PhD**

**US Army Engineer Research and Development Center
Vicksburg, Mississippi, USA**

**PRESENTED FOR THE 2002 FEDERAL AVIATION ADMINISTRATION
AIRPORT TECHNOLOGY TRANSFER CONFERENCE**

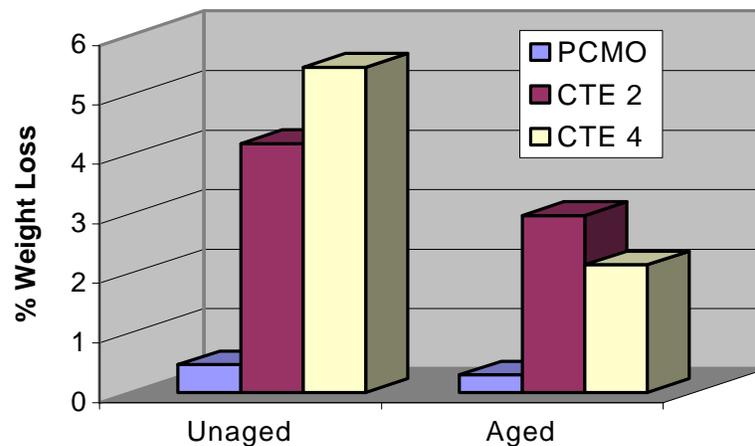
The results of the abrasion testing indicate that the unsealed PCMO material is approximately 8 to 10 times more abrasion resistant than a standard coal tar emulsion. The sealed PCMO is approximately 2 times more abrasion resistant than the CTE. The difference between the sealed and unsealed PCMO indicates that the surface sealer is abraded more rapidly than the PCMO base. Although the abrasion resistance of the CTE's is higher after aging due to embrittlement, it is well documented that these materials exhibit severe “chicken-wire” or “map” cracking with age and must be resealed every 2-5 years (Shoenberger, 1993 and Saraf et al., 1992). There is no statistical loss in abrasion resistance after aging of the PCMO material.

Figure 1. Abrasion resistance of PCMO compared to coal tar emulsion using a modified form of the wet track abrasion test.
