DOT/FAA/TC-12/48

Aircraft Skin-Penetrating Nozzle Testing of a Freighter Aircraft Cargo Liner

December 2012

Final Report

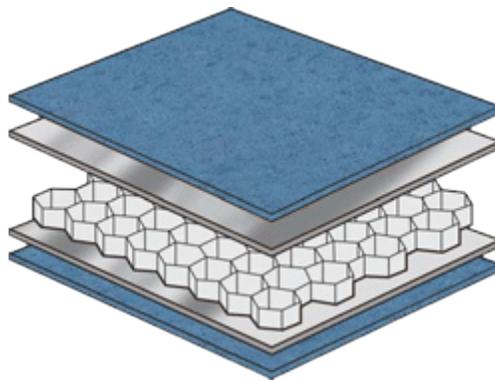
Cargo compartment liners are one of two types of composite laminate panels. The first type of laminate is a thick composite sandwich that typically combines fiberglass or polymer fabric outer laminate layers over a core panel made from an aluminum honeycomb, a resin-coated polymer fabric honeycomb, or a plastic foam. Figure 1 illustrates the construction of a honeycomb panel. The core provides the rigidity necessary for decompression compensation. The second type of cargo liner lacks the stiff core, making it thinner, lighter, and more flexible. It has the appearance of a thin, flexible, plastic-covered fiberglass sheet versus a stiffened panel. It is common to use modified polyester resin to construct cargo liner. Phenolic resin is also available, though its relatively higher cost reduces its demand.

Figure 1. Honeycomb Panel Structure [5]

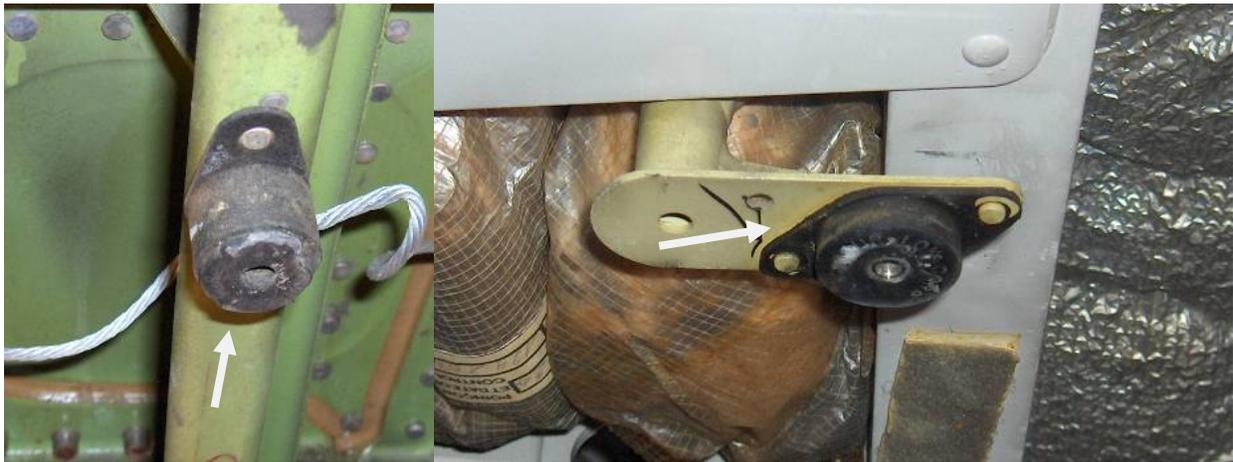
The cargo liner in freighter aircraft mounts to a lightweight frame [10] that holds the cargo liner in place while adding minimum weight to the aircraft. This nonstructural frame attaches to the aircraft frame through various brackets and fasteners. Some are solid brackets held in place with rivets, and others fasten to vibration isolation nuts held in rubber mounts riveted to the frame. Other fasteners, such as Hi-Lok® fasteners or Cherrymax® blind rivets, are sometimes used, but these are mainly for repairs and locations where it would be difficult to use solid rivets. The cargo liner framework is not a main, load-bearing, stressed structure, so the lightest weight hardware that can handle normal wear and tear is usually used. The full-scale tests described in this report used standard, aircraft supply, aluminum, solid-flush rivets, as well as steel nutclips, screws, and fender washers. This test did not include vibration-isolation hardware, which is discussed briefly in section 4.2 and shown in figure 2.

Figure 2. Rubber Vibration-Isolation Hardware

Although not used in this test, note that the cargo liner is sometimes fastened to the airframe with rubber anti-vibration or anti-noise mounts, as shown in figure 2. However, the stress resistance of an elastomer mount (figure 2) would be equal to or less than that of aluminum fasteners, and the heat resistance could be considerably less. The failure of mounting hardware observed under the stronger conditions of all-aluminum construction would happen faster with elastomer mounts. Furthermore, elastomer hardware attaches to the airframe with aluminum fasteners, which become the point of failure even if the rubber does not deteriorate from heat or if the hardware was designed to maintain integrity with rubber failure.

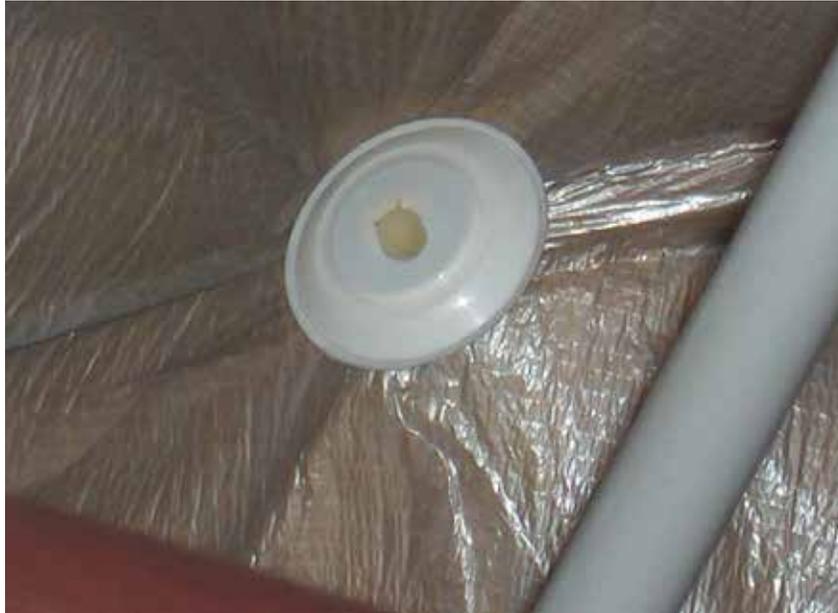
AN-4C polymer moisture barrier forms an insulation blanket assembly. Plastic pins attached to the stringers or frame, shown in figure 3, hold the insulation blanket in place in production aircraft. These protrude through the insulation blanket, then metal or plastic clips slide over the pins to keep the insulation blanket in place. The test used plastic zip ties to hold the insulation blankets instead of plastic pins because of ease of installation and similar plastic material properties used for the clips and zip ties.

Figure 3. Plastic Insulation Retention Pin and Clip

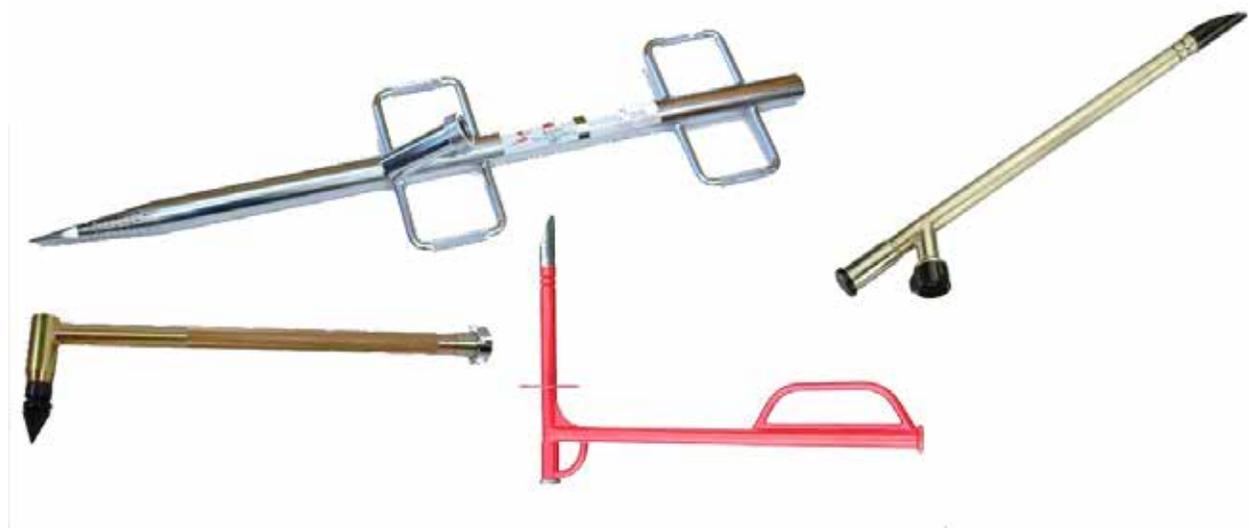
Unpowered penetrating nozzles are impact driven and are available in battering ram, spike, and hammer styles, as shown in figure 4. Battering ram style penetrators have large, looped handles and hammer hit plates. The simple spike penetrating nozzles do not have the looped handles; they hammer inward. Both the battering ram and simple spike styles have hose connections at an angle to the main body of the nozzle and can flow about 125-300 gallons per minute (GPM), depending on size and model. Some can be fitted with extension tubes to give further reach inside the aircraft. Hammer-style penetrating nozzles, marketed primarily for structural firefighting, can have some limited use in fighting aircraft fires. Hammer-style penetrating nozzles can flow at about 80-100 GPM.

Figure 4. Examples of Unpowered Penetrating Nozzles

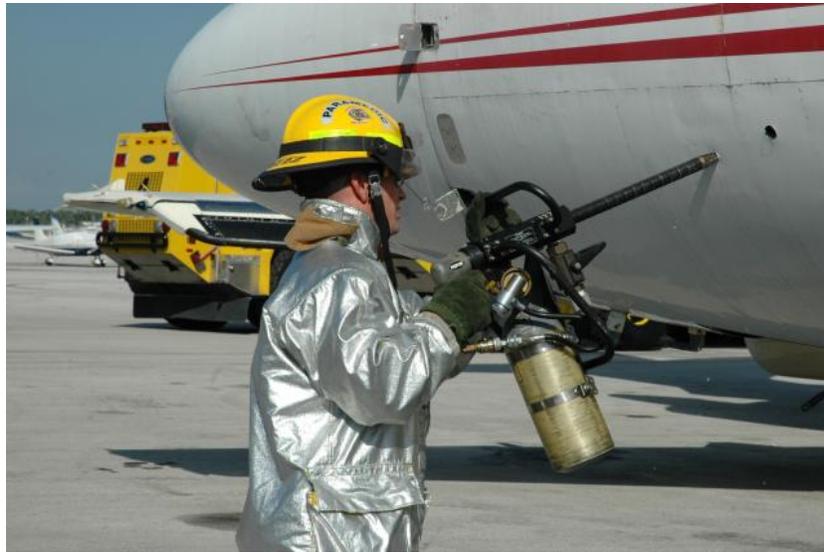
The SPAAT pneumatic rotary tool, shown in figure 6, can flow about 100 to 150 GPM of firefighting agent. A hollow-bit pneumatic drill dispenses firefighting agent through the body of the drill. Pneumatic power is provided either by an on-site air compressor or by a portable compressed gas bottle. Bits are changeable to provide a different pattern of holes for use with each type of agent.

Figure 6. Firefighter Training Using a SPAAT [11]

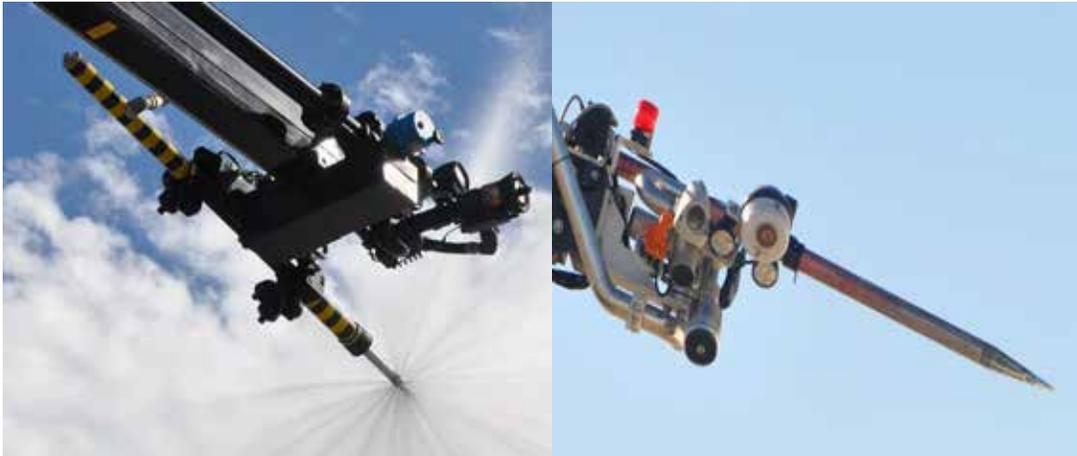
The ASPN is a firefighting nozzle mounted on the HRET of a fire apparatus. The HRET allows the fire apparatus operator to extend nozzles, cameras, and other equipment out to and above different parts of the aircraft. The ASPN penetrates the aircraft skin to deliver firefighting agent to the aircraft interior. It consists of a conical nozzle attached to the HRET and is equipped with a solid-steel, sharpened ASPN tip. Figure 7 shows two basic ASPN models: the Stinger[®] (left)

and Snozzle[®] (right). Both models are capable of flowing 250 GPM of water or foam agent through the piercing nozzle. The main difference between the two models is the method of aircraft penetration. The Stinger[®] hydraulically thrusts the ASPN in quick succession through the aircraft skin, and the Snozzle[®] uses the force provided from the boom to penetrate the skin of the aircraft slowly.

Figure 7. The ASPN System Models: Stinger[®] (left) and Snozzle[®] (right)

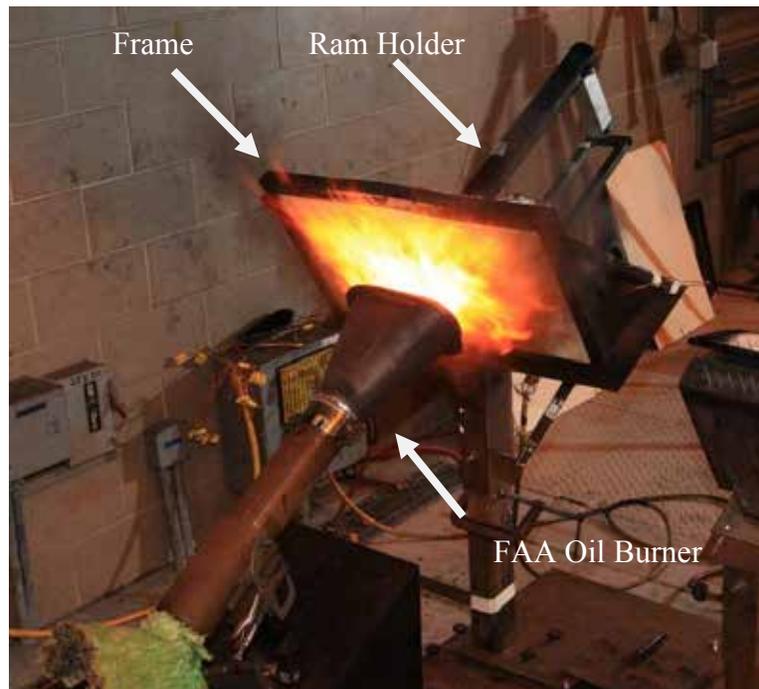
Performance of initial small-scale scoping tests helped to observe the behavior of heated cargo liner material when penetrated. These test results determined important test parameters for the full-scale testing. The small-scale tests were conducted at the FAA's Materials Fire Test Laboratory. The test apparatus used was the FAA's 2-gallon-per-hour, oil-fired burner and the frame that holds the test felt used to compare burner performance, as shown in figure 8. The cargo liner was attached to the inner frame with hardware of similar gauge to that used in the full-scale tests. A square tubular steel frame held the hydraulic ram that forced the penetrating nozzle through the cargo liner.

Figure 8. Small-Scale Test Setup

Preliminary tests verified the hydraulic ram setup (figure 8) would allow the ram to penetrate through the plane of the cargo liner as mounted in the frame. The ASPN passed far enough through the cargo liner sample to reach the full diameter of the ASPN. Penetration past this point would cause the ASPN to interfere with or impact and damage the burner in some test configurations. The penetration rate differed from an actual HRET/ASPN application, but this was determined to be acceptable due to variation from individual aspects of each situation, i.e. from variation in apparatus, penetration angle, how the operator performs the penetration, ASPN type (Snuzzle versus Stinger), hand versus powered penetration, etc. Both blunt and sharp tips were tested to determine whether ASPN tip wear would affect penetration.

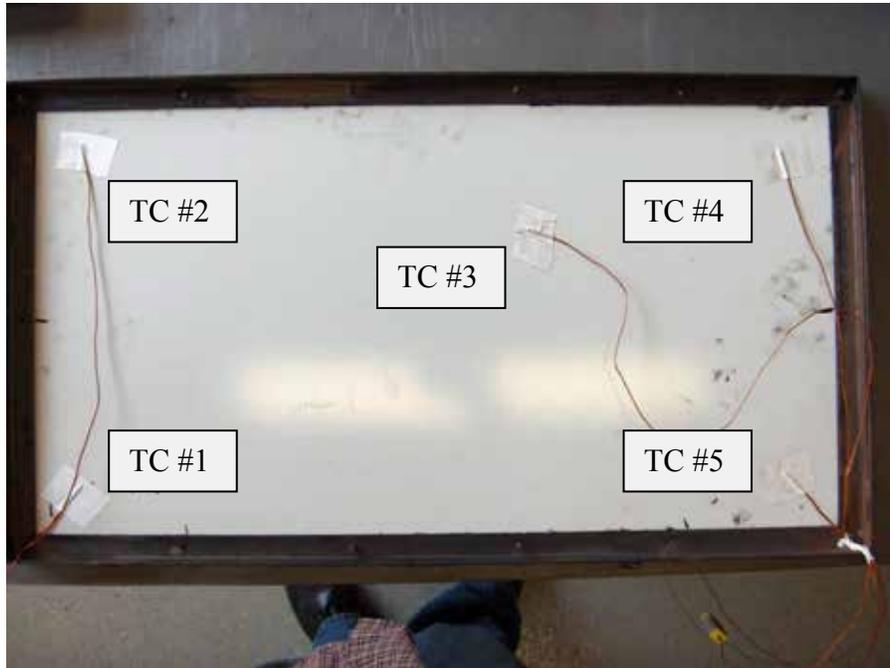
shown in figure 9 monitored temperatures. Thermocouple (TC) #3 was located near the point where the ASPN tip penetrated the material. Providing slack in the thermocouple leads and taping down the thermocouple ends with fiberglass tape reduced the occurrence of thermocouples detaching from the samples during the test.

Figure 9. Small-Scale Thermocouple Placement

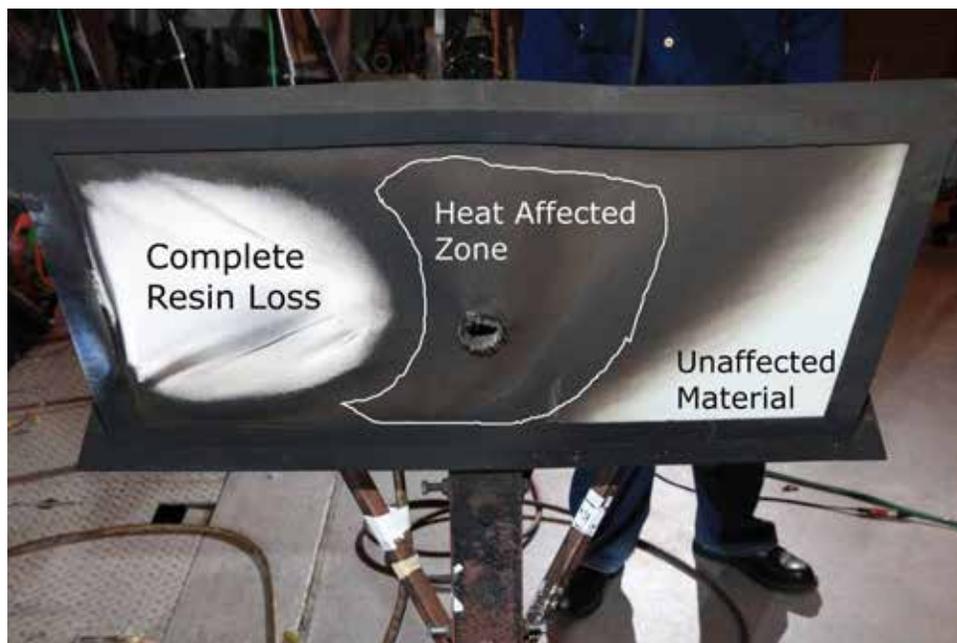
After observing these tests, exposures for subsequent tests were determined. Observations of the cargo liner delamination and discoloration locations relative to the burner centerline led to offset burner testing. This located the ASPN in the center of the heat-affected zone, as shown in figure 10. This zone marks the transition between unchanged cargo liner and the area of full delamination and complete resin loss. The gas pressure from resin decomposition products that is trapped between the fiberglass layers causes partial delamination. This pressure pries apart the layers in the cargo liner. Bare fiberglass cloth remains in areas where the resin completely burns away and can still function as a fire barrier.

Figure 10. Offset Burner Heat-Affected Zones

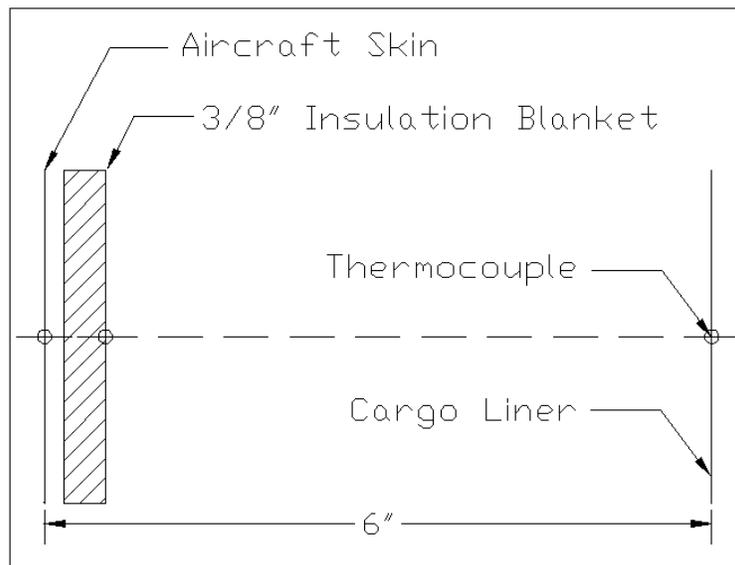
The full-scale test article was located in the aft section of a Douglas C-133 fuselage. Thermocouples collected data from two frame sections—one in the penetrated section and one in the adjacent section. The thermocouples were screwed to the interior surface of the aircraft's skin, placed on the interior face of the insulation blanket, and taped onto the backside of the cargo liner, as shown in figure 11.

Figure 11. Thermocouple Placement Diagram

The thermocouple locations are numbered from bottom to top: TC 1-8 on the fuselage, TC 9-16 on the insulation, and TC 17-24 on the cargo liner. Thermocouples also were placed on the interior surface of the cargo liner in tests 8-13, and data was collected with additional equipment. Interior temperatures were monitored but not recorded in previous tests by on-site personnel. Interior thermocouple positions are shown in figure 12.

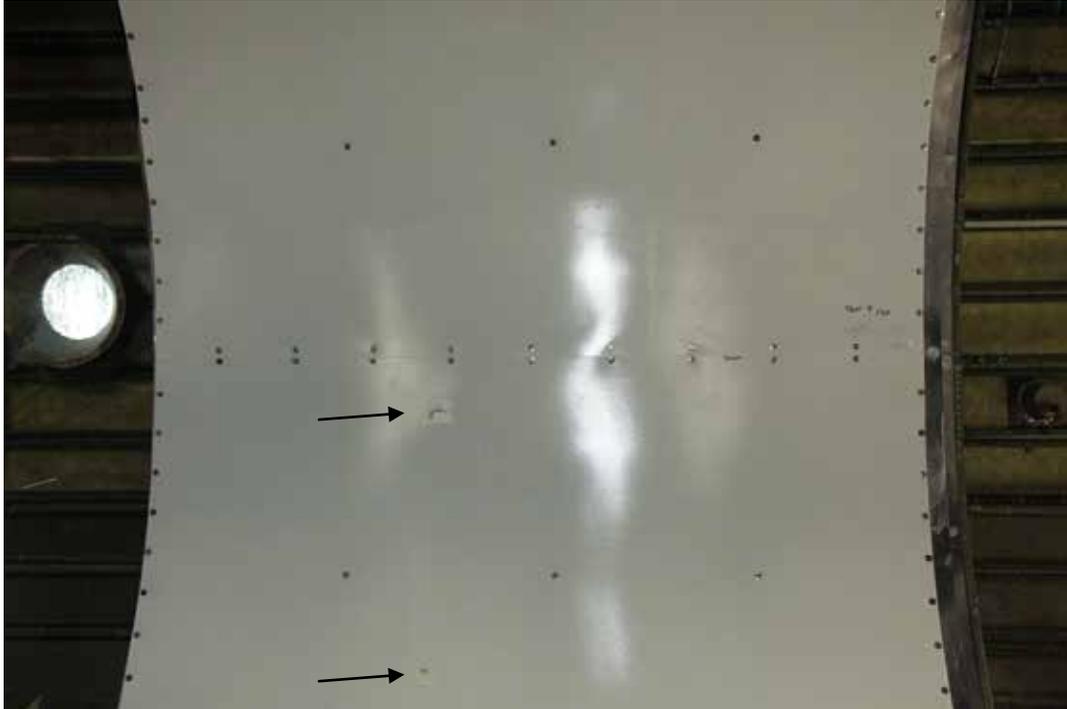
Figure 12. Location of Interior Thermocouples

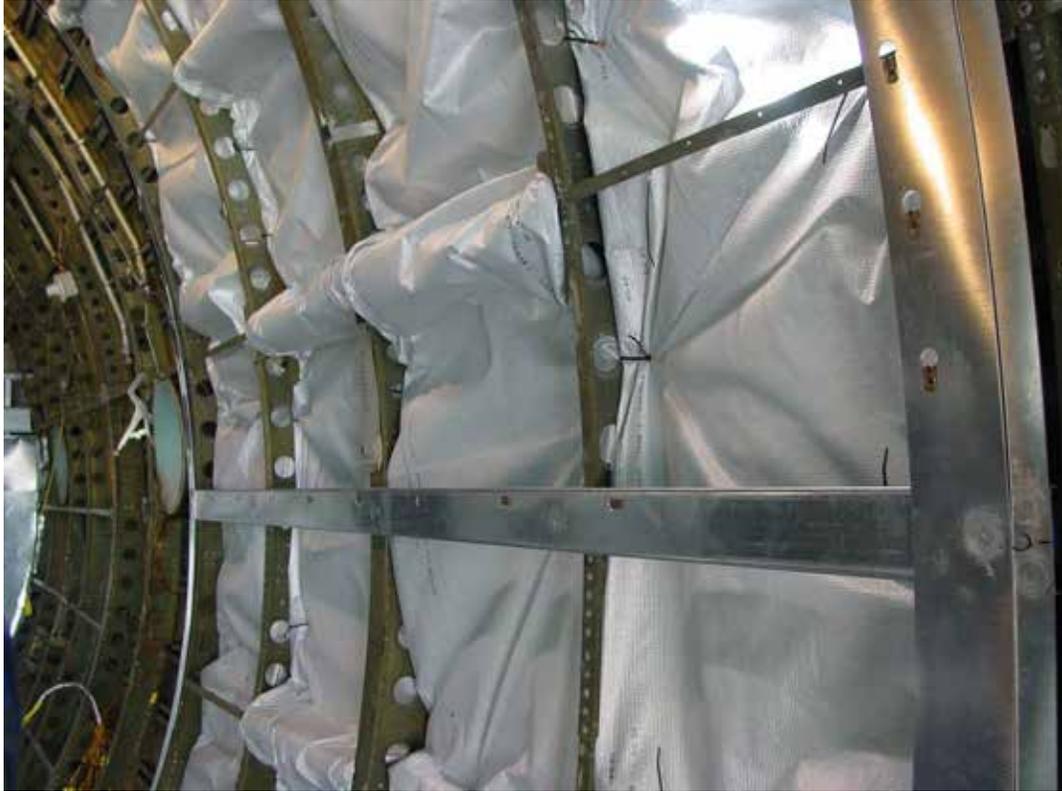
The test section was four frames wide to reduce edge effects that could occur from the discontinuous nature of only partially lining the test fuselage, rather than fully lining the fuselage as is done with normal aircraft. The installed assembly was complete including thermal insulation, cargo liner, and hardware in accordance to current aircraft, as shown in figure 13.

Figure 13. Test Section With Insulation Blankets and Framing Installed

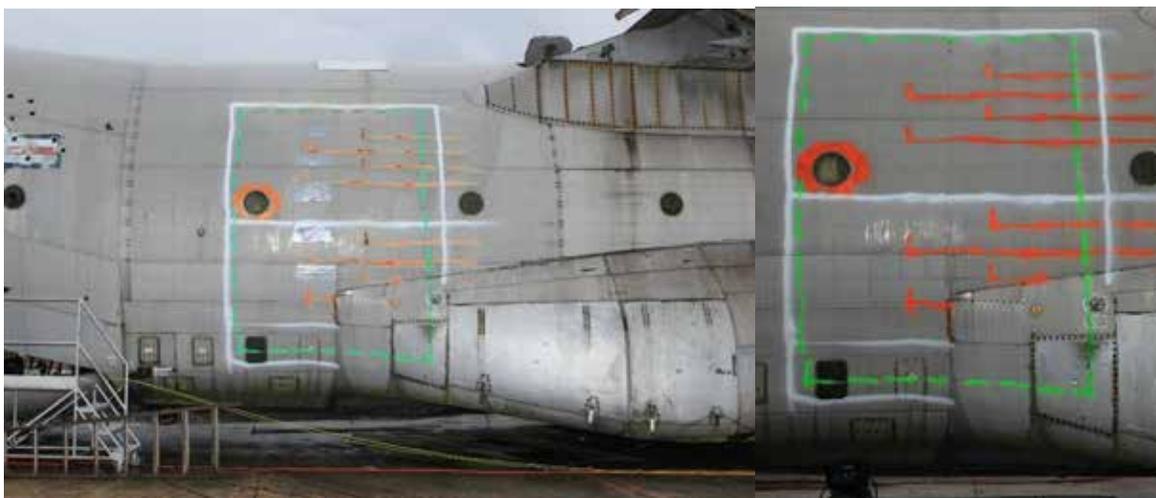
Figure 14 shows the exterior view of the test section. Color-coded fluorescent commercial construction marking paint was used to note the locations of the thermocouples and mounting hardware to the ASPN operator. Holes made at the penetration points were reused during each test to minimize variation from test to test. When wind and weather conditions dictated, gray cloth tape sealed the holes in the skin.

Figure 14. Test Section Exterior With Marking Detail

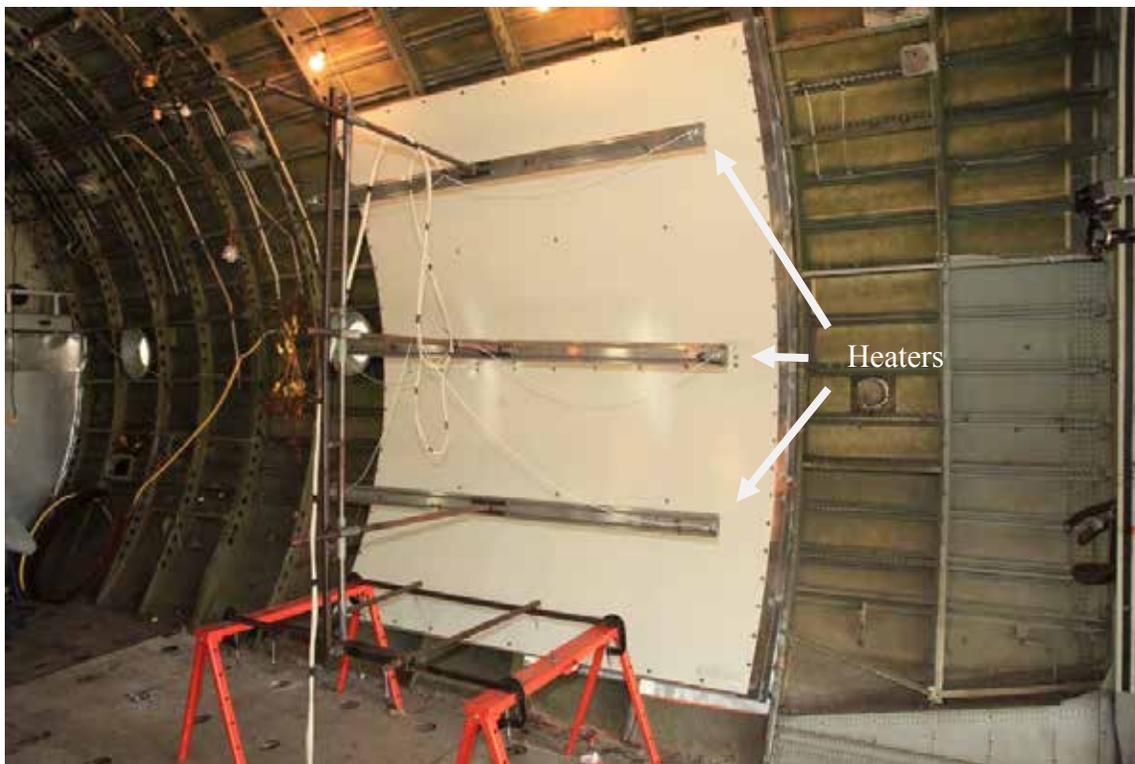
Three runs of each test occurred in the sequence of unheated, radiantly heated, and two fire heated scenarios. The radiant tests used an array of three 7.2kW electric heaters, as shown in figure 15. The heaters were approximately 18 inches from the cargo liner surface. This located them close enough to heat the cargo liner but kept them out of reach of the ASPN.

Figure 15. Electric Heaters in Place in Front of Test Section

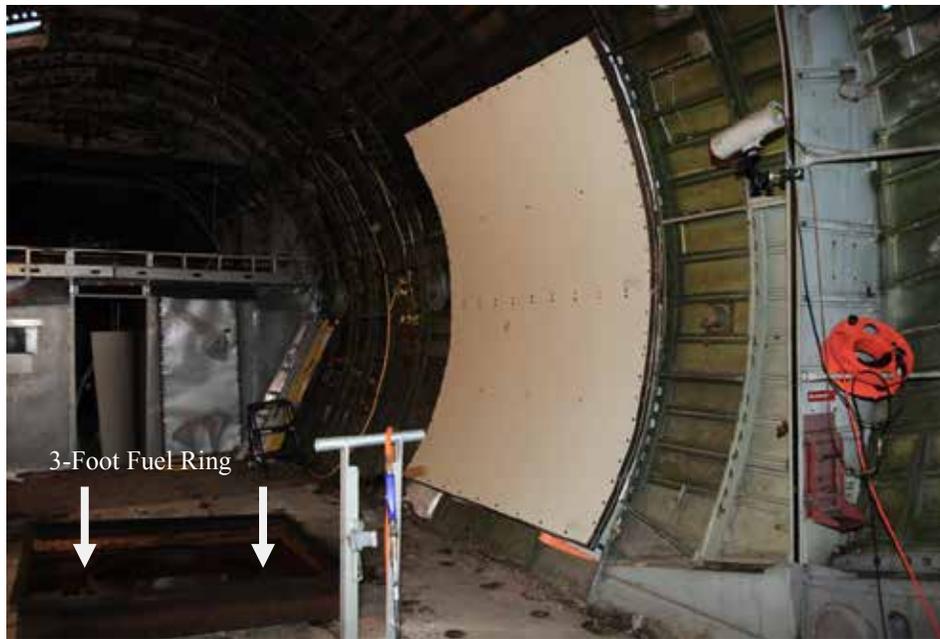
The fire tests used a pan fire within a 3-foot ring located 32 inches away from the cargo liner, with Exxon Mobile Corporation's Tekflame[®] used as the test fuel. This setup is shown in figure 16. Figure 17 shows the warm-up portion of the test. Penetration started once the cargo liner's backside reached the same temperatures of the small-scale tests.

Figure 16. Full-Scale Test Section Ready for Fire Heating

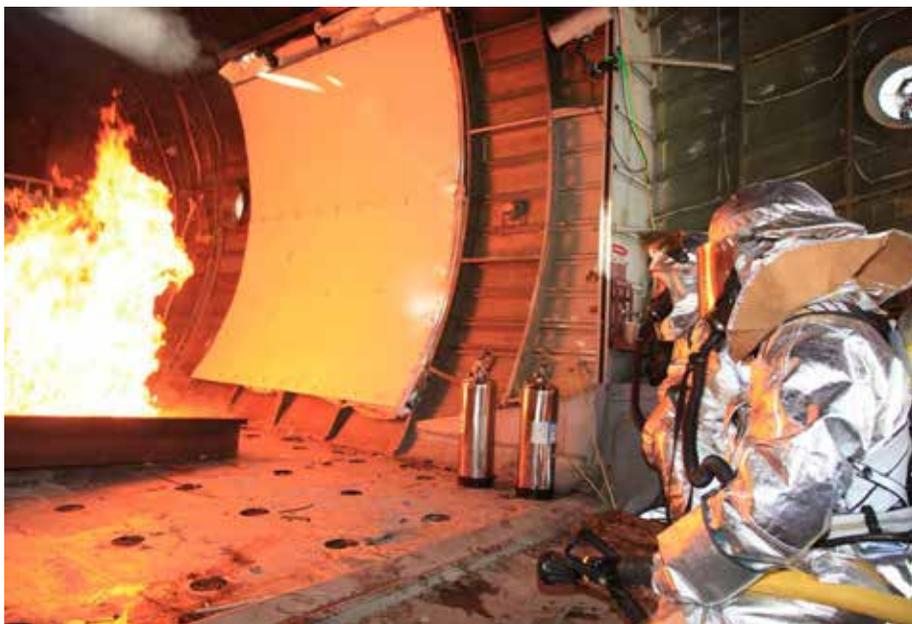
Figure 17. Fire Test

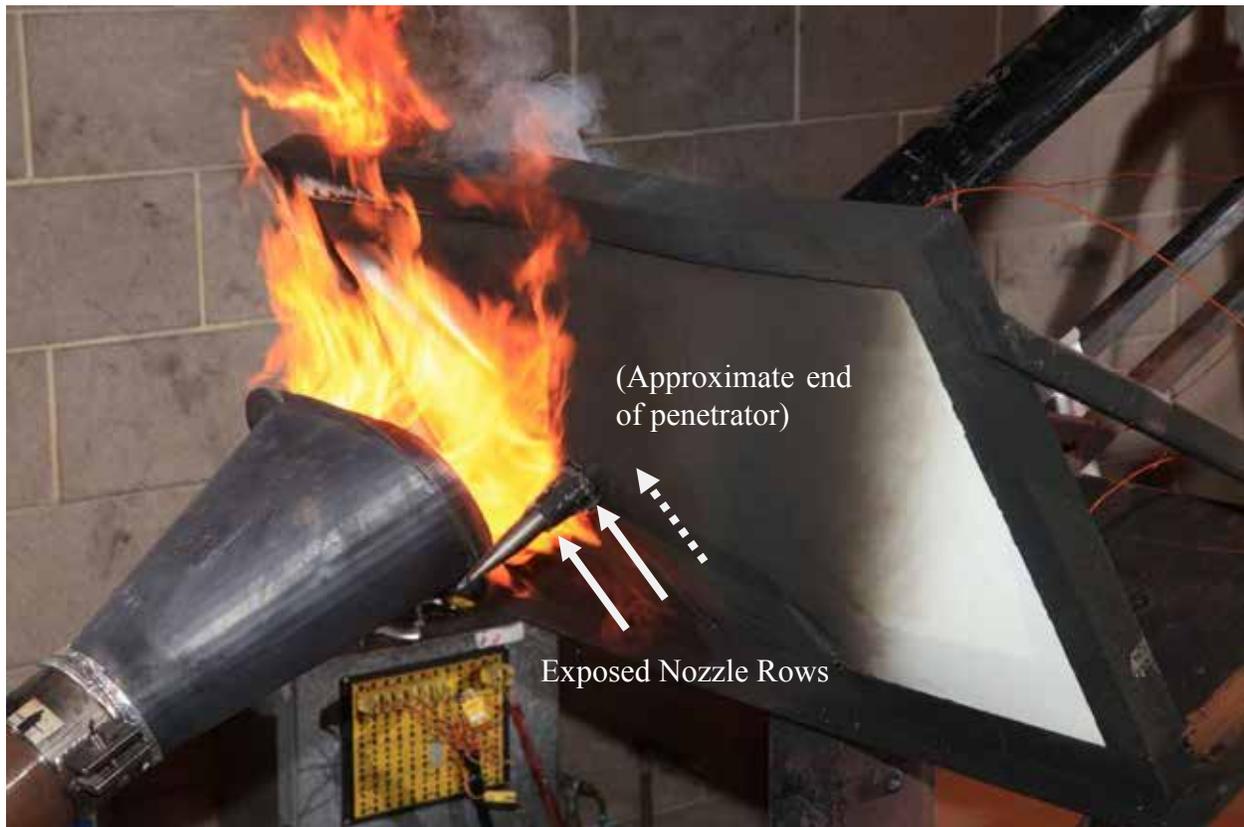
The tabulated results for the small-scale tests are listed in table 1. Ambient tests showed that unheated cargo liner provided little stretch or deflection, and once the cargo liner was initially penetrated, 67% of the nozzle holes were unobstructed by the cargo liner. Heated tests showed that, in some instances, the added softening and deflection caused enough flex in the cargo liner to obstruct between 56%-78% of the nozzle holes and have them remain on the backside of the cargo liner. This is evident in the small amount of penetration that occurred in the offset test shown in figure 18. The dashed arrow in figure 18 indicates the approximate end of the ASPN. The solid arrows indicate the nozzle holes that protrude through the cargo liner.

Figure 18. Incomplete Penetration During Heated Test

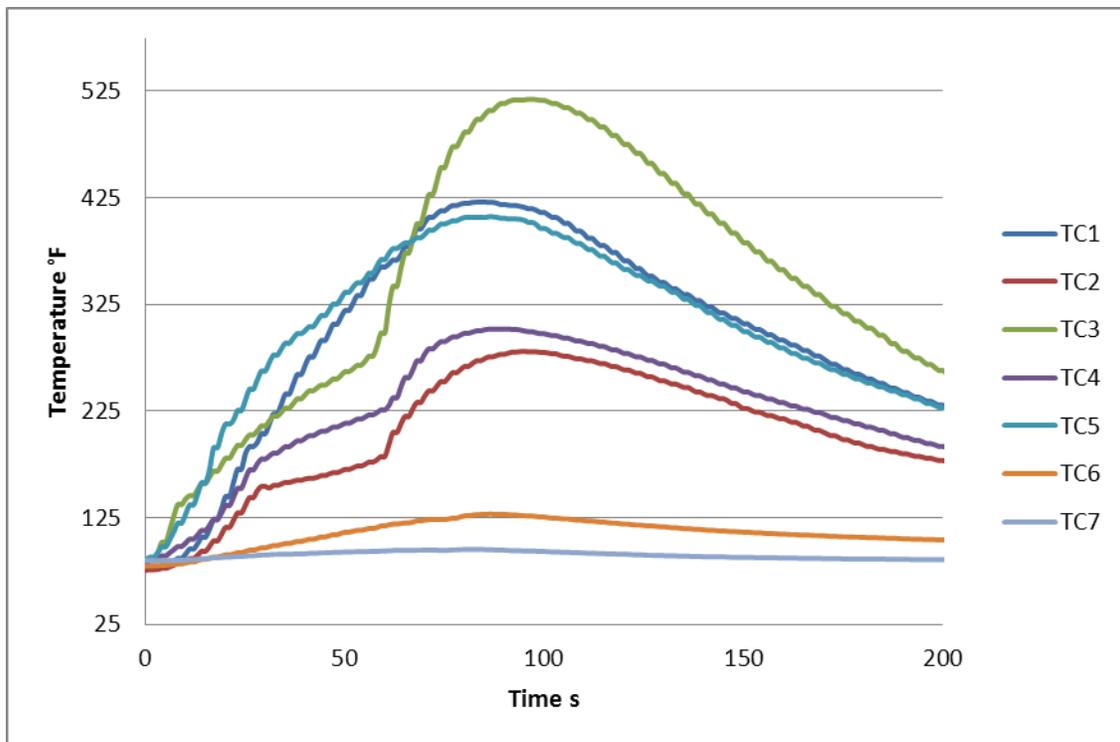
Figure 19. Small-Scale Cargo Liner Test 10 Backside Temperatures

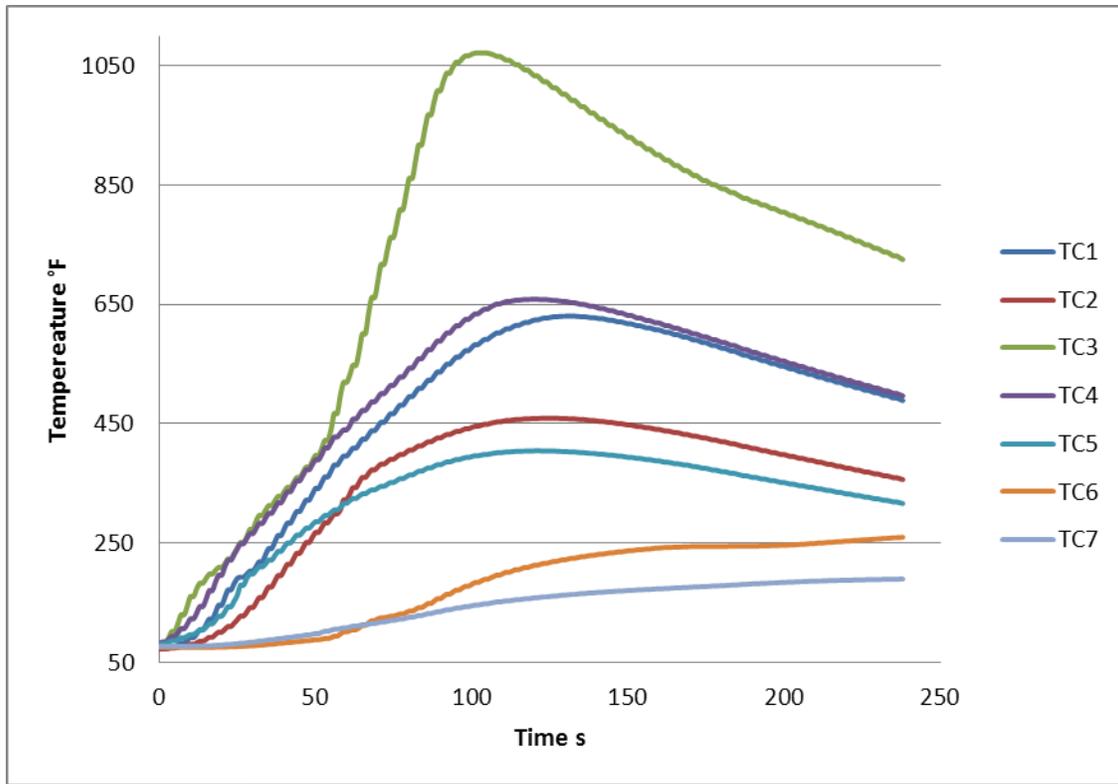
Figure 20. Small-Scale Cargo Liner Test 17 Backside Temperatures

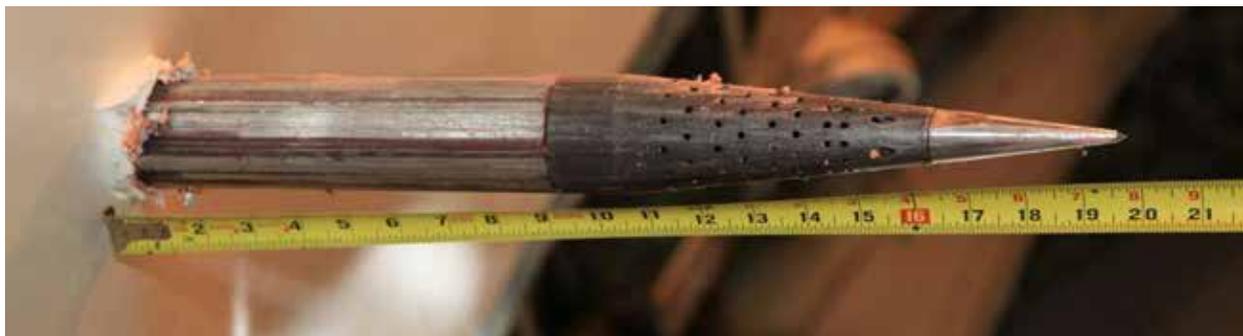
The ambient tests showed that intact and unheated cargo liner provided little resistance to penetration. The cargo liner did not bow or stretch significantly. The mounting hardware remained intact and kept the cargo liner close to the hull even after repeated penetrations. Figure 21 shows that the nozzle fully penetrated into the interior of the fuselage without any problem.

Figure 21. Complete Penetration During Ambient Test

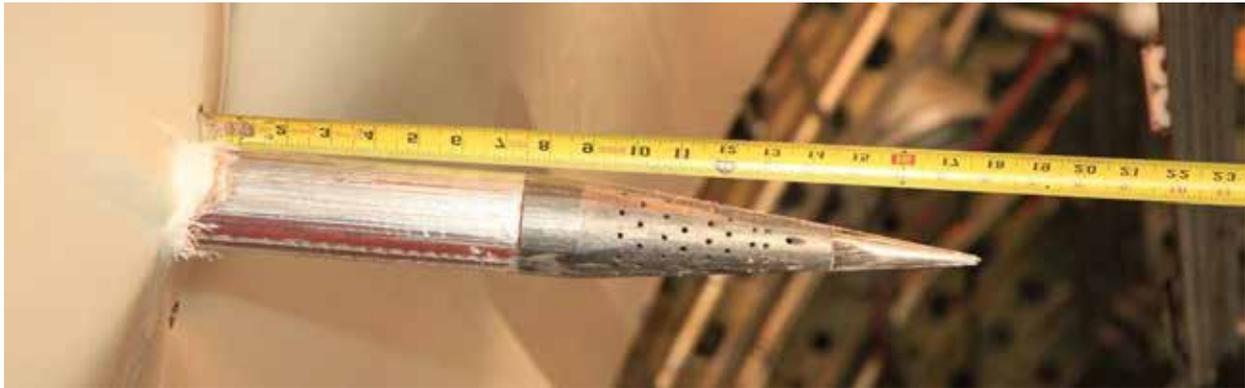
penetration sometimes bent the washers that attached the cargo liner to the mid-field support brackets. The brackets themselves were slightly bent, but remained attached to the aircraft. There was no significant damage where the cargo liner attached to the horizontal and vertical strips of the mounting frame. There was also no significant damage in the cargo liner, the washers, or the mounting frame. The cargo liner stretched slightly, but not enough to prevent penetration, as shown in figure 22.

Figure 22. Complete Penetration During Radiant-Heated Test

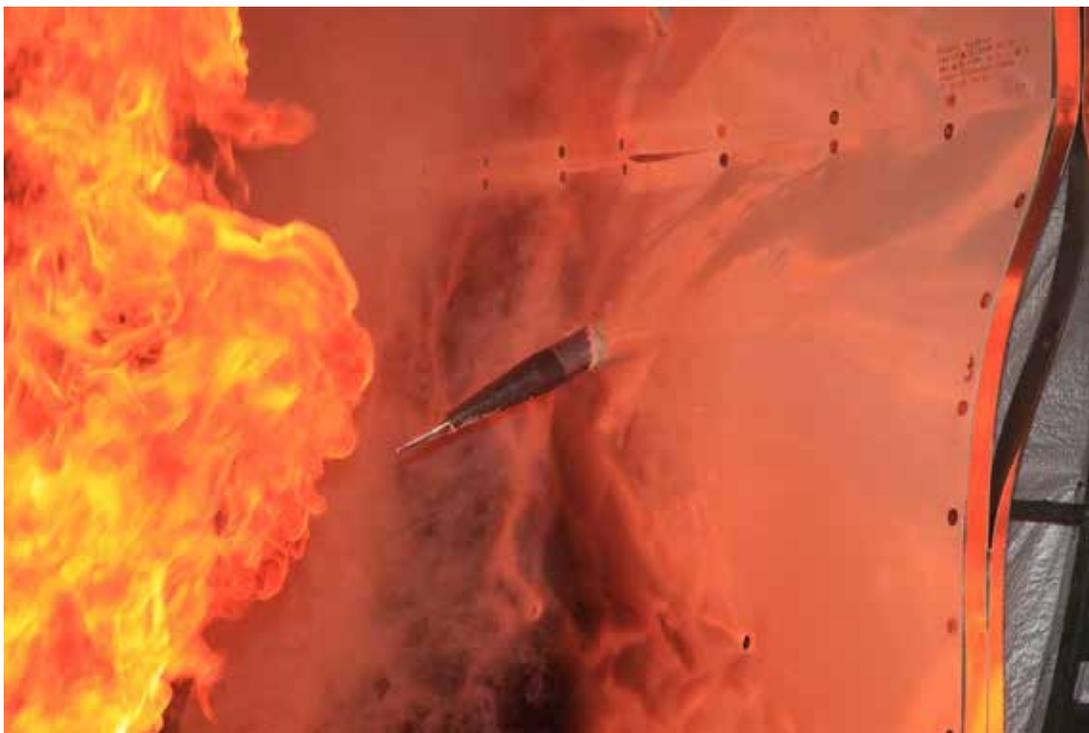
Figure 23. Complete Penetration During Full-Scale Test

The increased damage in the flame-heated tests did not interfere with penetration, as shown in figure 23. The increased heat resulted in delamination of the cargo liner, visible in the bubbled appearance of the backside in figure 24. It also came in the form of the obvious lamina separation reaching to the edge of the cargo liner as in figure 25.

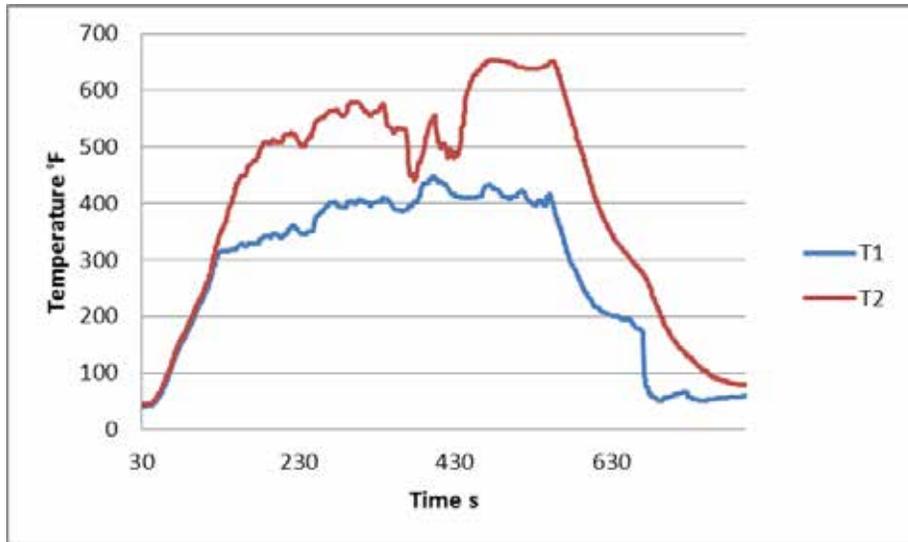
Figure 26. Inside Surface Temperature of Lower Cargo Liner Panel

Figures 26 and 27 show the temperature data from full-scale tests. Figure 26 data are from thermocouples in the center and upper parts of the lower cargo liner panel. The main mode of heat transfer in the full-scale tests was radiant heating. However, when the resin reached the right conditions, it would catch fire, and the surface flame would blend with the pan flame. The

surface charred, but often the char would burn away from further exposure to heat. This left spots of bare fiberglass, which presented as brittle or flexible, depending on the amount of localized heat.

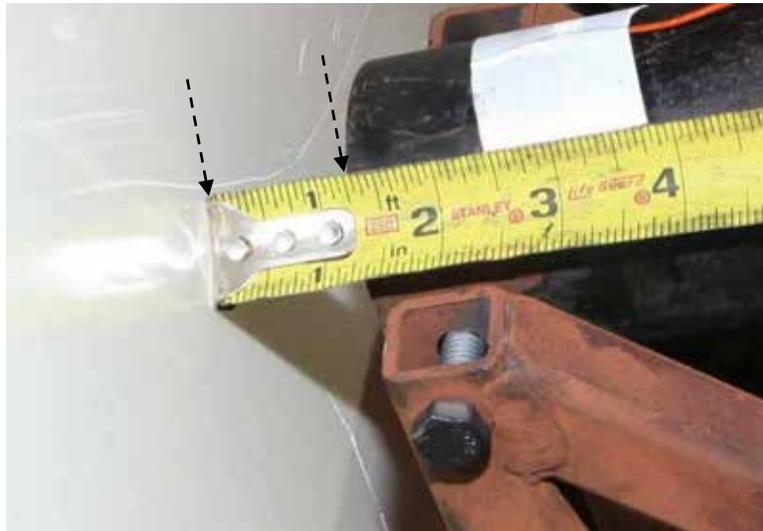
Figure 28. Deflection Offset

The small-scale tests showed that the cargo liner could stretch, although stretching was minimal when close to room temperature and much greater under heat. Figure 28 shows the offset present in the small-scale tests, and figures 29 and 30 show the amount of stretch or deflection during respective heated and unheated penetration.

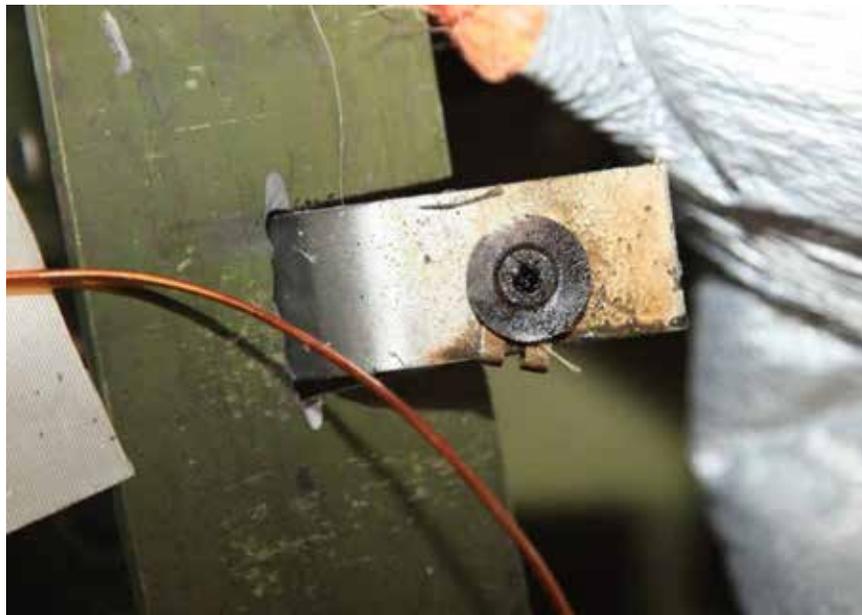
Figure 31. Screw and Washer Still Attached to Bracket

In the flame-heated scenario, if the cargo liner completely lost the resin surrounding the hardware fasteners or became hot enough to become completely pliable, the cargo liner stretched around and popped off the fender washers and screws that held it in place. In testing, this happened with the mid-field fasteners attached to single brackets, as shown in figure 31. However, when the cargo liner popped free from the mid-field mounting hardware, the ASPN was able to penetrate the cargo liner in most tests. In only 1 of the 45 fire-heated penetration tests, the ASPN was obstructed enough to possibly prevent firefighting agent from being applied. Given sufficient length, the ASPN is capable of penetrating into the interior of freighter aircraft without problem.

The flame-heated tests showed that once the cargo liner loses its resin, it becomes more susceptible to certain kinds of damage. This is evident by the screws and washers pulling through the fiberglass and remaining attached to the mounting brackets during penetration. The flame-heated tests also showed that there are instances where the mounting hardware can provide protection to the resin, thus allowing the stress applied to the cargo liner to transfer to the cargo liner frame instead of tearing the cargo liner. This protection is evident in figure 33.

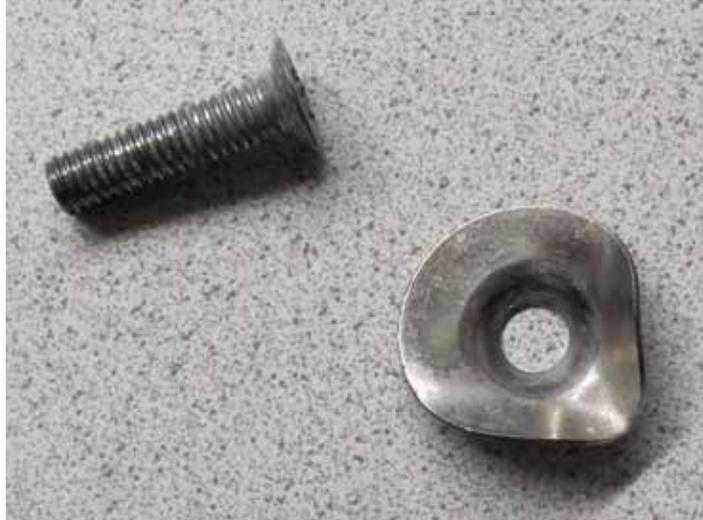
Figure 32. Washer Bent From Penetration Force

In some instances, the cargo liner pulled on the mounting hardware hard enough to bend and partially fold the fender washers surrounding the screws, as in figure 32, allowing the cargo liner to pop free from the bracket. At that point, the only hardware holding the cargo liner panels in place were the edge fasteners attached to the cargo liner frame. These fasteners typically remained secure due to their closer spacing and stress sharing between fasteners.

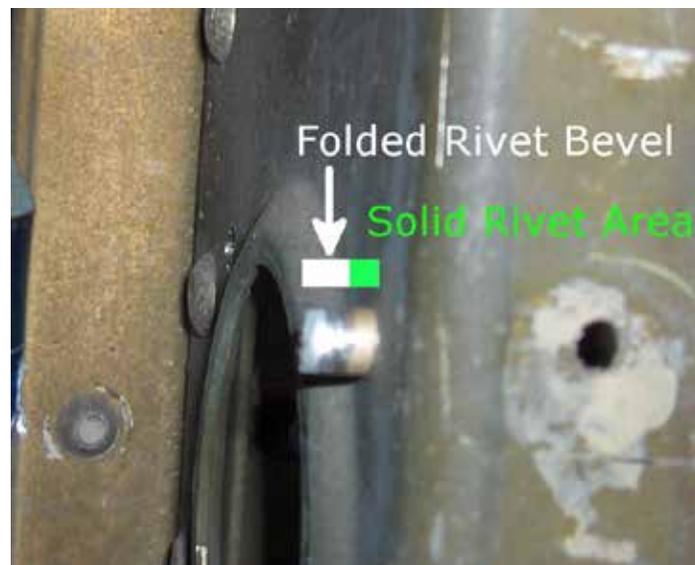
Figure 34. Rivet With Bracket Pulled off Beveled End

In general, the amount and type of stress anticipated drives the specification of aircraft hardware. Normal solid aluminum rivets are designed to hold against shear (pulling across) stresses rather than normal (pulling out/apart) stresses. Unheated cargo liner is sufficiently rigid to act as a taut membrane that transfers force to the hardware as shear stresses rather than normal tensile stresses. When the ASPN impinged on the heated and softened cargo liner, the cargo liner slackened enough to pull on the hardware differently than when rigid. It pulled at an angle that combined shear and normal stresses in such a direction as to warrant pulling out the rivets. It is then congruent that the mounting hardware would fail in this situation. In this case, the normally beveled head of the rivet folded and pulled through the fastener hole, as shown in figure 34. The addition of heat to the rivets further exacerbates the problem by softening the rivet, further reducing the strength of an otherwise already relatively low resistance to the types of forces encountered. Most aluminum alloys have typical melting points between 900°-1200°F [1], and this is within the range of aircraft fuel fires.
